RAILROAD ACCIDENT INVESTIGATION

REPORT NO. 4137

THE LONG ISLAND RAIL ROAD COMPANY

OCTOBER 18, 1967

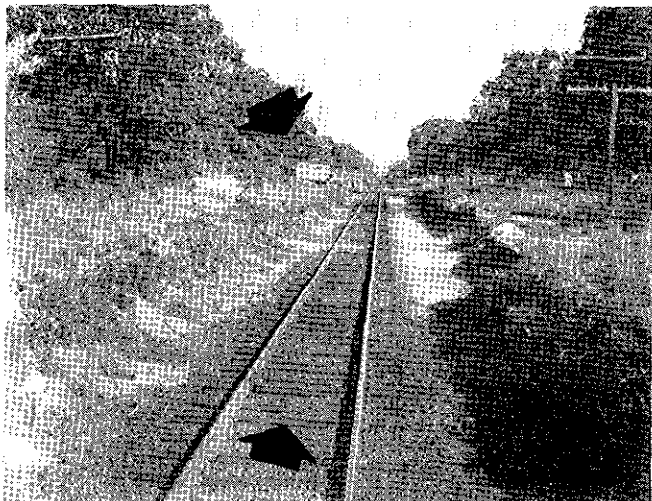
West of the Blue Point Road crossing, the main track is laid in a shallow cut. Because of the cut, trees, and other vegetation along the north side of the railroad, the view between an eastbound train approaching the crossing and a southbound vehicle approaching the track on Blue Point Road is materially restricted. However, as the vehicle approaches the crossing within a distance of 10 to 25 feet, the driver's view of the track westward increases to the extent that he may readily see any eastbound train approaching the crossing within 675 feet. As the vehicle approaches the track within 10 feet, the driver's view westward is unobstructed.

View of a southbound motortruck from an eastbound train approaching the crossing at 395 feet.

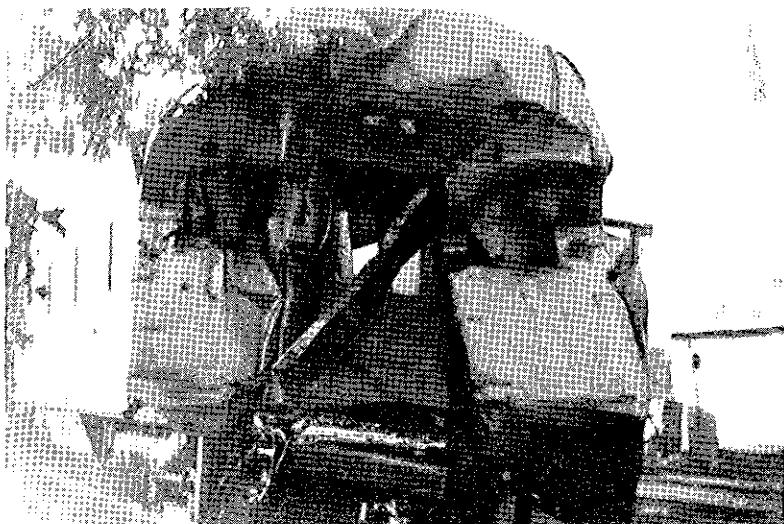
Unit 3101

The train stopped with the front end 582 feet east of the collision point. The impact of the collision caused the rear truck of the first unit to derail 67 feet west of the crossing. It rerailed itself as it moved over the Blue Point Road crossing. No other trucks were derailed. The front of the first unit was heavily damaged (see photo).

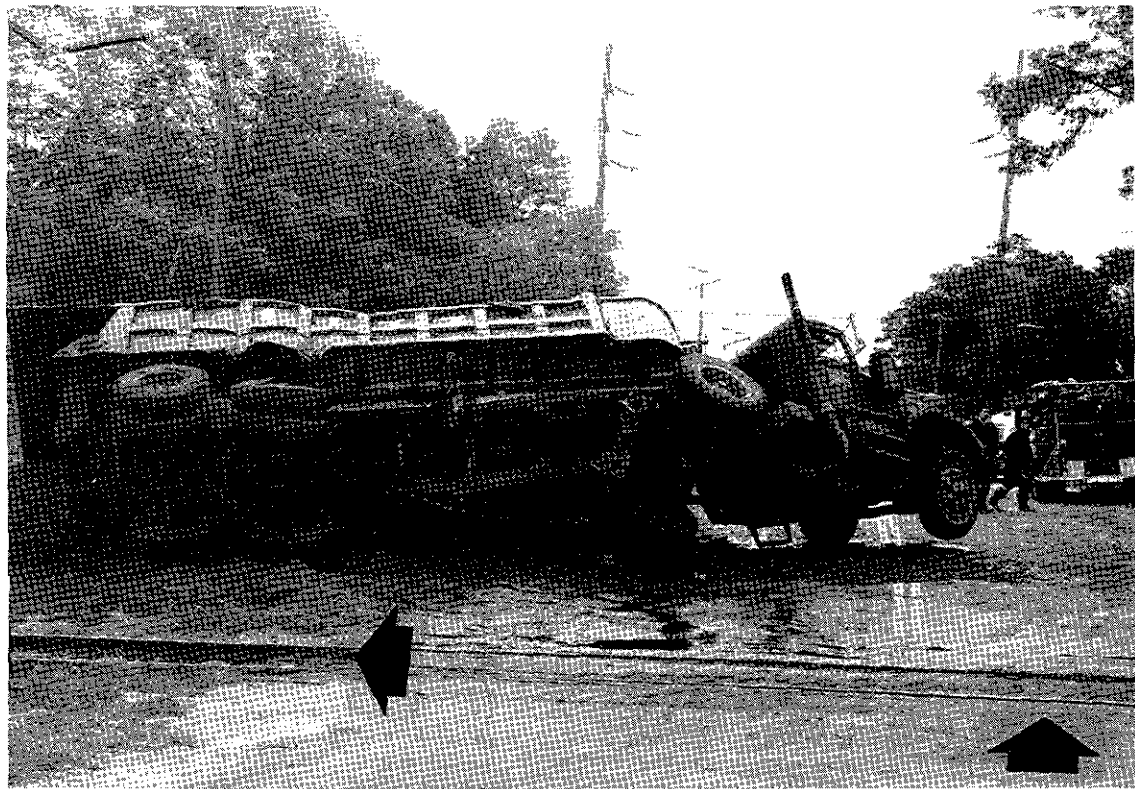
The tractor with the semitrailer attached, stopped on Blue Point Road, 35 feet south of the collision point (see photo) The tractor was heavily damaged and the semitrailer was destroyed

Arrows show direction of train and motortruck.

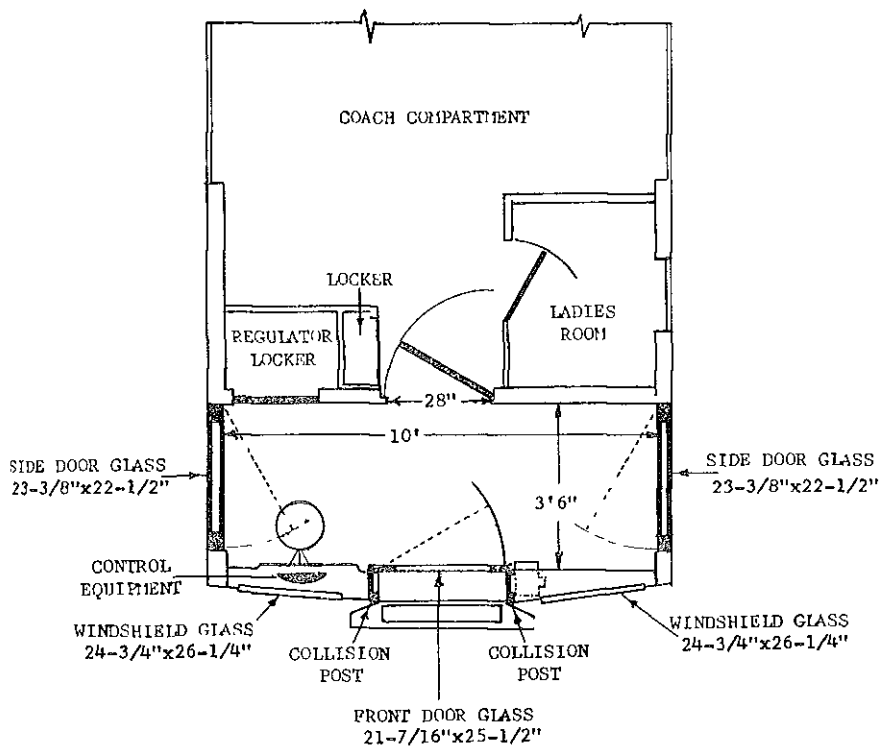
PLATE 1

No. 204, an eastbound first-class passenger train, consisted of diesel-powered passenger units 3101 and 3121, coupled in multiple-unit control. Each unit was of all-steel construction and had tightlock couplers. Unit 3101, the first unit, was 85 feet long and had vestibules at both ends. A control station was on the right side of the front vestibule. A doorway, 28 inches wide and 74 inches high, was at the rear of the vestibule, for entrance to, and exit from, the passenger compartment. The door opened inward to the passenger compartment aisle, which was 33 inches wide. See Plate 1 for details concerning the vestibule and control compartment at the front of unit 3101.
