# RAILROAD ACCIDENT REPORT

LONG ISLAND RAIL ROAD COMPANY  
DOOR ACCIDENT  
HUNTINGTON STATION, NEW YORK  
DECEMBER 1, 1974

NATIONAL TRANSPORTATION SAFETY BOARD  
Washington, D.C. 20594  
REPORT NUMBER: NTSB-RAR-75-5

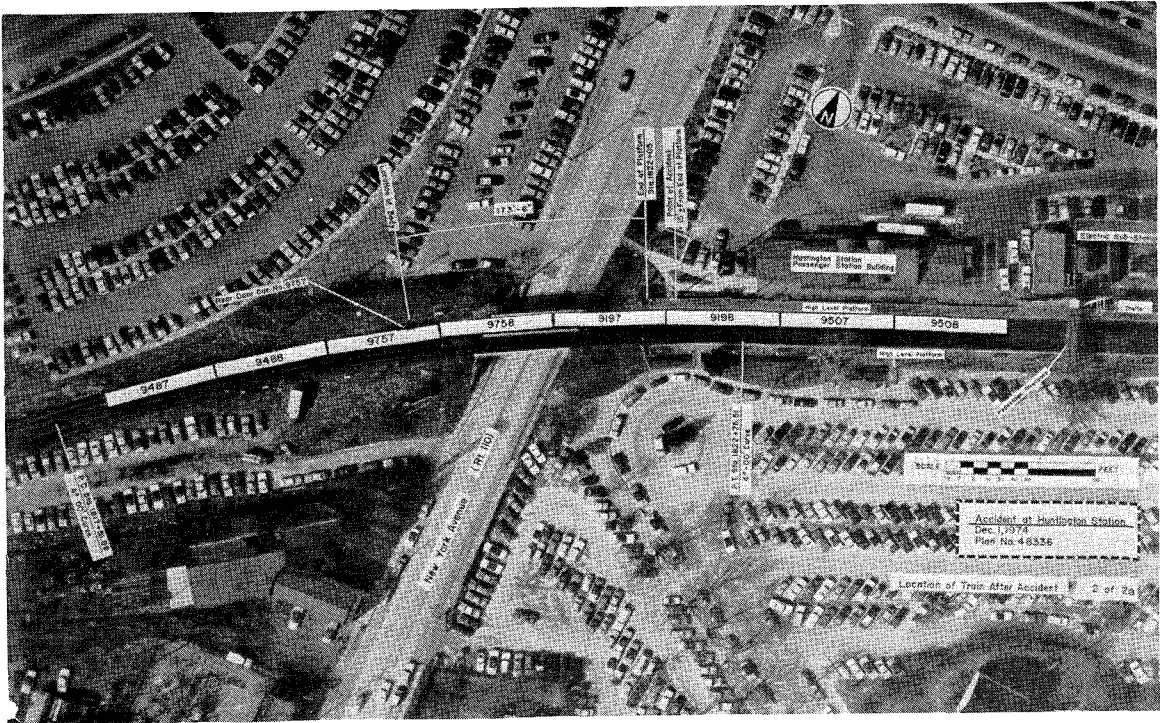
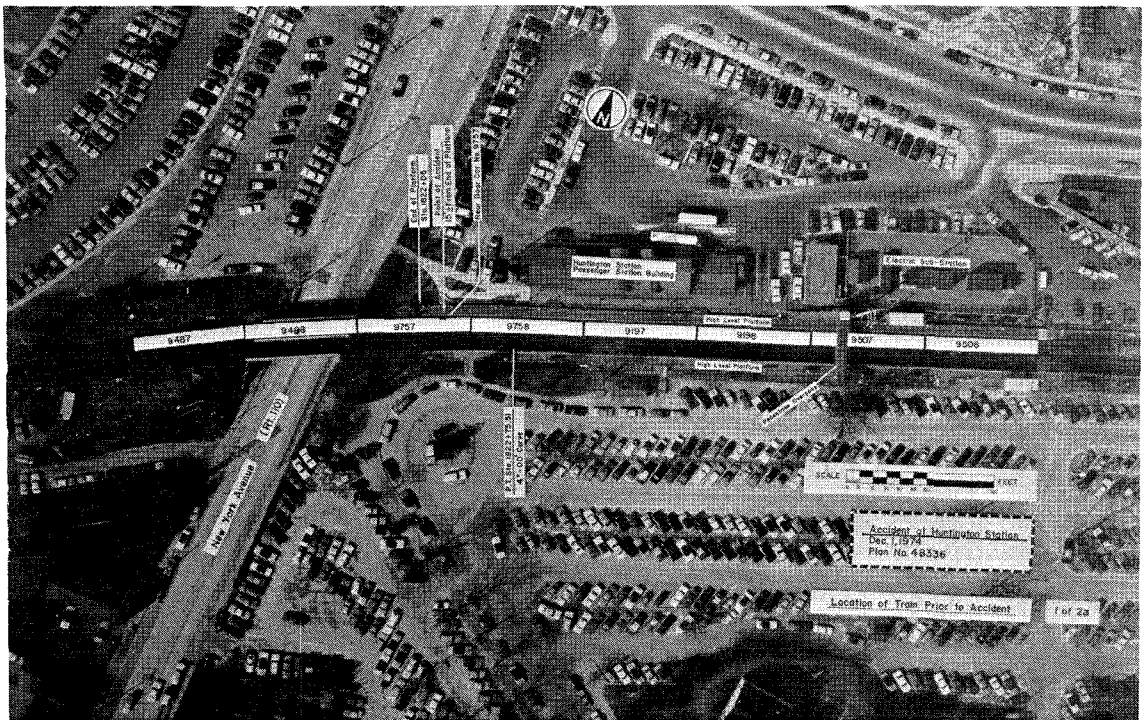
Figures 1 and 2. Site and position of train No. 5613 before and after the accident.

The track at Huntington Station, on which train No. 5613 was standing, has a slight curvature at the west end of the platform which caused the east doorway of car No. 9757 to be out of view of the conductor from his operating position in the east end of car No. 9758. (See Figure 1 for aerial view of position of train No. 5613 before the accident. See Figure 2 for position of train No. 5613 after the accident.)

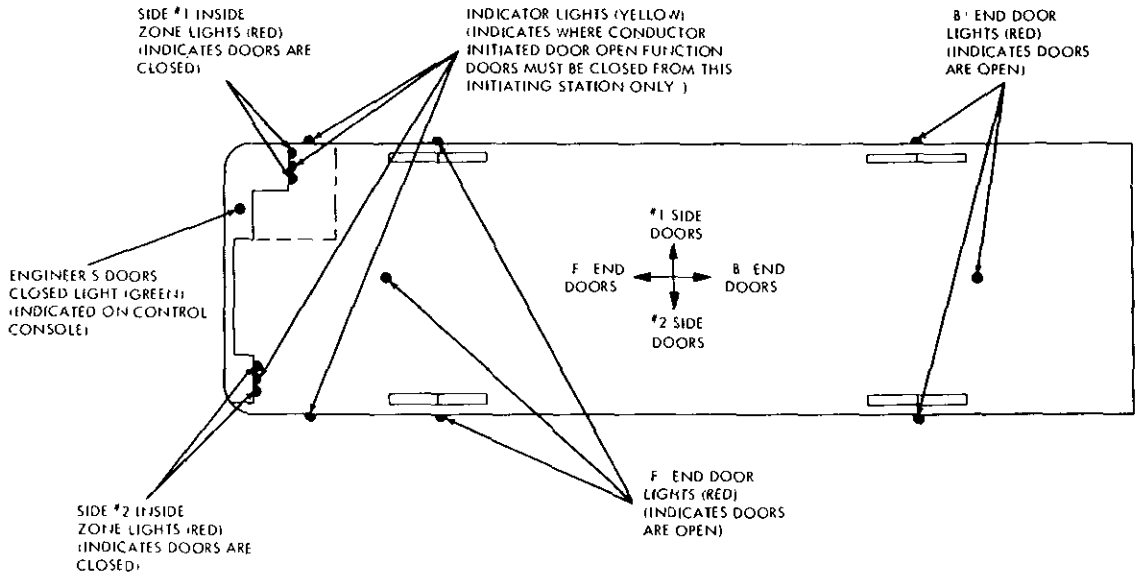
Figure 3. Door-indicator light locations.

The door indicator lights in the car in which the conductor was stationed and in the four cars to the rear were not lit, which indicated the doors were closed. The conductor could not see the doorway through which the victim attempted to exit because that car was located

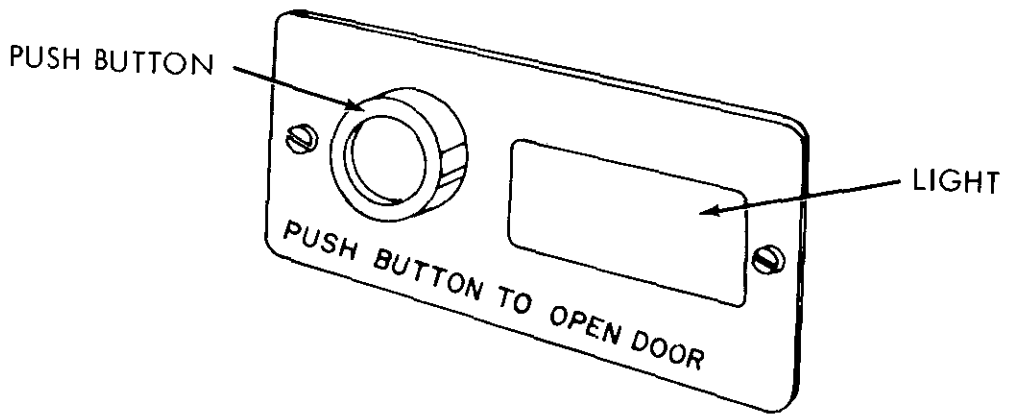
Figure 4. Interior passenger door controls.

The M-1 cars have "passenger door open" push buttons on the outside and inside of the cars at each door. See Figure 4. Operation of these controls by the passenger is at the discretion of the conductor, who may elect to use these controls during inclement weather. Only train crewmembers can close doors opened by passengers. The "passenger door open" mode was used by Train No. 5613 when it was at the Huntington Station. While both these controls exist, only the outside button is used, because the LIRR has deactivated the inside control.

10. The label on the "passenger door open" button is misleading since it implies that it could be used to open a train door in an emergency.

- b. Establish a program to inform passengers on the operation of door mechanisms, the actions to take if caught, and how and when to use the emergency brake.
- c. Modify the passenger door release label "Push Button to Open Door" so that it does not suggest or indicate that the button has an emergency use.  
(Recommendation R-75-23)

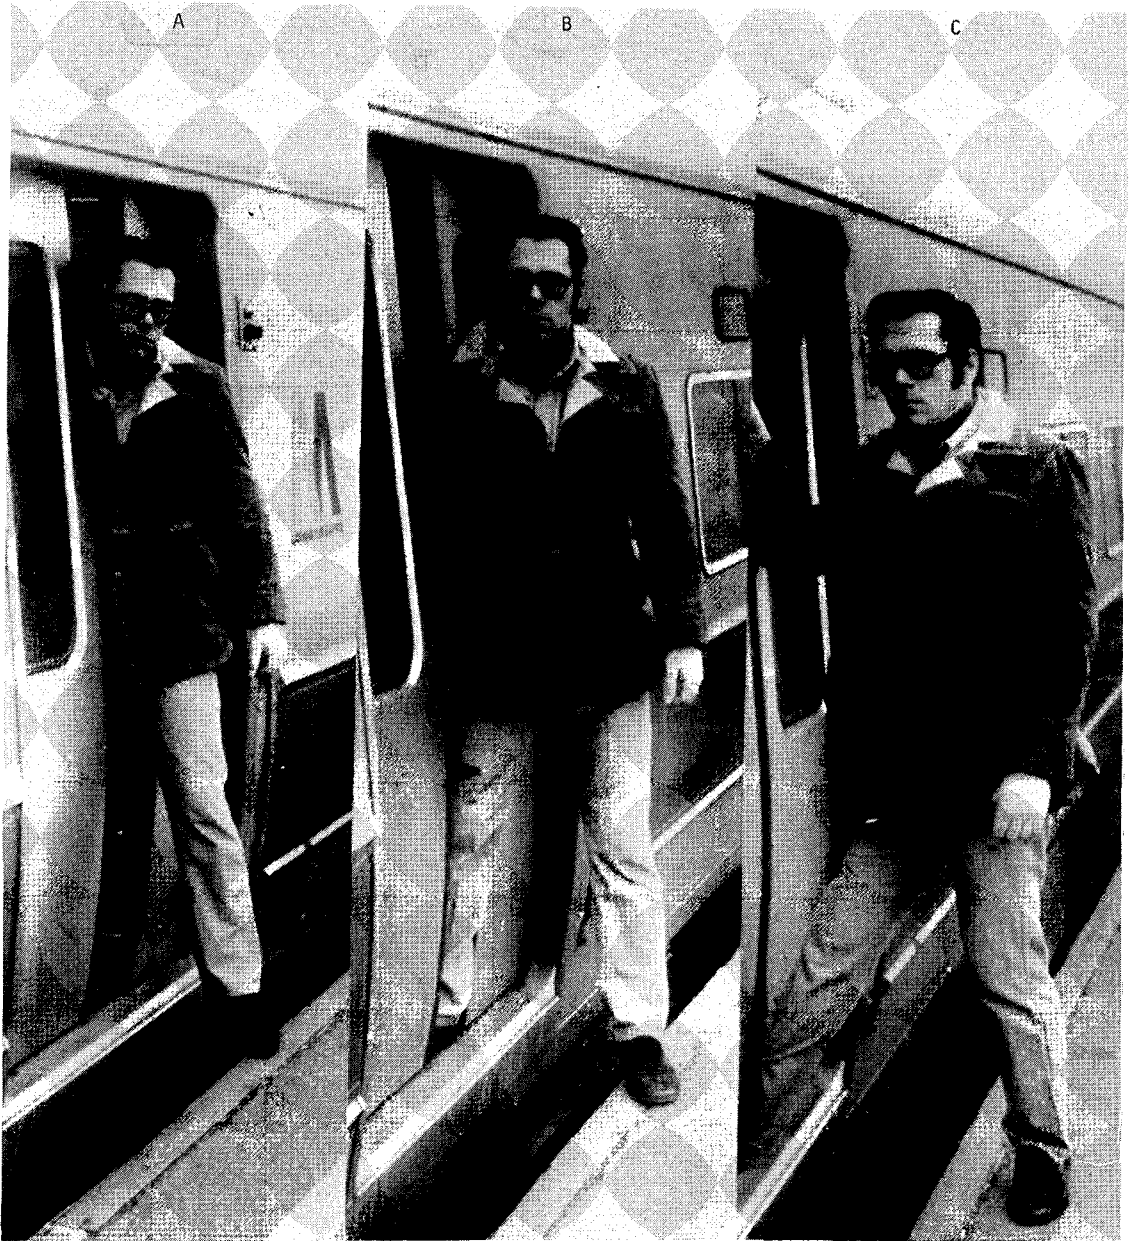
the conductor, and the woman thought to pull the emergency cord but did not know where it was. The woman passenger and two observers on the outside saw the victim get caught between the doors, chest to back. They observed that he extricated himself from between the edges of the door with the exception of his ankle (see Figures 5a, b, and c).

Figures 5a and 5b.  
Views a and b illustrate conditions  
of entrapment which afford sufficient  
door-edge separation to prevent train  
movement.

Figure 5c.  
View c is the simulated  
condition experienced by the  
victim of the accident.

This accident occurred because the design of the door allowed a 3-inch metal-to-metal separation when the door was locked. It is evident from the 22 dragging accidents the LIRR has experienced that if a passenger catches a part of his body, such as a foot, between the door edges, he cannot remove it until the door is opened (see Figure 5c).
