INTERSTATE COMMERCE COMMISSION

Ex Parte No. 176

ACCIDENT NEAR JAMAICA, N. Y.

Decided December 18, 1950

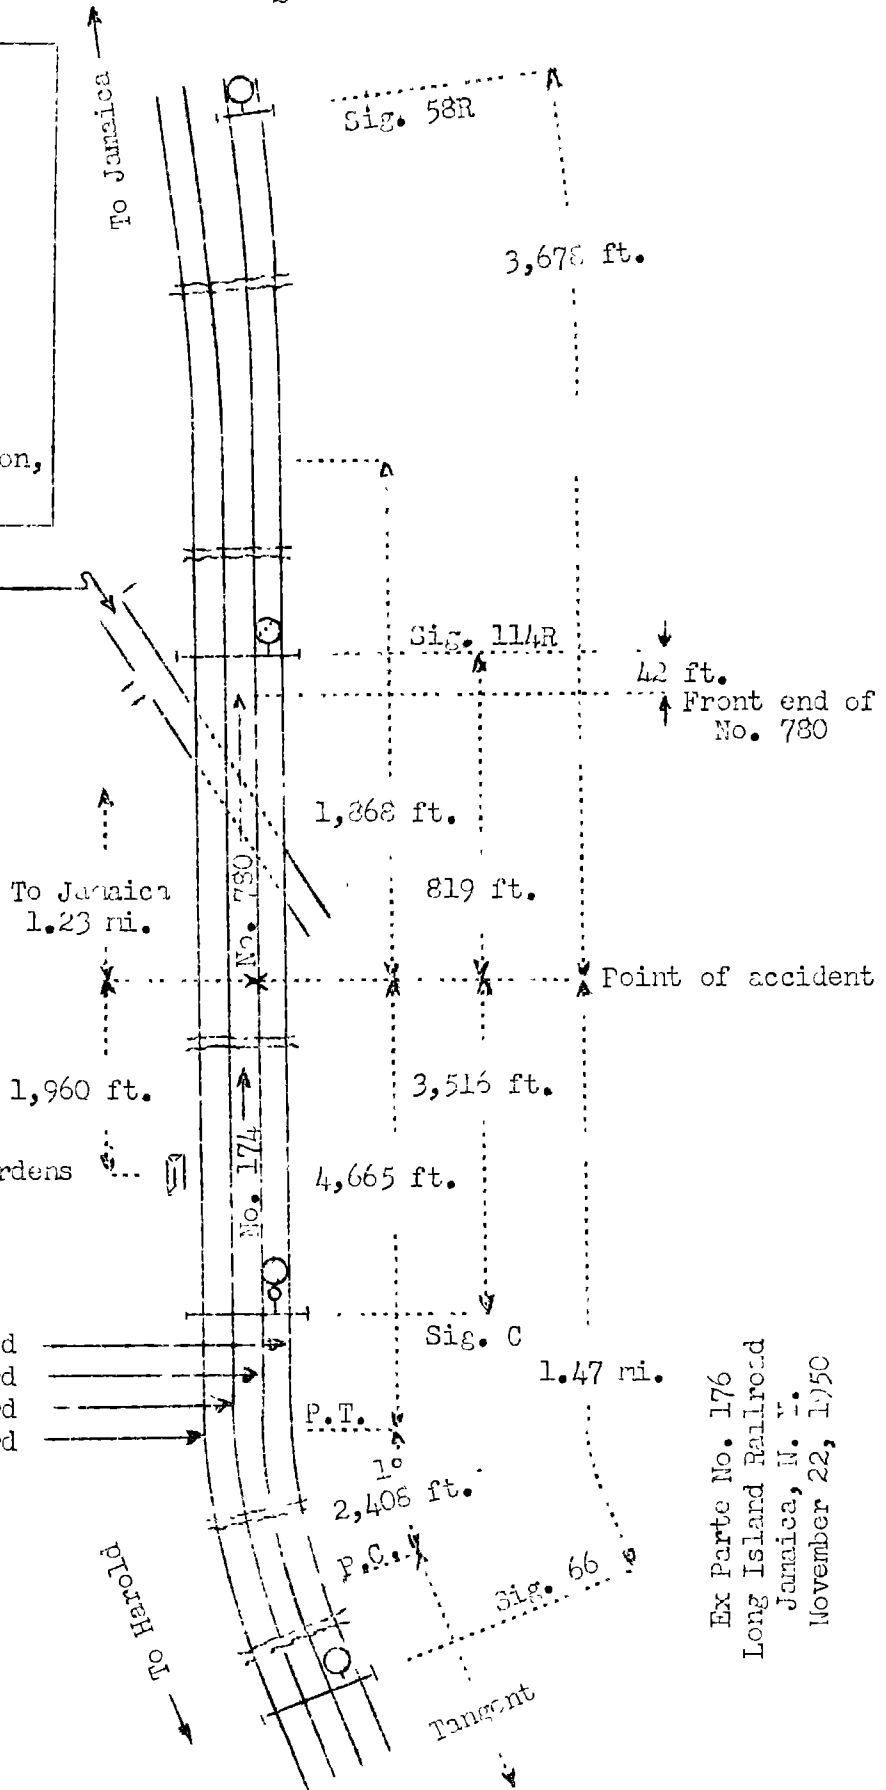
Ex Parte No. 176  
 Long Island Railroad  
 Jamaica, N. Y.  
 November 22, 1950

- o Jamaica, N. Y.
- | 0.30 mi.
- o Jay
- | 0.93 mi.
- X Point of accident
- | 0.37 mi.
- o Kew Gardens
- | 3.90 mi.
- o Win
- | 2.00 mi.
- o Harold
- | 3.70 mi.
- o Pennsylvania Station,  
New York, N. Y.

Track No. 4, eastward  
 Track No. 2, eastward  
 Track No. 1, westward  
 Track No. 3, westward

Automatic signals 66 and C and semi-automatic signals 114R and 58R, governing east-bound movement on track No. 2, are located, respectively, 1.47 miles west, 3,516 feet west, 819 feet east, and 3,678 feet east of the point of accident. These signals are of the position-light type and are continuously lighted. Signal 66 displays three aspects, signal C displays five aspects, and signal 114R displays eight aspects. Signals 114R and 58R are controlled from the interlocking station at Jay, 7.2 miles east of Harold. Aspects applicable to this investigation and the corresponding indications and names are as follows:
