INTERSTATE COMMERCE COMMISSION

REPORT OF THE DIRECTOR OF THE BUREAU OF SAFETY CONCERNING AN
ACCIDENT WHICH OCCURRED ON THE LONG ISLAND RAILROAD
NEAR MONTAUK, N. Y., ON OCTOBER 25, 1932.

December 19, 1932.

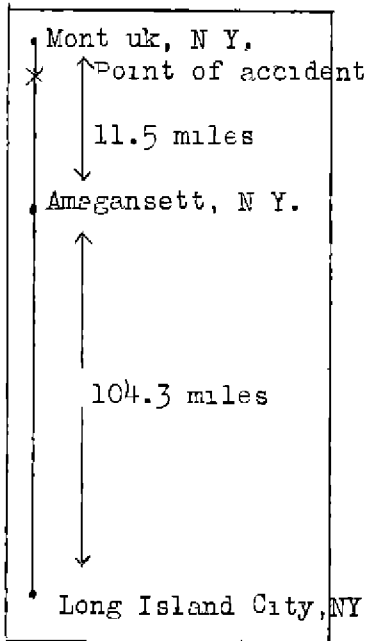
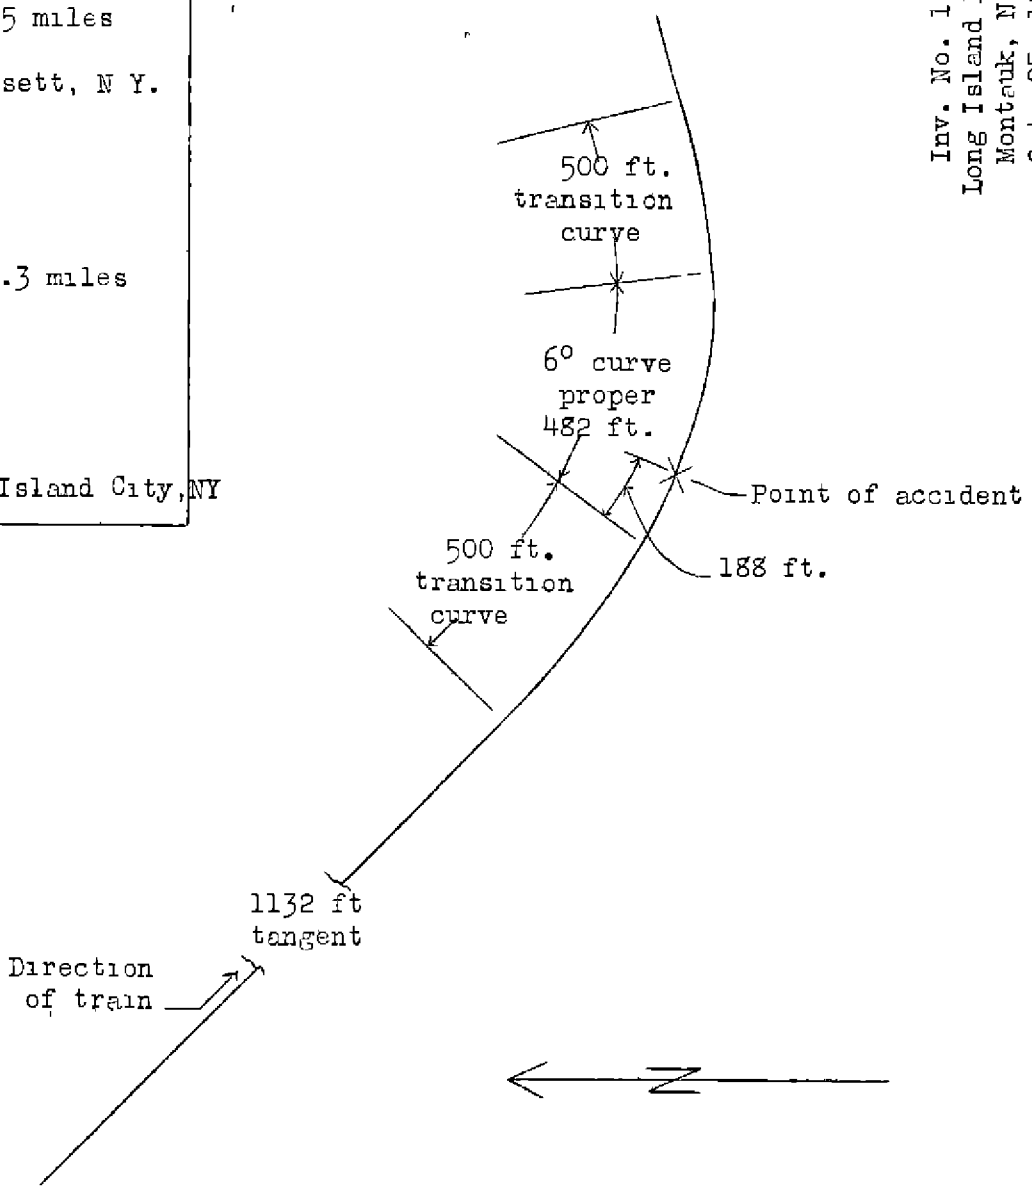
Inv. No. 1792
Long Island R.R.,
Montauk, N Y
Oct. 25, 1932

The entire train was derailed, with the exception of the rear truck of the last car. The engine, tender and first car were derailed to the south and stopped on their right sides, the front end of the engine being 325 feet east of the initial point of derailment, the first car was resting diagonally across the tender. The second car was to the north and alongside the first car, while the third car was upright, with its head end wedged against the rear of the first and second cars. The engine, tender, and first three cars were badly damaged, while the last two cars were upright and only slightly damaged. The engine had been forced ahead some distance after it overturned and the open throttle kept the driving wheels revolving until the steam pressure was exhausted. The employees killed were the engineman and fireman, while the employee injured was a coach cleaner, no revenue passengers were on the train at the time of the accident.

This accident was caused by excessive speed on a sharp curve.
