INVESTIGATION NO. 3104
THE LONG ISLAND RAILROAD COMPANY
REPORT IN RE ACCIDENT
AT NORTH YARD, LONG ISLAND CITY, N. Y., ON
MAY 25, 1947

June 30, 1947

Accident at North Yard, Long Island City, N. Y., on May
25, 1947, caused by separation of couplers during
yard movement of engines and cars, as a result of
a knuckle lock not being in locking position.

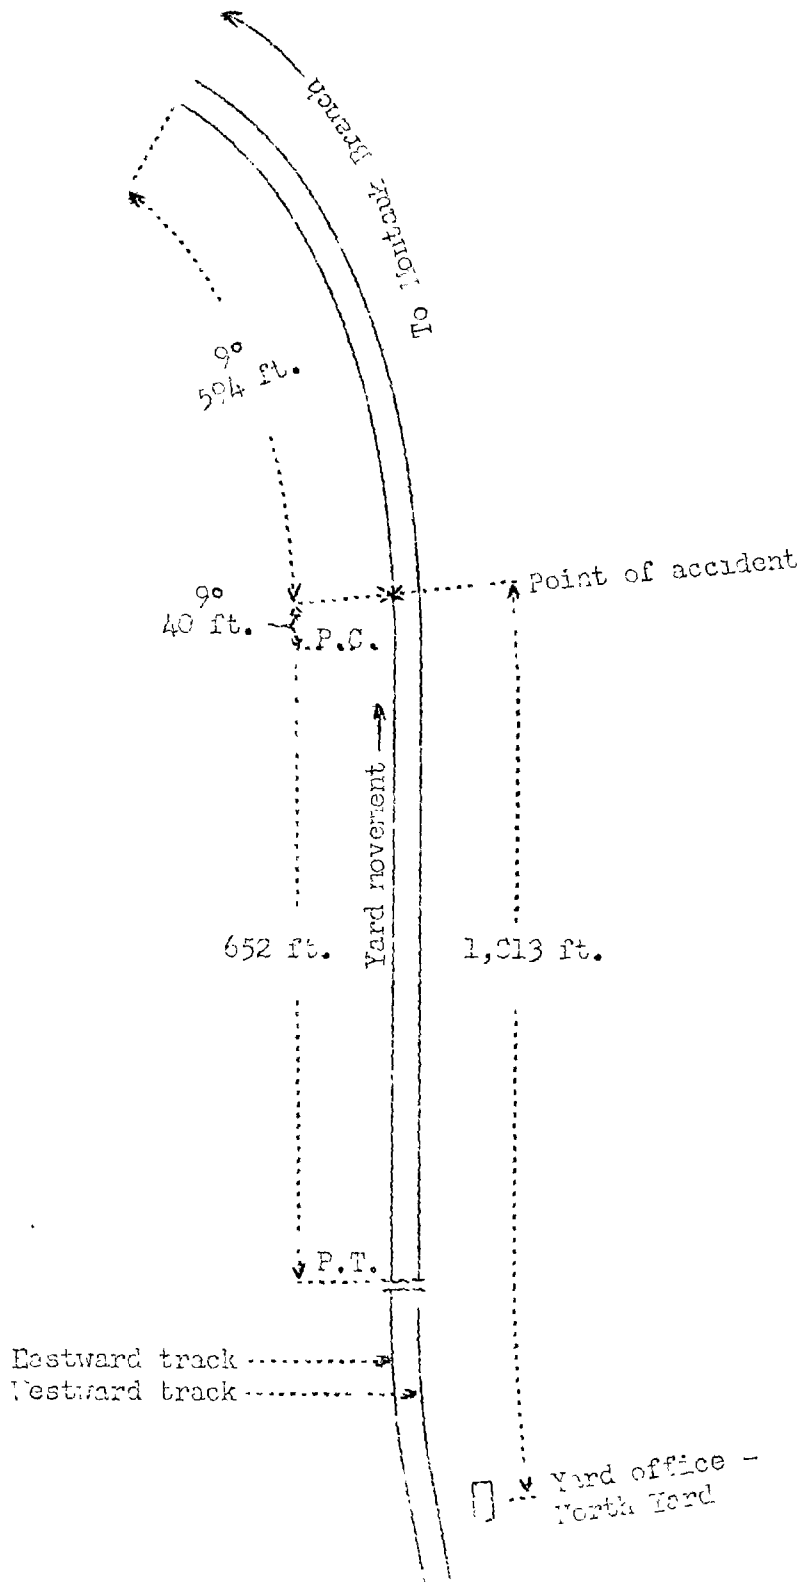
Inv. No. 2104
Long Island Railroad
North Yard, Long Island City, N. Y.
May 25, 1947

This accident occurred on that part of the railroad designated as North Yard, Long Island City, N. Y. In the vicinity of the point of accident two parallel lead tracks, 0.63 mile in length, connect a classification yard on the west and the main tracks of a line designated as the Montauk Branch on the east. The lead tracks from south to north are designated as westward track and eastward track. Movements on these tracks are governed by operating rules and special instructions. The accident occurred on the eastward track at a point 1,813 feet east of the yard office at North Yard. From the west on the eastward track there is a tangent 652 feet in length, then a 9° curve to the left 40 feet to the point of accident and 594 feet eastward. The grade is 1.2 percent ascending eastward.
