REPORT NO. 3311
THE LONG ISLAND RAILROAD COMPANY
IN RE ACCIDENT
NEAR ROCKVILLE CENTRE, N. Y., ON
FEBRUARY 17, 1950

Date: February 17, 1950

Kind of accident: Side collision

Accident near Rockville Centre, N. Y., on February 17,
1950, caused by failure to operate the east-bound
train in accordance with signal indications.

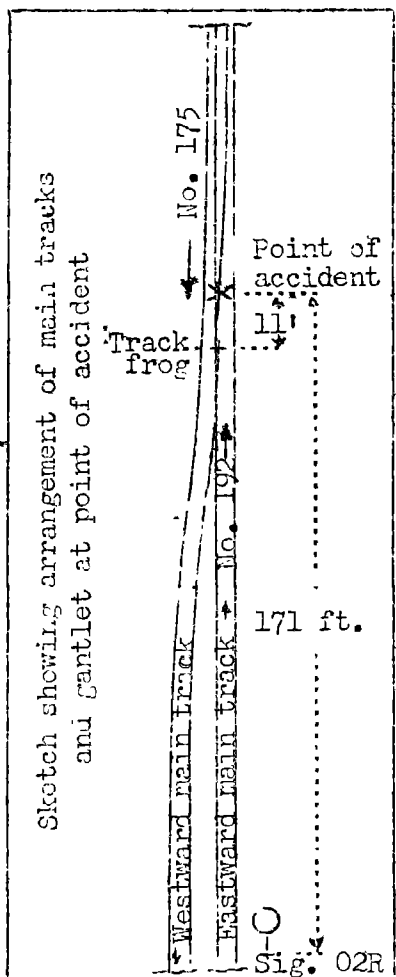
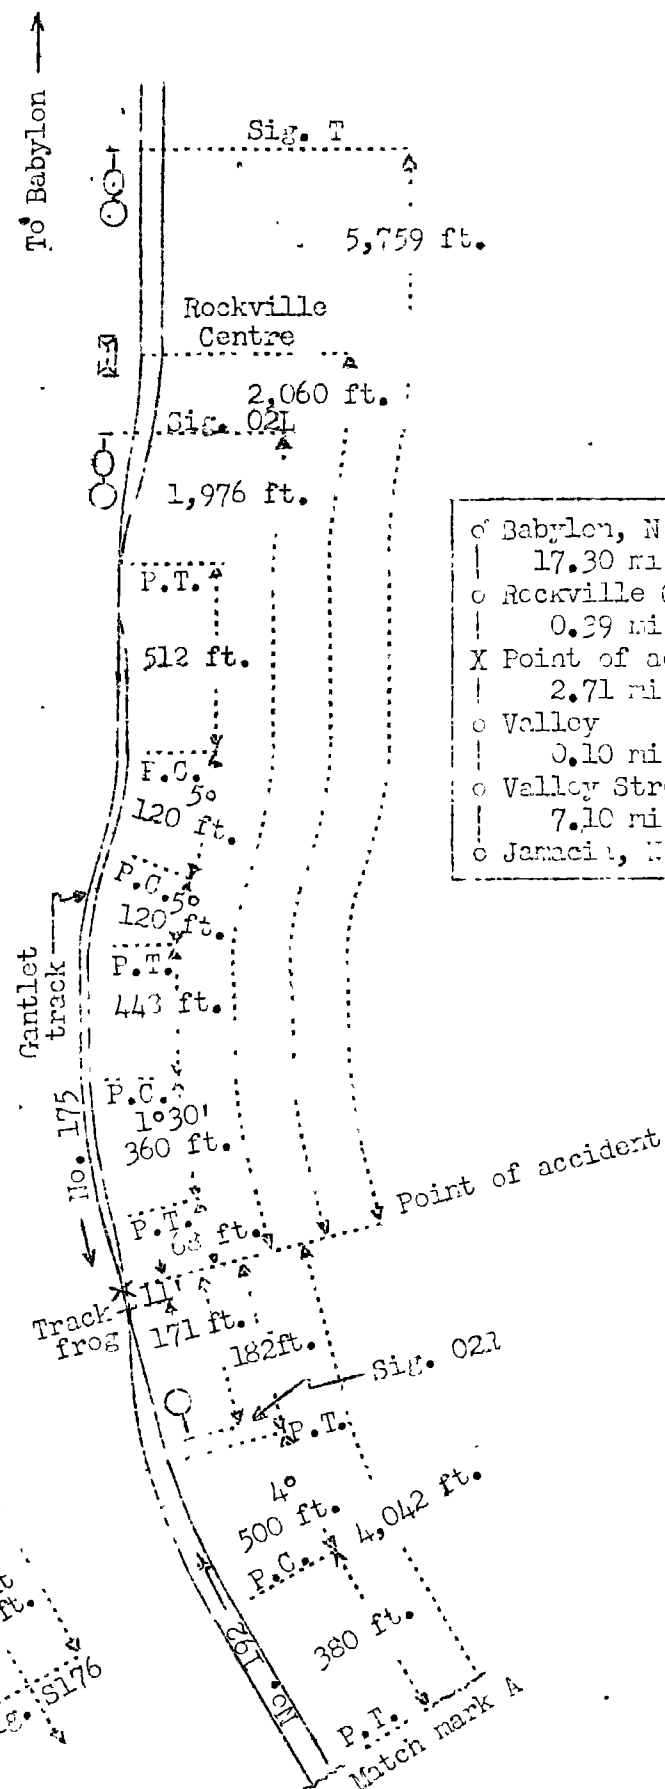
Sketch showing arrangement of main tracks and gantlet at point of accident

The trains collided at a point about 11 feet east of the frog at the west end of the gantlet. The first car and the front truck of the second car of No. 175 were derailed to the north, and the train stopped with the west end of the first car 49 feet west of the point of accident. The first car stopped against an embankment north of the track and leaned to the right at an angle of 30 degrees. The left side of the front vestibule was crushed and the left side of the car was demolished. The second car remained upright and was badly damaged. The third, fourth, fifth, sixth, ninth, and tenth cars were somewhat damaged. The front truck of the first car of No. 192 was derailed to the south, and
