RAILROAD ACCIDENT INVESTIGATION

Report No. 4139

LOUISIANA & ARKANSAS RAILWAY COMPANY

DECEMBER 8, 1967

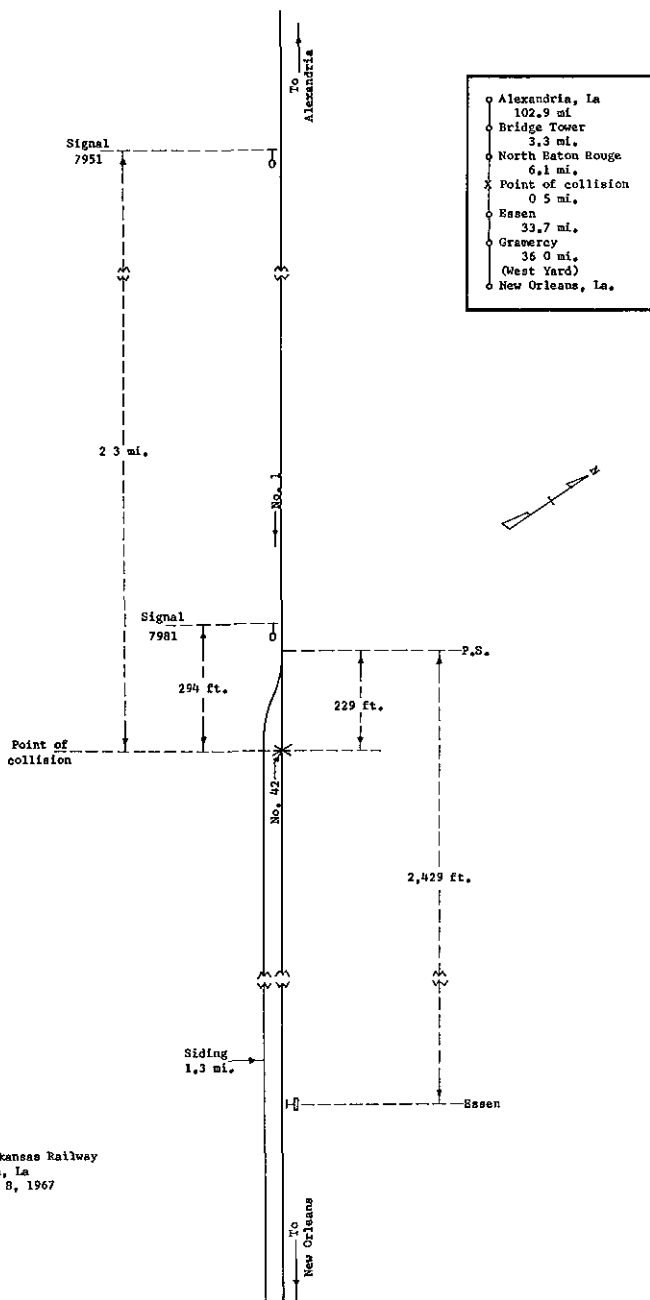
Louisiana & Arkansas Railway
Esson, La.
December 8, 1967

The collision occurred on the main track, 229 feet south of the north switch of the Essen siding

Automatic signals 7951 and 7981, governing southbound movements on the main track, are 2.3 miles and 294 feet north of the collision point, respectively These signals are of the color-light type and are continuously lighted. The applicable aspects, and corresponding indications and names, are as follows:
