# NATIONAL TRANSPORTATION SAFETY BOARD

**COLLISION OF A  
LOUISIANA & ARKANSAS RAILWAY  
FREIGHT TRAIN AND A L.V. RHYMES  
TRACTOR-SEMITRAILER AT  
GOLDONNA, LOUISIANA  
DECEMBER 28, 1977**

REPORT NUMBER: NTSB-RHR-78-1

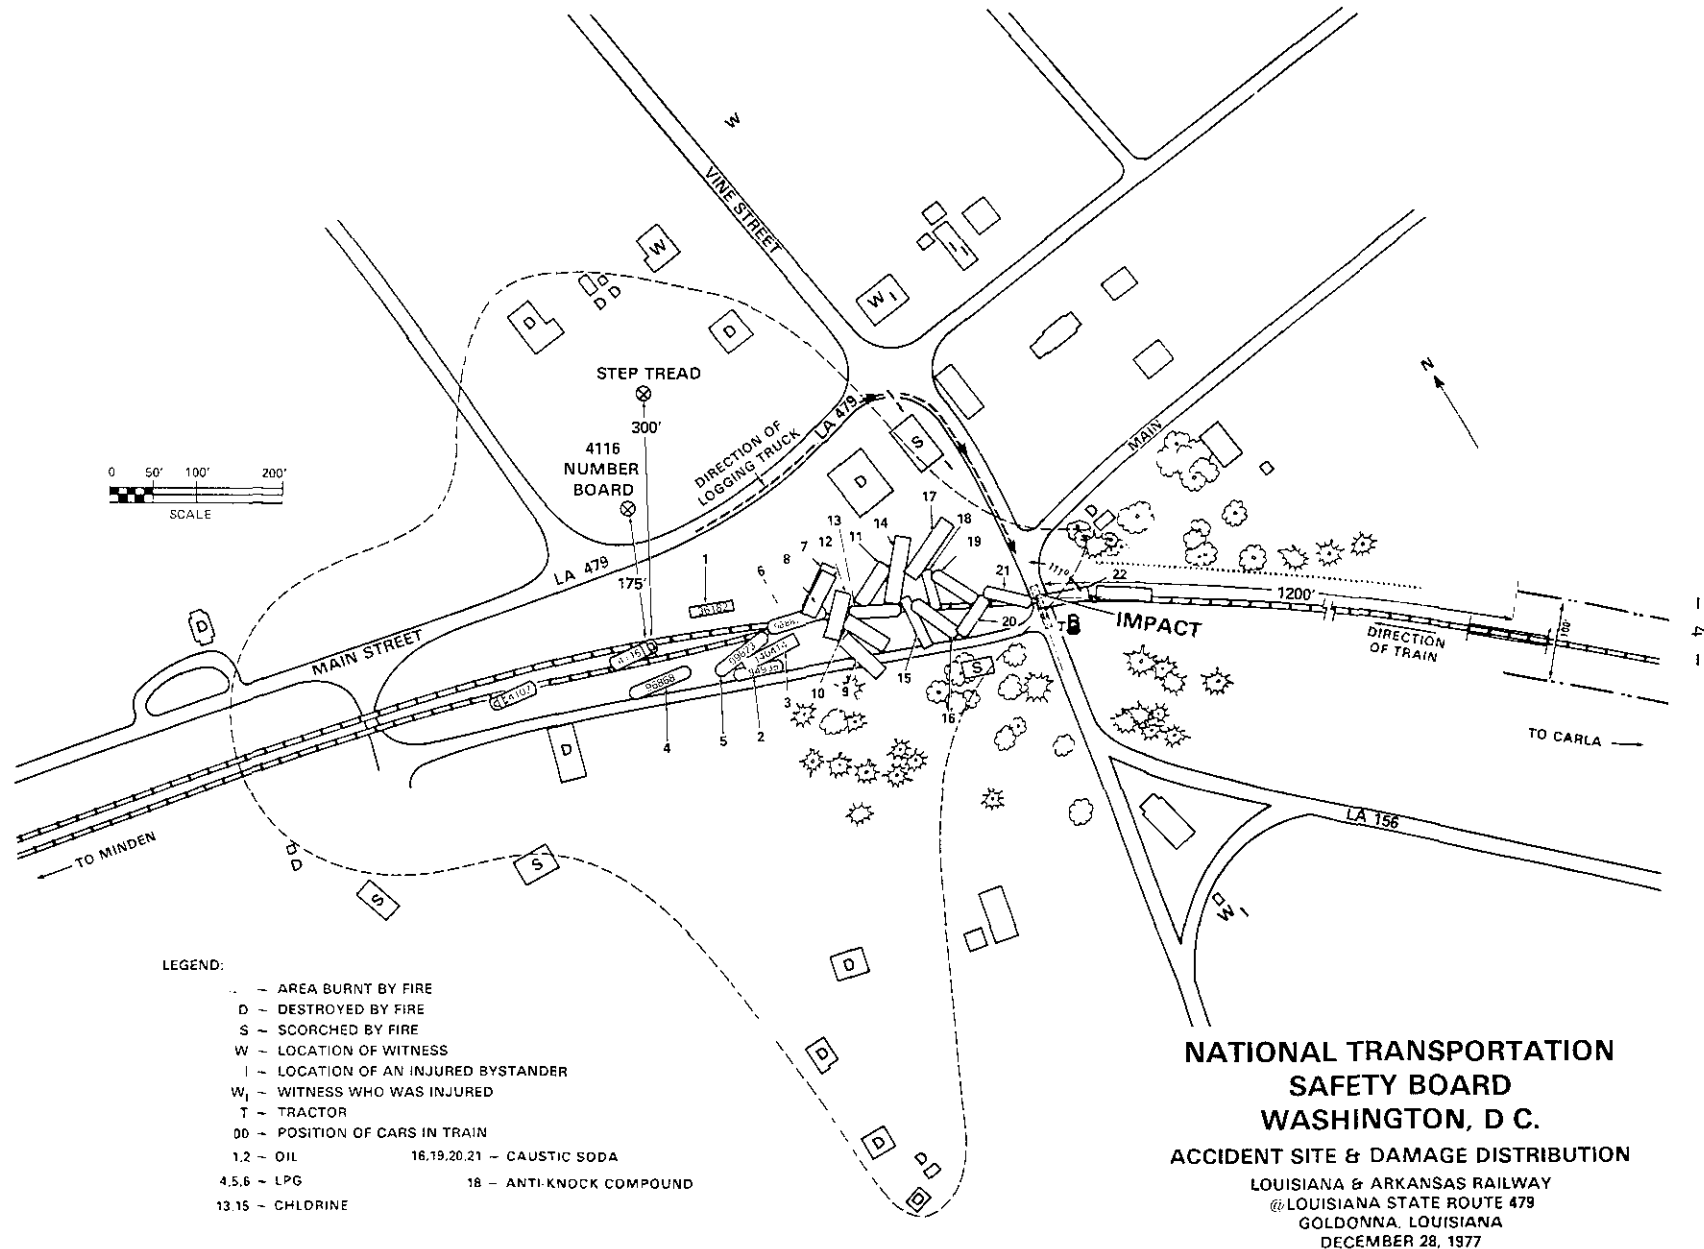
Figure 1. Plan view of accident site and wreckage distribution.

The lead locomotive unit struck the semitrailer near the middle of the load of logs, immediately ahead of the lead trailer axle. The deck of the locomotive unit went under the logs and severed the connecting pole of the semitrailer. The tractor, which had cleared the crossing, jackknifed to the left 160° and came to rest upright about 20 feet from the crossing.

The front truck of the lead locomotive unit derailed about 50 feet west of the crossing when it struck logs which had fallen across the track. The derailed wheels struck a facing-point turnout 211 feet west

of the crossing, where the trailing truck derailed. Straddling the main track and siding, the unit traveled 440 feet beyond the turnout before it stopped. During the derailment the unit's fuel tank was ruptured by a rail. Both trucks of the trailing locomotive unit derailed, and the unit separated from the lead unit. The train stopped 75 feet east of the lead unit.

The first 22 cars of the train derailed between the turnout and the crossing, and all but the last two derailed cars became separated. The first car veered to the north and the next two cars derailed to the south. The fourth car, a tank car loaded with liquefied petroleum gas (LPG), left its trucks at the turnout, and had its rear tank head punctured by the coupler of the following car. The tank car continued to slide forward along the main track and rammed the rear of the trailing locomotive unit which was still moving westward. The impact punctured the front head of the tank and ignited the gas. The resultant fireball covered an elliptical area about 1,200 feet long on a north-south axis. (See figure 1.) Fire completely enveloped the trailing unit, killing the flagman in the cab. Fuel that escaped from the ruptured tank of the lead locomotive unit was ignited and killed the engineer and severely injured the head brakeman. The truckdriver was burned slightly as he fled his truck. Sixteen buildings in the area were burned and eight persons were injured when caught in the open after the LPG ignited.

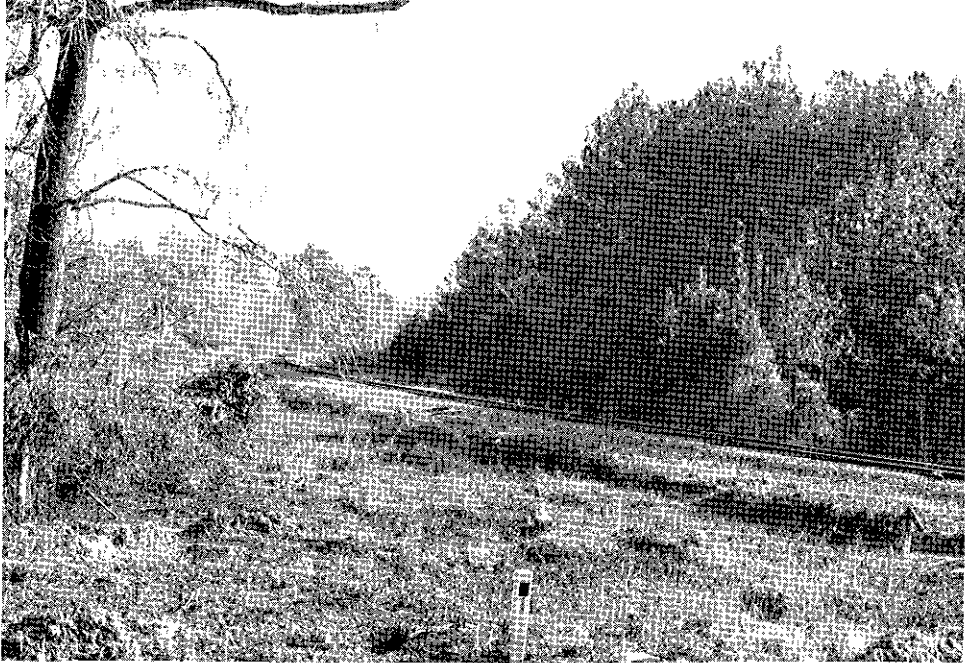
The first unobstructed view that the driver of a southbound vehicle had of the track east of the crossing was from a point 96 feet north of

the crossing. (See figures 2 and 3.) Angle of intersection in the northeast quadrant is 111°. Standard crossbuck warning signs with reflectorized faces were located in the northwest and southeast quadrants. There was a standard advance warning sign for southbound traffic located on the right shoulder of the road 106 feet north of the crossing.

Figure 2. View of track to east from 96 feet north of the crossing - truckdriver's first, unobstructed view across northeast quadrant.

In addition to the short sighting distance in the northeast quadrant of the crossing, the train's angle of approach was nearly dead ahead as seen from the point of first clear view. The driver would have had great difficulty judging the speed of the approaching train when viewing it dead ahead. After seeing the train, a driver of a heavy vehicle must instantly decide what action to take. Louisiana law requires him to stop and yield the right of way only when, in his judgment, the train's speed and location represent a hazard to him.

"Include in its grade crossing safety criteria the evaluation of existing quadrant sight distances. Include in its grade crossing safety program provision for intermediate remedial action to eliminate hazards at crossings where there are no train-activated warning devices. (Class II, Priority Action) (H-78-47)

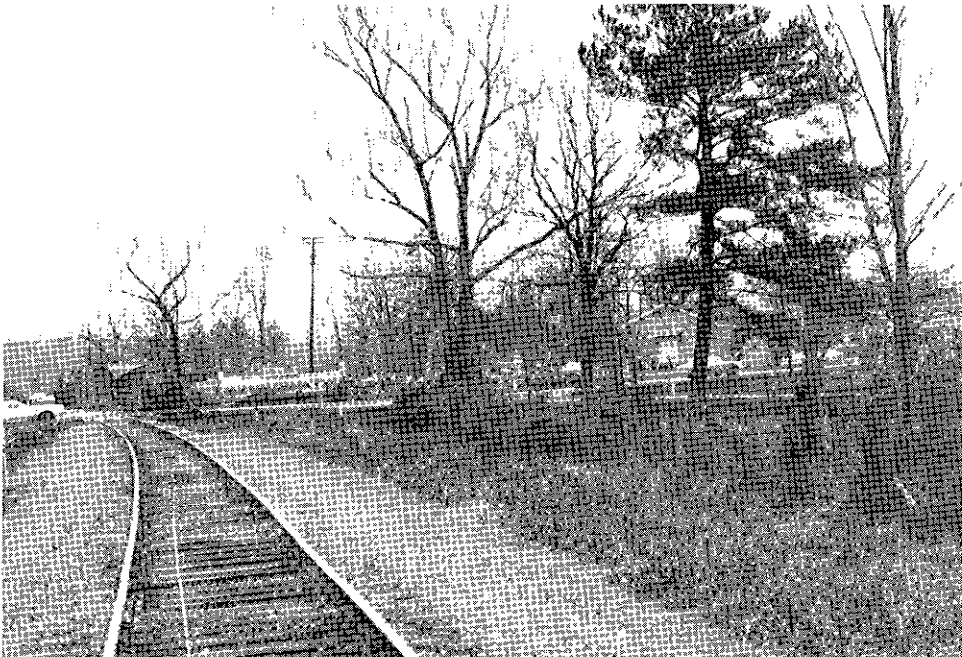
Figure 3. View of north approach to the crossing from the track 300 feet to the east. Fire defoliated the trees and destroyed a small building located in this quadrant.

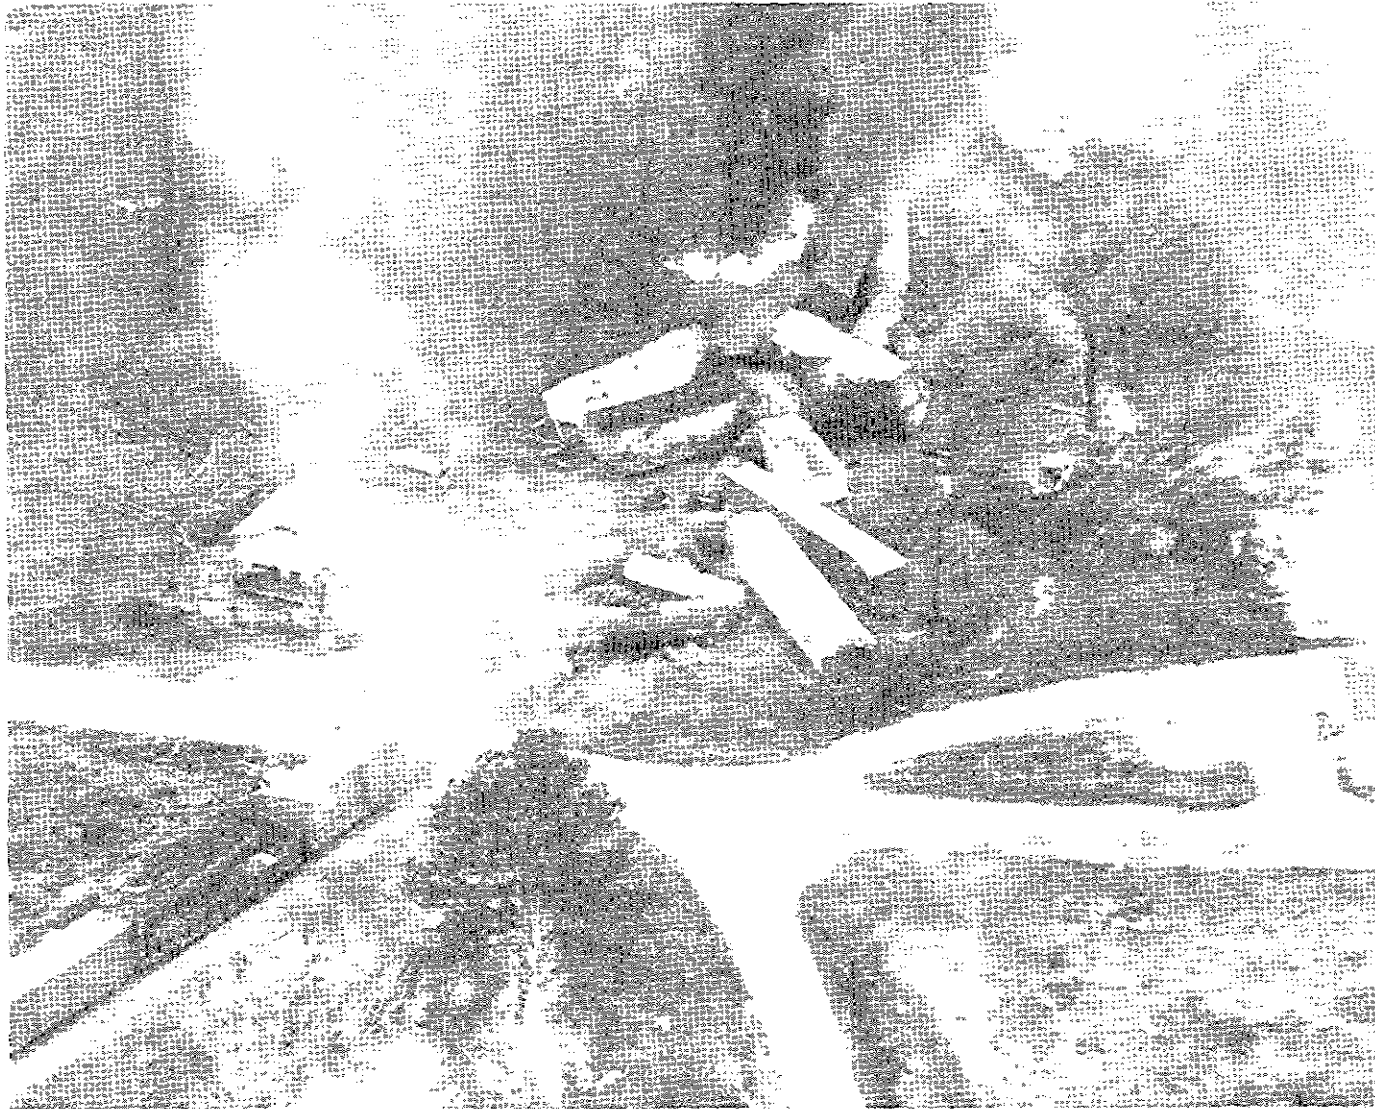
The lead locomotive unit's short hood compartment and cab were heavily damaged by the collision. Fire from the fuel tank completely burned out the unit. The trailing locomotive unit was extensively damaged when it was rammed by the tank car. Additional damage was caused by the explosion of the gas and the resultant fireball. Both locomotive units and 9 of the 22 derailed cars were destroyed. All but 2 of the remaining 13 cars were heavily damaged and much of their lading was lost. About 1,000 feet of track and a turnout were destroyed. (See figure 4.)

Figure 4. Aerial view of accident area taken from the east.

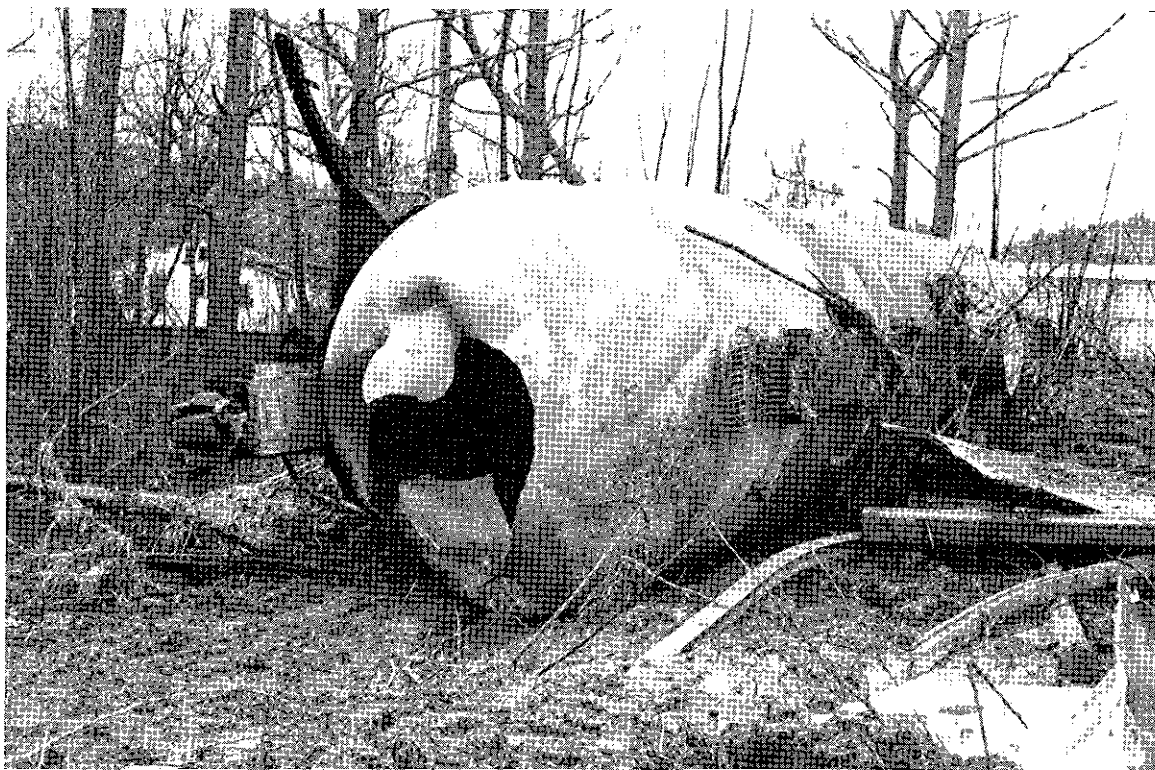
The three loaded tank cars coupled together near the head end of the train were DOT Specification 112A340W, provided with standard Type E couplers. Each was loaded with about 31,000 gallons of LPG and was placarded "Flammable Gas." The tank heads of these cars were of 11/16-inch plate steel. None of the cars were fitted with head shields or top and bottom shelf couplers. (See figure 5.)

Figure 5. Punctured head of LPG tank car GATX 96868.

The three train crewmembers on the locomotive units should have survived the collision without serious injury. The severity of the casualties was attributed to the rupture and ignition of the LPG tank car, the proximity of this car to the locomotive units, and the inability of the engineer and head brakeman to escape because the operator's compartment was so badly deformed.

"Assure that the Louisiana & Arkansas Railway Company complies with the requirements of 49 CFR 174, Transportation of Hazardous Materials. (Class II, Priority Action) (R-78-26)

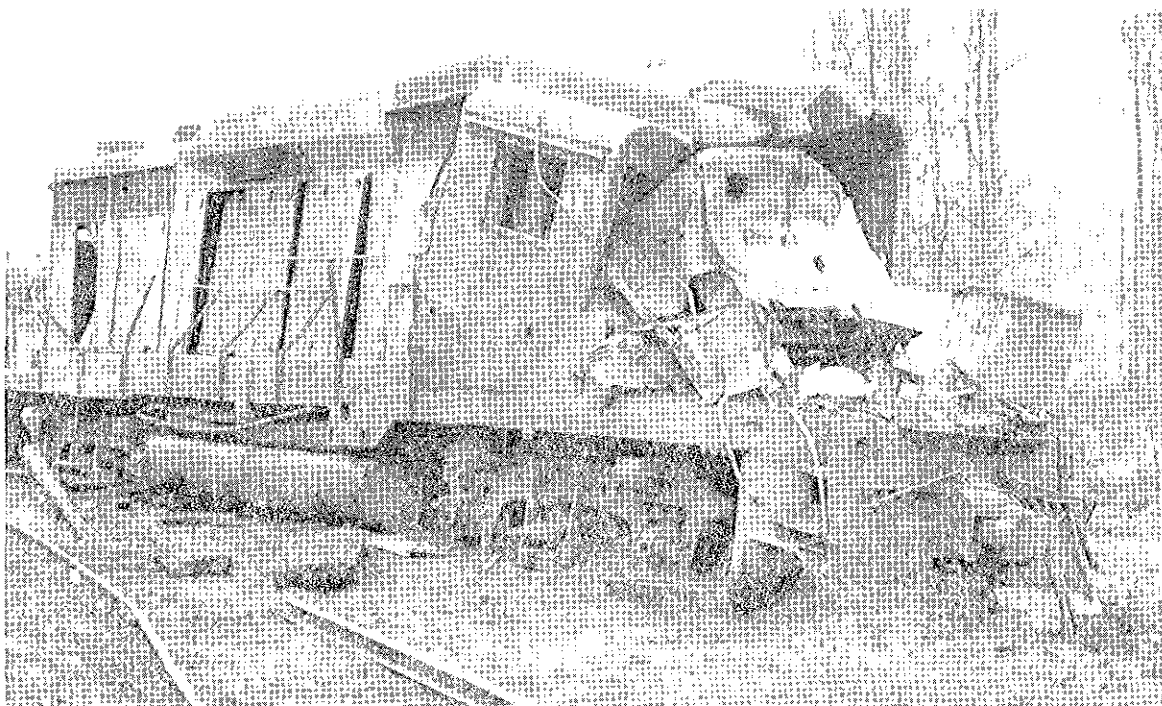
Since the lead locomotive unit's deck passed under the truck's load of logs, most of the collision impact was absorbed by the unit's forward hood compartment and cab face. (See figure 6.) The two T-type collision posts inside the hood compartment were butt-welded to the frame and the welds were not sufficient to withstand the impact force. The hood was driven back displacing 90 percent of the cab area. The cab roof partially collapsed and the floor supports on the right side were torn loose permitting the engineer's control stand to be moved back to within 7 inches of the back cabinet wall. Because of this deformation of the cab, the engineer and head brakeman could not escape. Both were trapped on their respective sides of the cab with the brakeman pinned between the hood and the left side seats. The cab of the trailing unit was within a few feet of the ruptured tank car when its cargo of LPG ignited. The force blew in the cab windows on the south side, passed through the cab, blew out the windows on the north side, and scattered parts of the locomotive unit as far as 300 feet to the north. The brakeman inside the cab was killed. There were no other persons within the area affected by the fireball; those bystanders who were injured were outside the fireball's perimeter.

Figure 6. Front end of lead locomotive unit 4102.

Because the lead locomotive unit's collision posts were inadequate, the operator compartment was so severely deformed that the men inside were trapped and unable to escape. The inability of locomotive cabs to withstand collision impacts was originally pointed out by the Safety Board in its report on an accident at Sound View, Connecticut, in 1970. <sup>4/</sup> The Safety Board recommended in 1971 that the FRA:

"Quickly conclude its study of improvements to the design of locomotive operator compartments to minimize crash damage, and promulgate necessary regulations to assure the adoption of appropriate findings. (Class II, Priority Action) (R-78-27)"
