INVESTIGATION NO. 2680
THE LOUISIANA & ARKANSAS RAILWAY COMPANY
REPORT IN RE ACCIDENT
AT PULLION, LA., ON
FEBRUARY 22, 1943

INVESTIGATION NO. 2680

THE LOUISIANA & ARKANSAS RAILWAY COMPANY

Accident at Bullion, La., on February 22, 1943, caused by an inferior train occupying the main track on the time of an opposing superior train and then by failure to provide adequate flag protection.

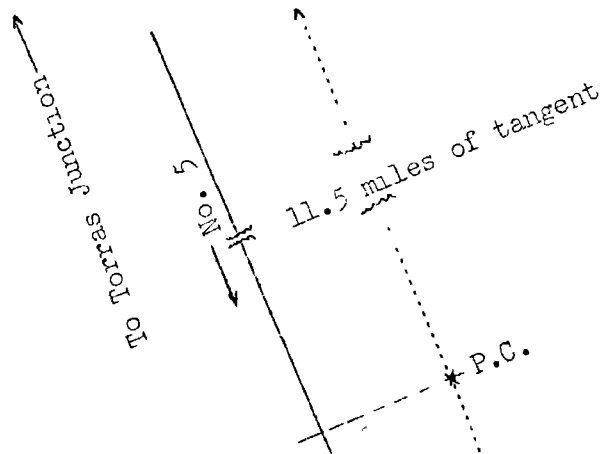
Inv-2680
 Louisiana & Arkansas Railway
 Bullion, La.
 February 22, 1943

Point of accident

From the right side of the cab of a south-bound engine the view of the point where the accident occurred is restricted to a distance of 2,578 feet, because of vegetation on the west side of the track and track curvature.
