INTERSTATE COMMERCE COMMISSION

REPORT OF THE DIRECTOR

LOUISIANA & ARKANSAS RAILWAY

MOORE, LA.

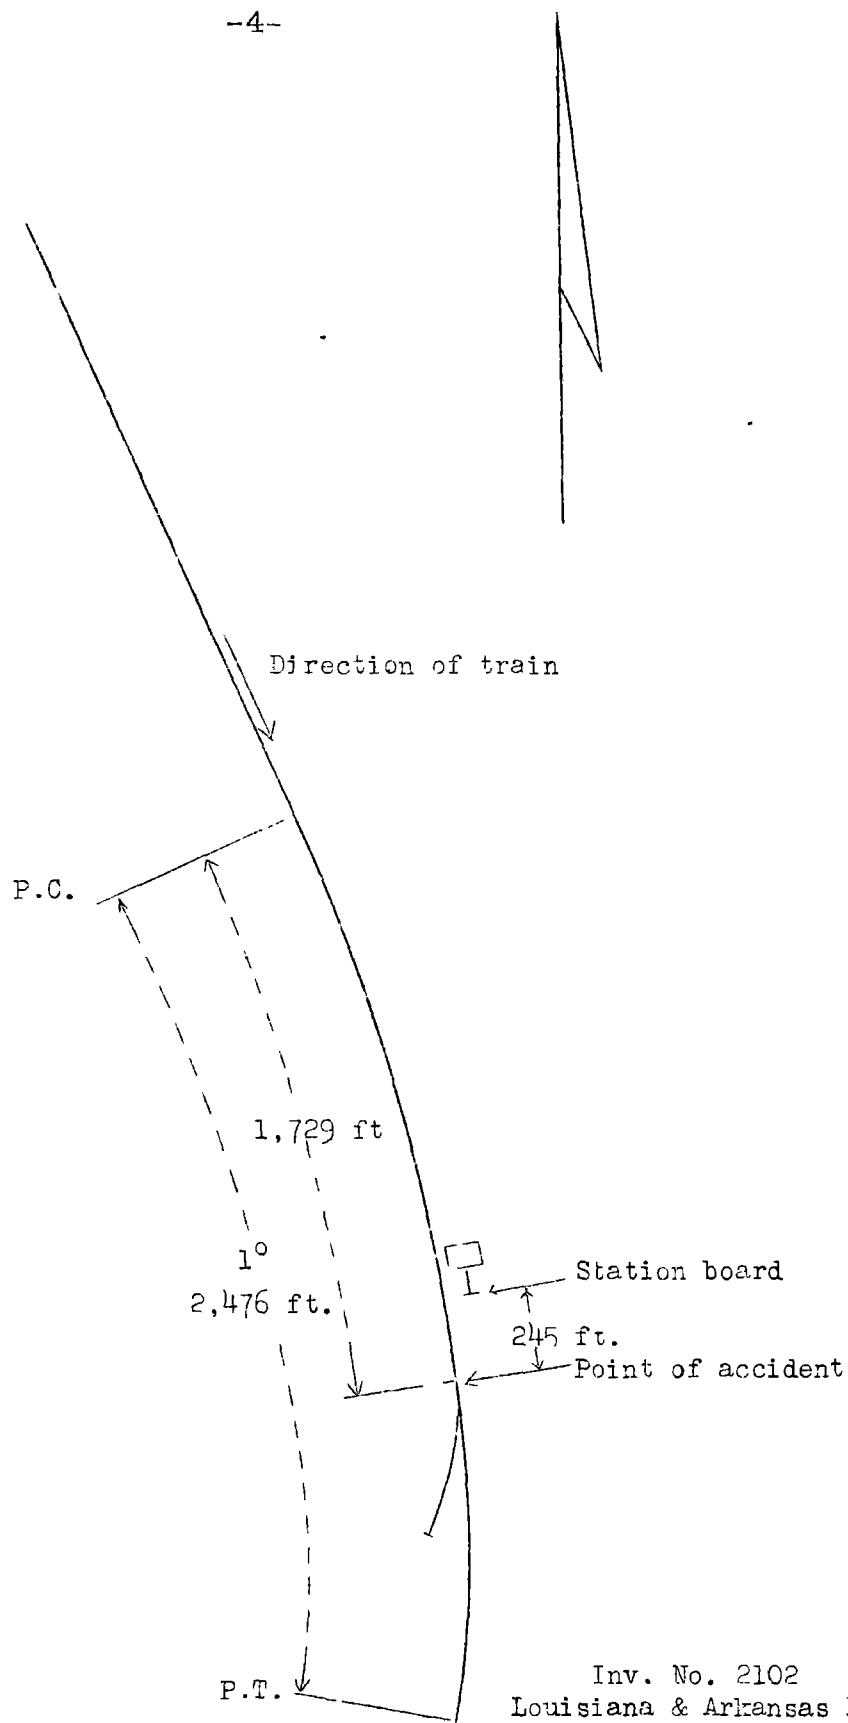
Inv. No. 2102  
Louisiana & Arkansas Ry.  
Moore, La.  
Sept. 28, 1936

The spur-track switch is a facing-point switch for southbound trains, with a No. 9 turnout, and leads off the main track to the right. The switch stand, of the Ramapo type, is located on the right side of the track and is equipped with a lamp and two targets. The center of the lens, of the reflector type, is located about  $6\frac{1}{2}$  feet above the head-block and displays a green indication when the switch is lined for the main track and a red indication when lined for the spur track. The targets,  $15\frac{1}{2}$  inches by 15 inches, are placed below the lamp and display corresponding indications. At about the center of the curve the main track runs through a shallow cut, and due to this cut, and to trees and shrubbery on the inside of the curve, the view of the switch to be had by the engineman of a southbound train is limited to 900 feet.
