RAILROAD ACCIDENT INVESTIGATION

REPORT NO. 4143

LOUISVILLE AND NASHVILLE RAILROAD COMPANY

CASKY, KY.

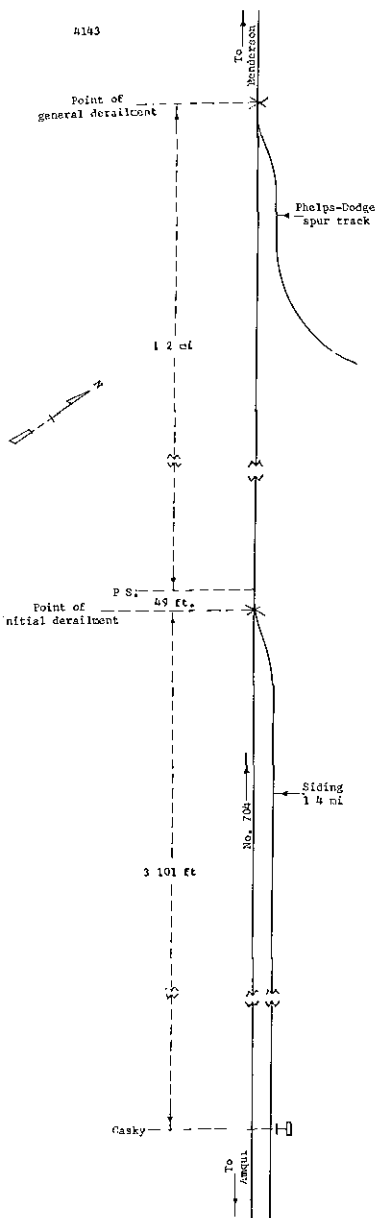
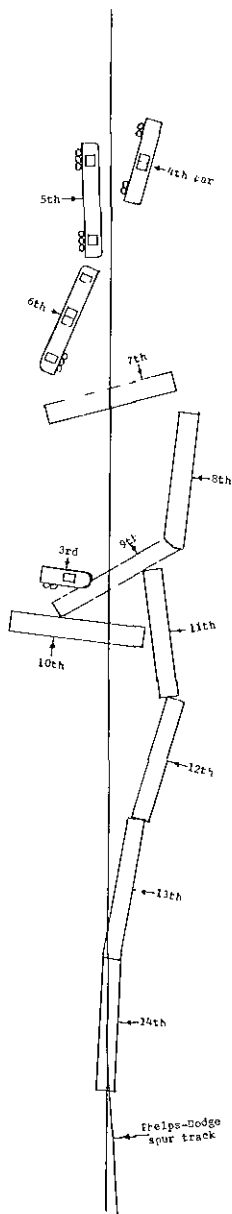
Louisville and Nashville Railroad  
Casky, Ky.  
January 29, 1968

The train stopped with the front end 2,896 feet north of the general derailment point. The derailed cars stopped in various positions on or near the track structure, as shown in the sketch appended to this report. The 3rd to 6th cars, inclusive, and the 9th and 10th cars were destroyed. The 7th, 8th, 11th, 12th and 13th cars were heavily damaged, and the 14th car was slightly damaged.
