Railroad Accident Investigation Report, 1979. no.9

Report No. 79-9

LOUISVILLE AND NASHVILLE RAILROAD COMPANY

CRESTVIEW, FLORIDA

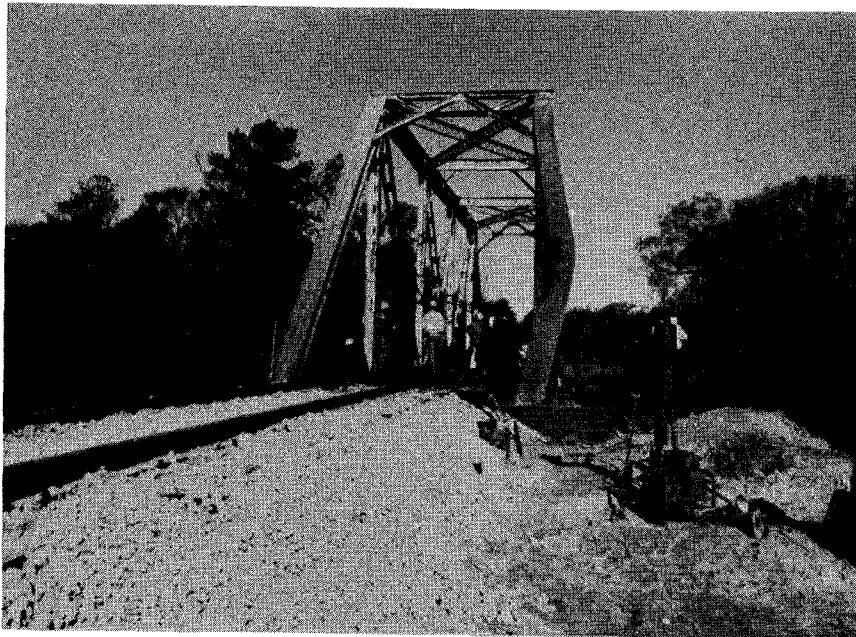
Post-accident examination of the bridge structure revealed that the 72-foot, pile-driven trestle was completely destroyed by the derailment and resulting fire. The thru-truss span sustained substantial damage to the southeast hip hanger, south end stringers of panel five, east bottom chord of panel five and south end floor beam. Heat damage was also sustained to various other bridge members. The 125-foot track structure on the thru-truss span of the bridge received extensive heat damage from the burning cars. About 80 percent of the ties and 70 percent of the rail were destroyed on the truss. Samples of the web of the south ends of both stringers, the bottom flange angles, and a rivet from the west stringer were tested by an independent laboratory. The results indicate that the fire did not alter the metallurgical or mechanical properties of the samples tested.

Damage to west portal member of Yellow River bridge.

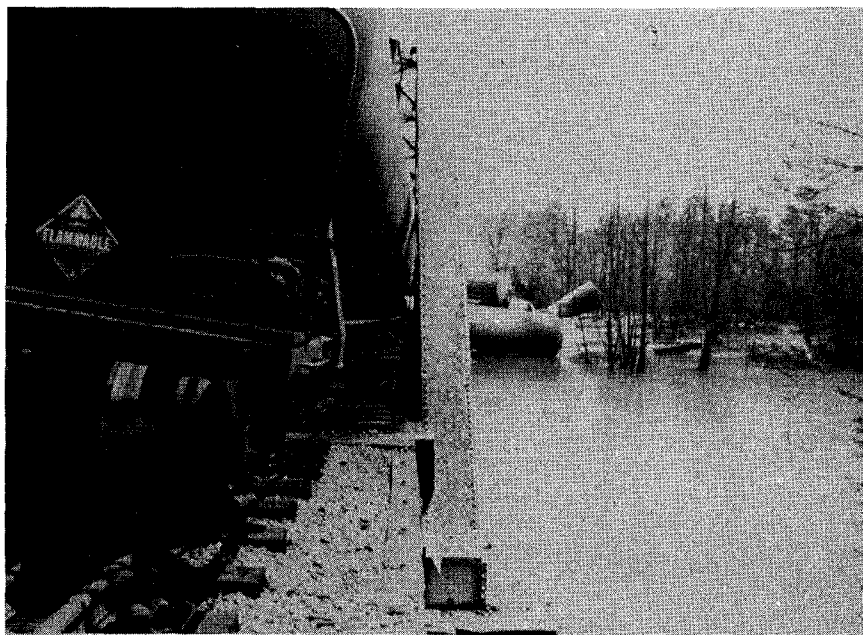
View of derailment site from east portal member of bridge

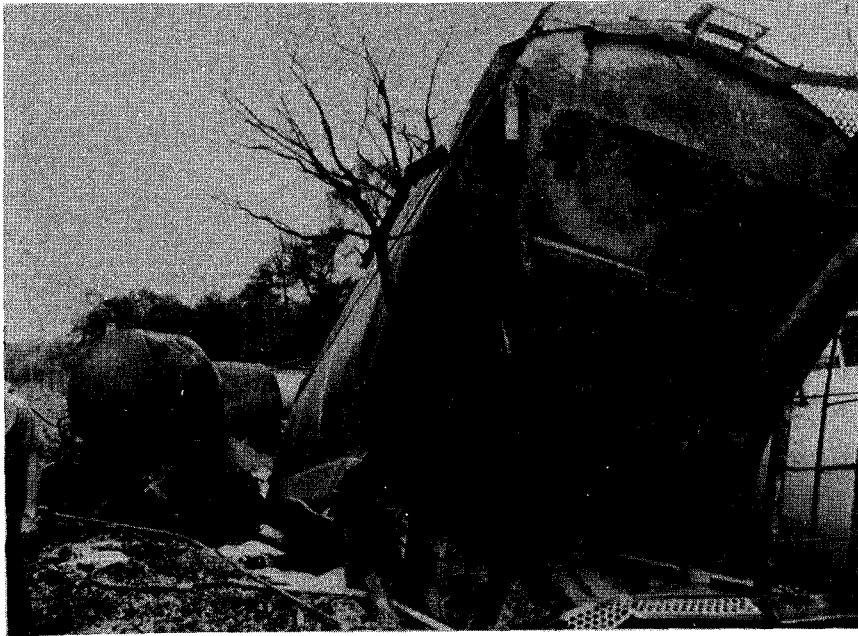
View of damaged equipment.

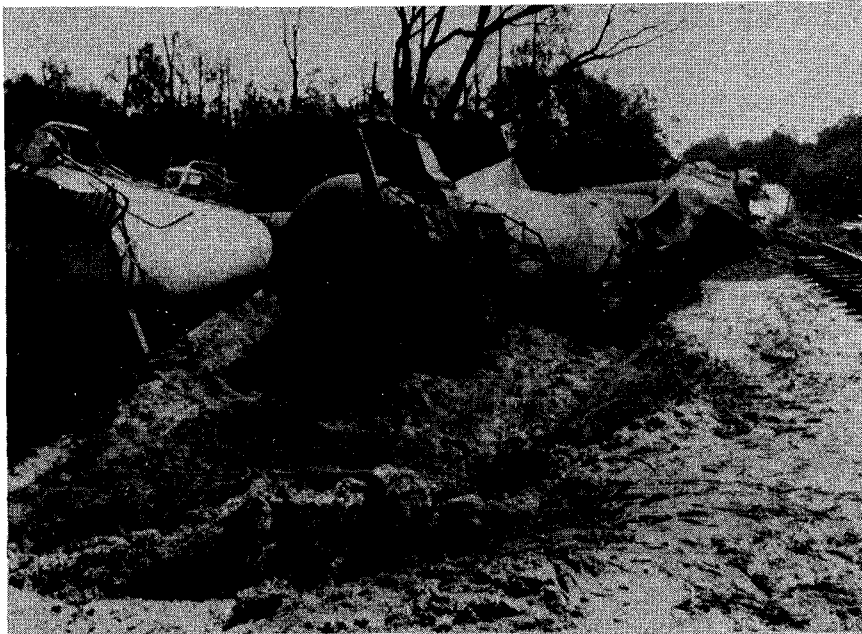
View of damaged tank cars.

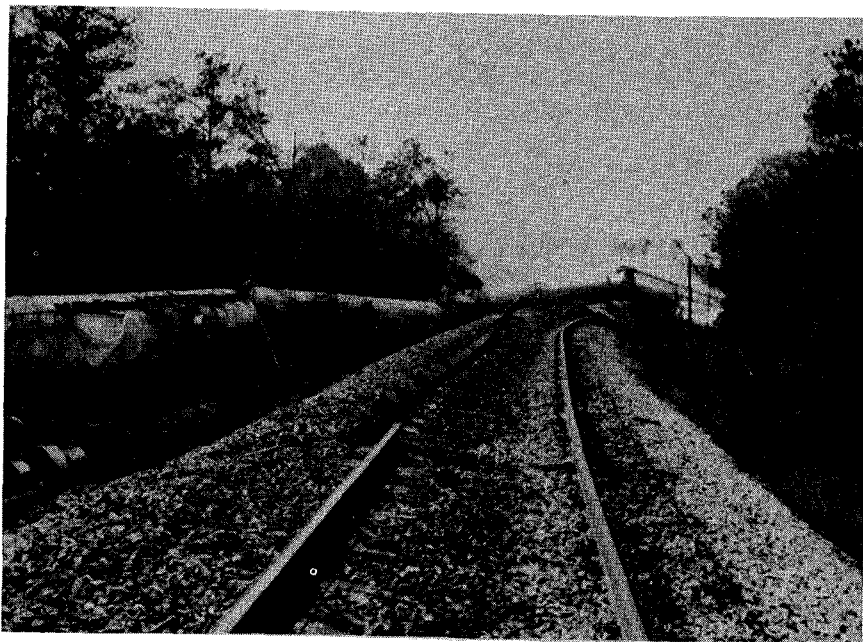
Track structure after derailment.

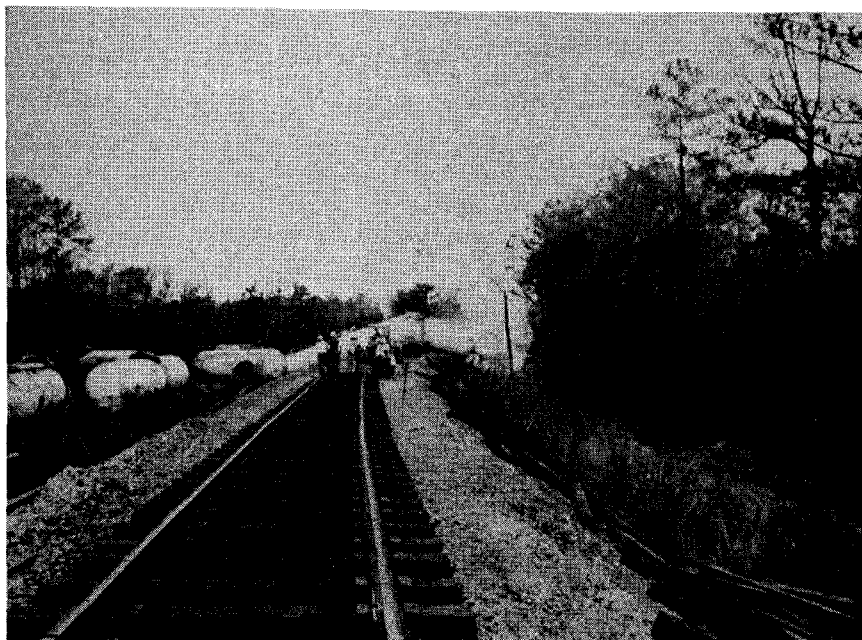
Track structure being restored.

The wreck was cleared, the track and bridge were temporarily repaired, and train operations were resumed on April 14, 1979. At that time, L&N issued additional operating instructions on the line between Pensacola and Chattahoochee, Florida. Southward trains were restricted to a maximum of 120 cars and 8,000 tons. A speed restriction of 5 mph, later increased to 10 mph, was placed in effect in the area of the derailment until permanent bridge repairs could be made. Supervisors were assigned to ride all road trains on this sub-division for a period after the track was reopened.
