Railroad Accident Investigation Reports

ACCIDENT REPORT NO. 82-2

LOUISVILLE AND NASHVILLE RAILROAD COMPANY

DUDLEY, ALABAMA

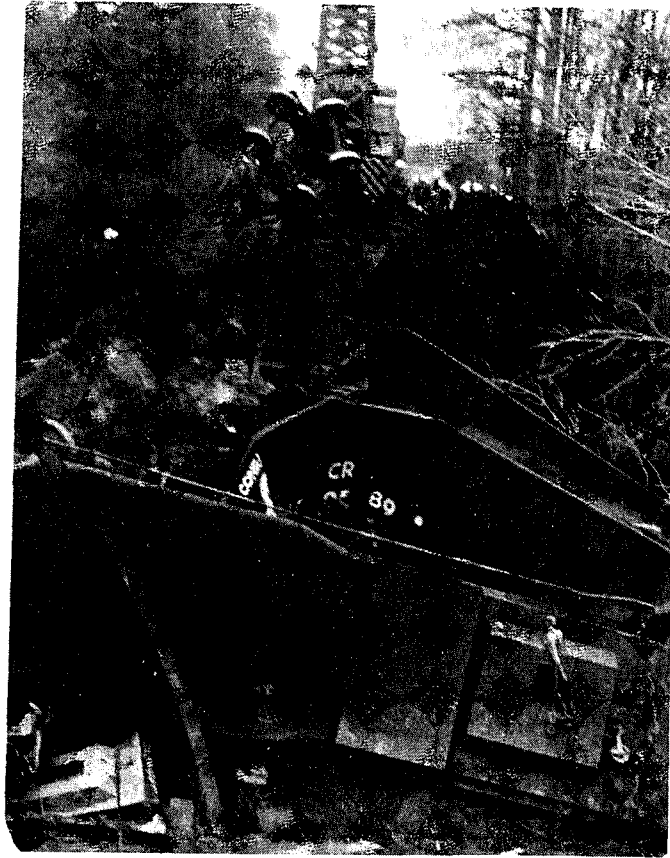
Extra 4108 South proceeded south from Mile Post 419 to Holt Junction, Alabama. The train was traveling at about 25 mph when the two locomotives and the first three cars dropped into the depression (caused by the failure of the fill) and derailed. (See figures 1 and 2.) As a result of the derailment, the engineer and apprentice engineer were killed, and the front brakeman was critically injured.

Figure 1. View of accident showing large gap in the fill.

Examination of the fill disclosed that it was saturated with water in the immediate area of the depression. A section of the fill about 85 feet long, uneven and sloping downward to a depth of about 18 feet below the rails, had been washed out to the east. Sections of the fill on the west, on each side of the depression, had slipped downward. Water was ponding on the west side up to the toe of the fill. This pond of water covered approximately 3/4 of an acre and was about 30 inches deep at the toe of fill.
