RAILROAD ACCIDENT INVESTIGATION

REPORT NO 4079

LOUISVILLE AND NASHVILLE RAILROAD COMPANY

ERIN, TENN

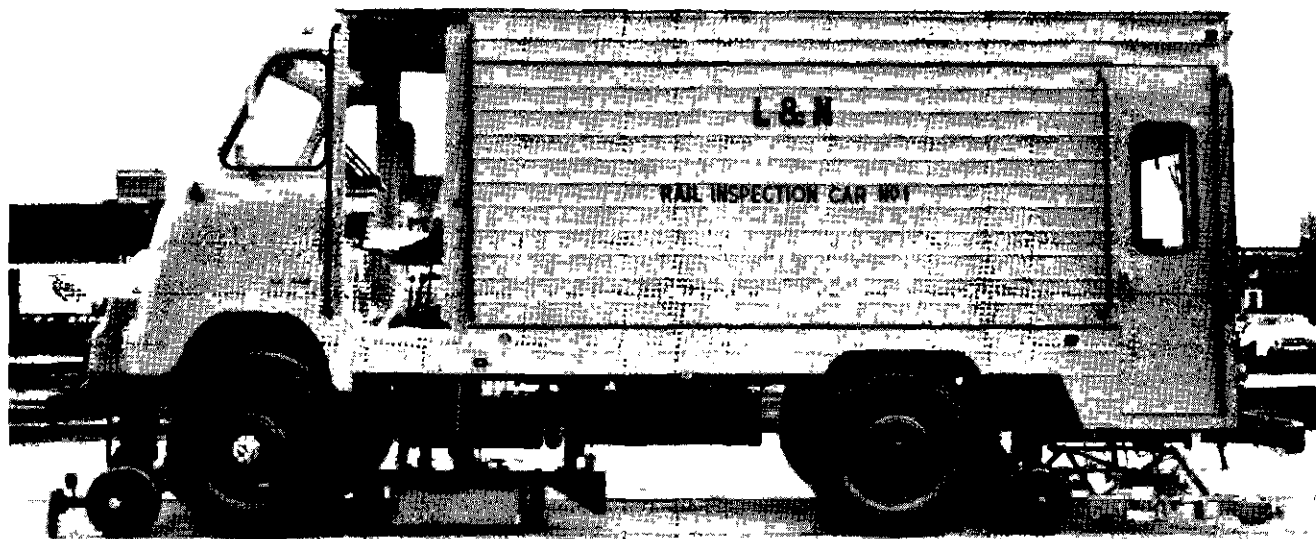
The rail-defect detector car was a 1963 Ford Model motortruck owned and operated by the Louisville and Nashville Railroad Company. It had a special body (see photo appended to this report) and was equipped for movement on rails and highways. In addition to conventional tire mounted wheels, it had retractable flanged wheels at the front and rear for guides when operating on rails. The car was provided with magnetic-type equipment for detecting defective rails. It was 22 feet long between the front and rear bumpers and weighed about 16,000 pounds, with about 1,000 pounds carried on each pair of flanged wheels when operating on rails.

The rail-defect detector car was derailed. It was overturned and stopped on the west side of the track structure, 171 feet north of the first collision point and about 15 feet from the main track. It was destroyed.

Rail-defect detector car involved in accident
