NATIONAL TRANSPORTATION SAFETY BOARD

RAILROAD ACCIDENT REPORT

**HEAD-END COLLISION OF
LOUISVILLE AND NASHVILLE RAILROAD
LOCAL FREIGHT TRAIN AND
YARD TRAIN AT
FLORENCE, ALABAMA
SEPTEMBER 18, 1978**

Adopted: February 22, 1979

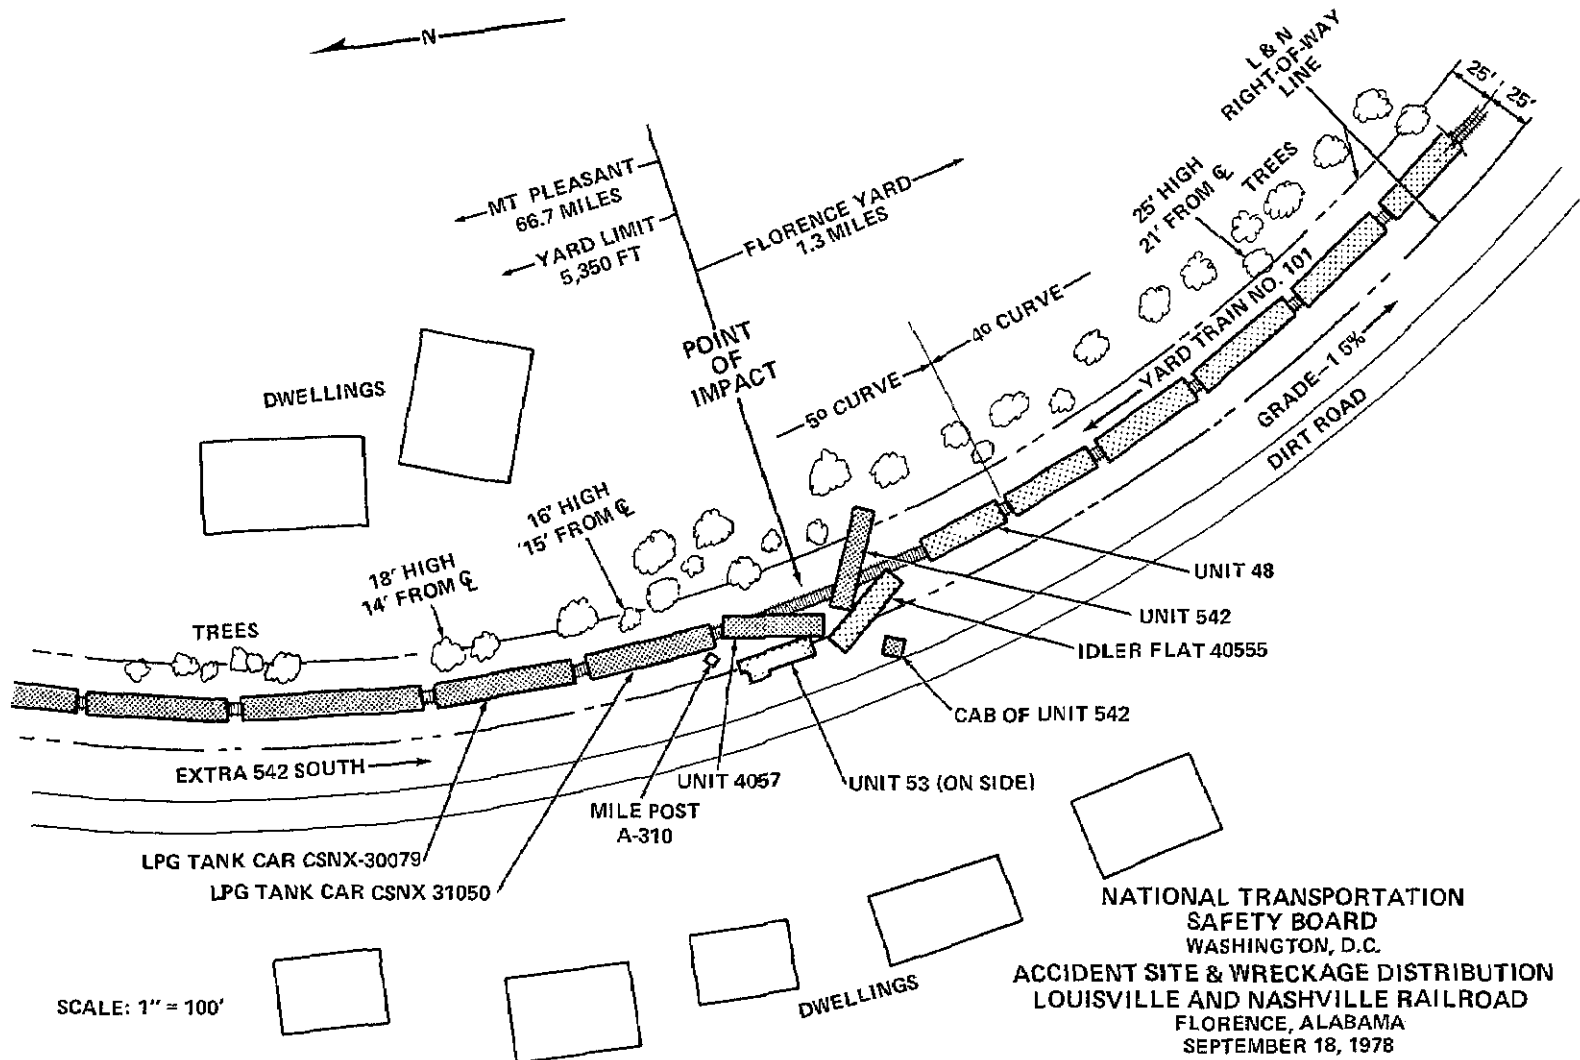
Figure 1. Plan view of accident site and wreckage distribution.

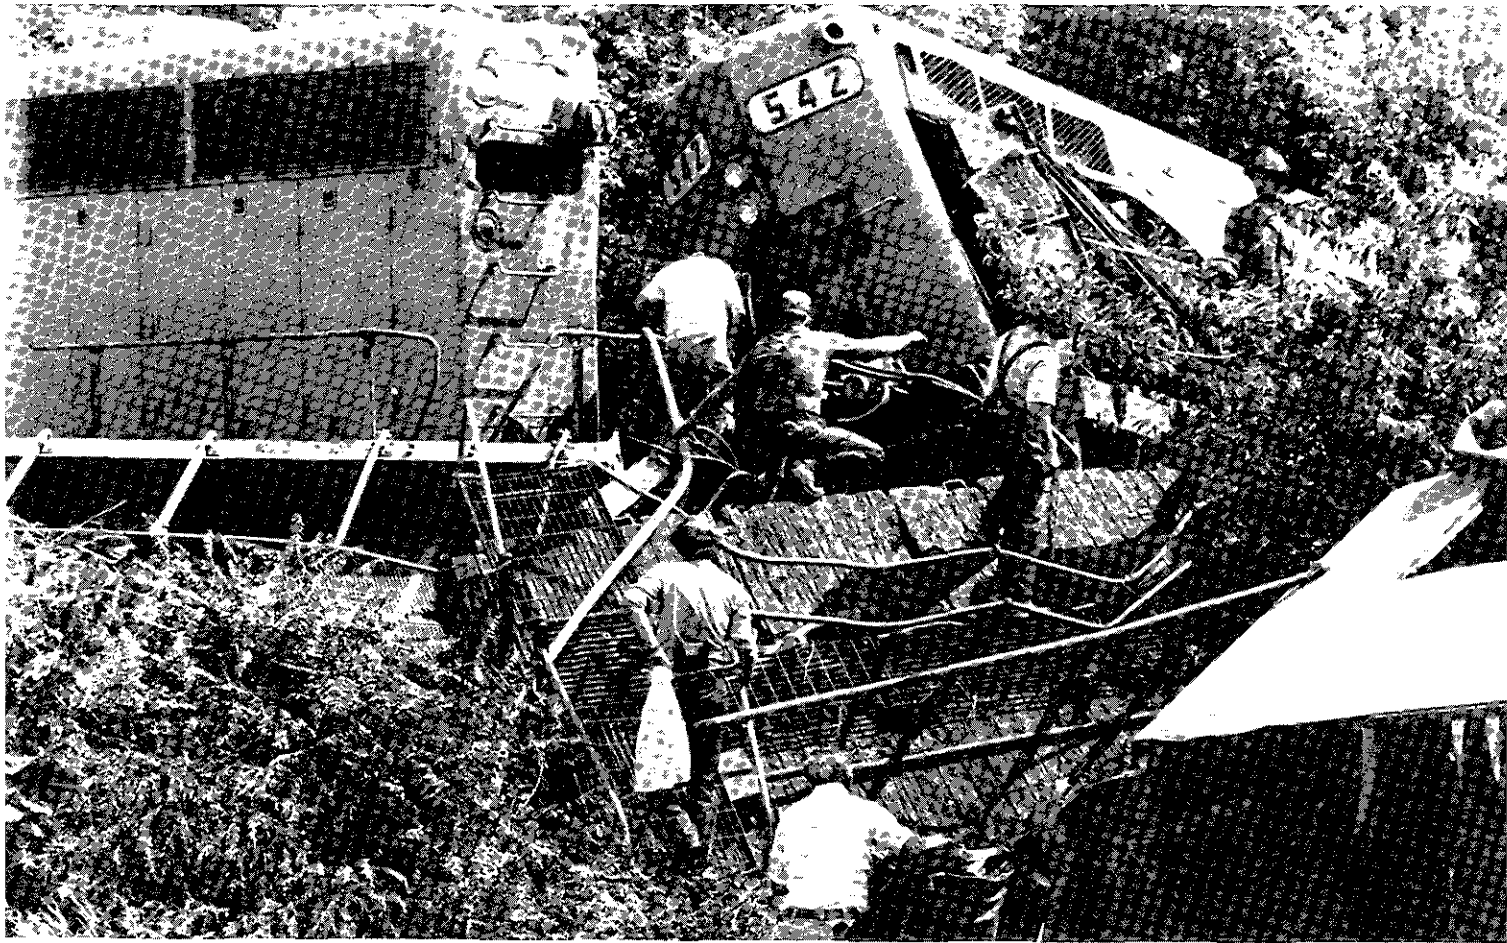
The lead unit of train No. 101 overrode the lead unit of Extra 542 South and then turned on its left side. The lead unit of Extra 542 South derailed to the east, but remained upright. This unit absorbed most of the collision impact; both the short hood and operator compartment were torn loose and thrown 30 feet west of the track. (See figure 3.) There was no evidence to indicate the engineer and head brakeman attempted to escape from the cab before the collision. Both received fatal injuries as a result of being ejected and run over by their locomotive. They were found on the track with the engineer under the trailing truck of the lead unit and the brakeman under the lead truck of the trailing unit.

Figure 3. The accident location viewed from the west. The operator compartment of the lead unit of Extra 542 South is in the right foreground. The overturned lead unit of yard train No. 101 is at the lower left, partly obscured by foliage. Between unit 542 and its cab is the yard train's idler car.

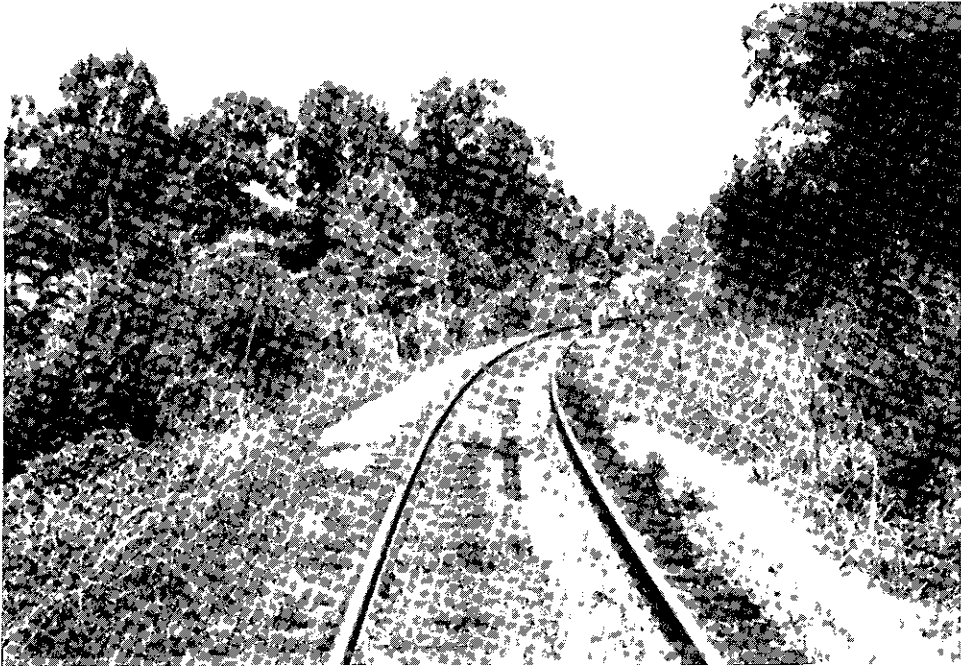
Figure 4. View of track to the south from a point 375 feet north of the accident site.

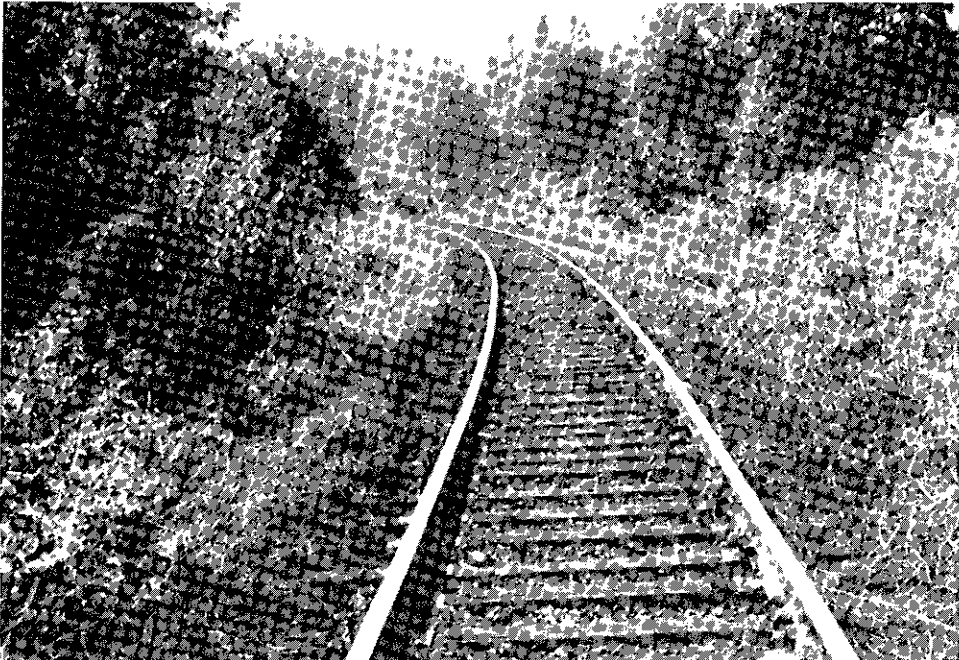
Figure 5. View of track to the north from a point 300 feet south of the accident site.
