RAILROAD ACCIDENT INVESTIGATION

Report No. 4127

LOUISVILLE AND NASHVILLE RAILROAD COMPANY

AUGUST 17, 1967

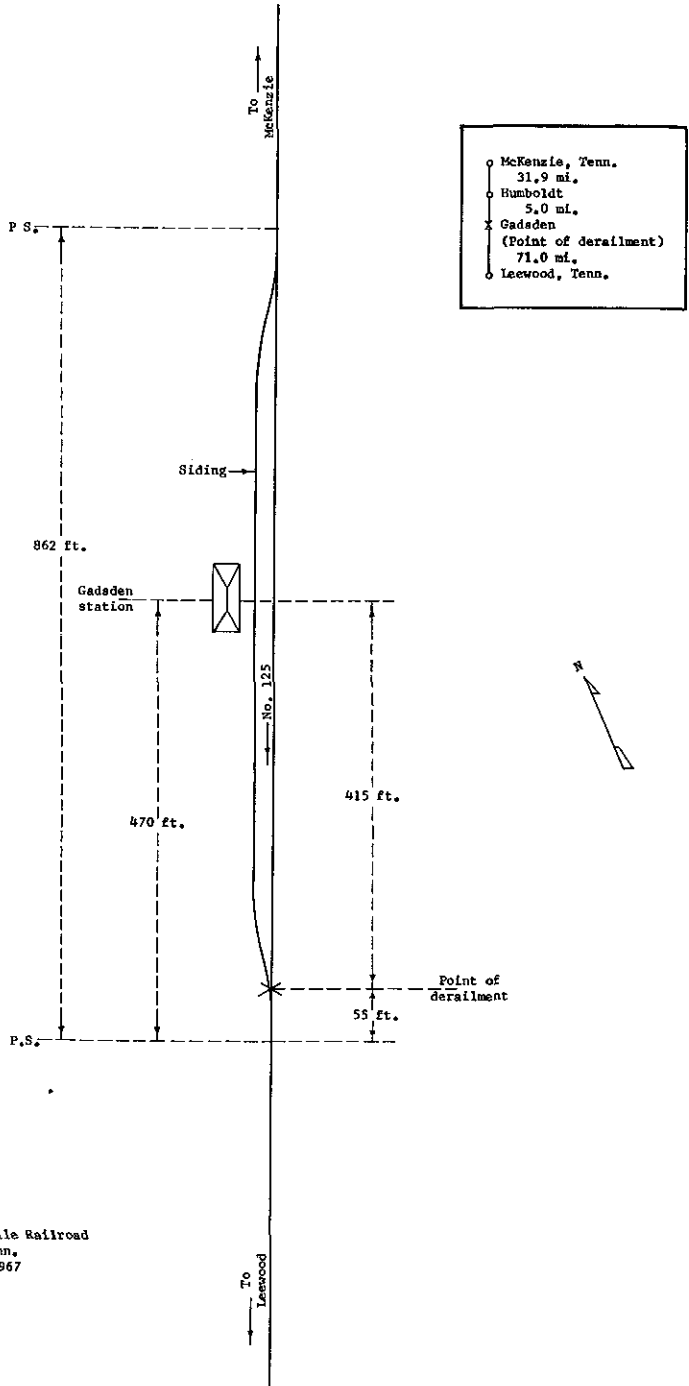
Louisville and Nashville Railroad
Gadsden, Tenn.
August 17, 1967

The first mark of derailment was a flange mark on top the head of the west rail of the main track. It appeared at the toe of the frog of the south turnout of the siding. About 17 feet farther southward, wheel marks appeared on the base of rails, on the gage side of the east rail and on the field side of the west rail, indicating that a pair of wheels, apparently the front wheels of the front truck of the fourth car, had derailed to the west at this point. The derailed pair of wheels then struck and overturned the bent stock rail of the south turnout of the siding, causing the general derailment. Southward from the bent stock rail, the structure of the main track was destroyed or heavily damaged for a distance of about 400 feet.

Examination of the main track disclosed that within a distance of about 210 feet north of the initial derailment point, the track gage varied between 56-1/8 inches and 56-5/8 inches with a maximum lateral movement of the east and west rails of 3/8 inch and 1 inch, respectively. The cross levels in this area varied up to 1 inch. At a joint of the west rail 148 feet north of the initial derailment point, two rail-holding spikes on the field side and one rail-holding spike on the gage side were missing. The remaining spike on the gage side of the rail joint was protruding about 3 inches above the top of the tie plate, and the top of the tie plate was 1 inch below the base of rail.

The structure of the main track within a distance of 210 feet north of the initial derailment point was inadequately maintained and was below standards prescribed by the carrier's rules and instructions of the Maintenance of Way Department. As No. 125 moved over this portion of the track, excessive variations in cross levels apparently caused the fourth car to develop a harmonic lateral rocking action to the extent that the right front wheel of the front truck was lifted sufficiently above the top of the rail to derail to the west, resulting in derailment of the mate wheel also. Soon afterward, the derailed pair of wheels struck the bent stock rail of the south siding-turnout, causing the general derailment.

It is recommended that the Louisville and Nashville Railroad Company immediately correct the poor track conditions in the vicinity of the south turnout of the Gadsden, Tenn. siding to the extent necessary for this portion of the track structure to meet prescribed standards of the carrier's Maintenance of Way Department.
