REAR END COLLISION OF
LOUISVILLE & NASHVILLE RAILROAD COMPANY
TRAINS NO. 586 AND EXTRA 8072 NORTH
NEW JOHNSONVILLE, TENNESSEE
DECEMBER 28, 1981

NTSB-RAR-82-4

**REAR-END COLLISION OF
LOUISVILLE AND NASHVILLE RAILROAD COMPANY
TRAINS NO. 586 AND EXTRA 8072 NORTH
NEW JOHNSONVILLE, TENNESSEE
DECEMBER 28, 1981**

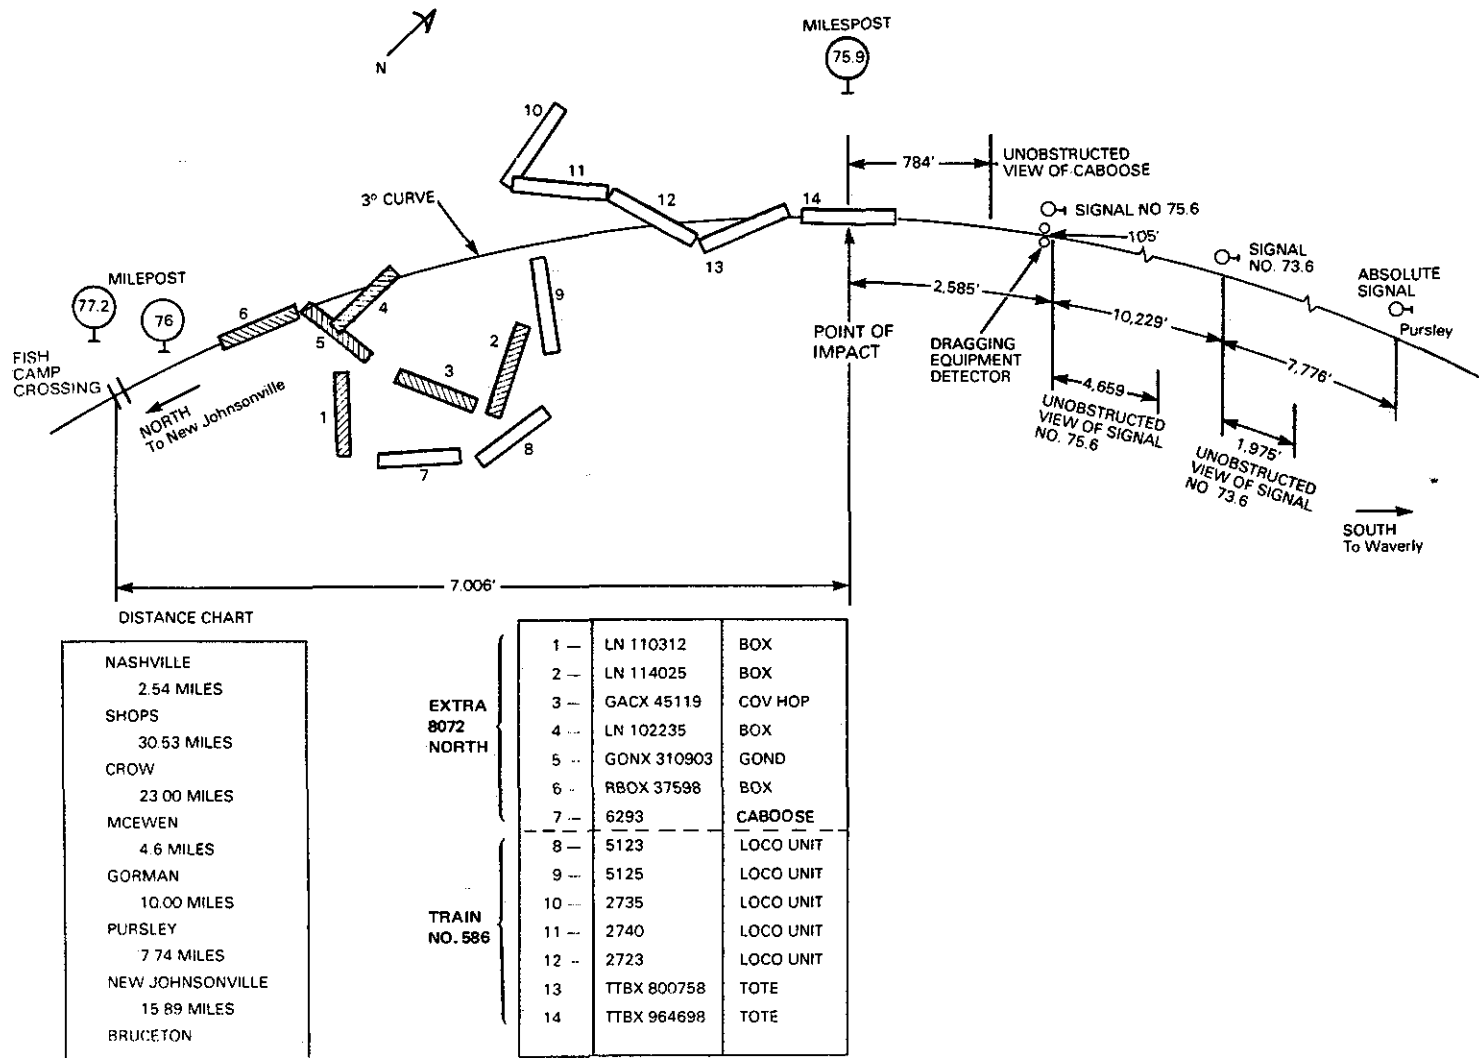
Figure 1.--Plan view of accident site.

About 9:35 a.m., while the cars of Extra 8072 North were standing in the block of automatic signal No. 75.6, they were struck from the rear by No. 586. (See figure 1.)

The engineer and head brakeman said that when the train approached automatic signal No. 73.6 (see figure 1), the signal was displaying an approach (yellow) aspect, and that the train's speed was about 38 to 40 mph. L&N operating rule No. 285 requires that, upon approaching or passing an approach signal aspect, trains exceeding a speed of 30 mph must at once reduce to that speed, and the engineer should operate the train prepared to stop at the next signal. Rule No. 34 requires the crewmembers in the locomotive operating compartment to call automatic wayside signal aspects to each other, but they do not have to radio signal aspects to the crew on the caboose. Both crewmembers on the locomotive said that they called the signal aspects to each other. (See appendix C.)

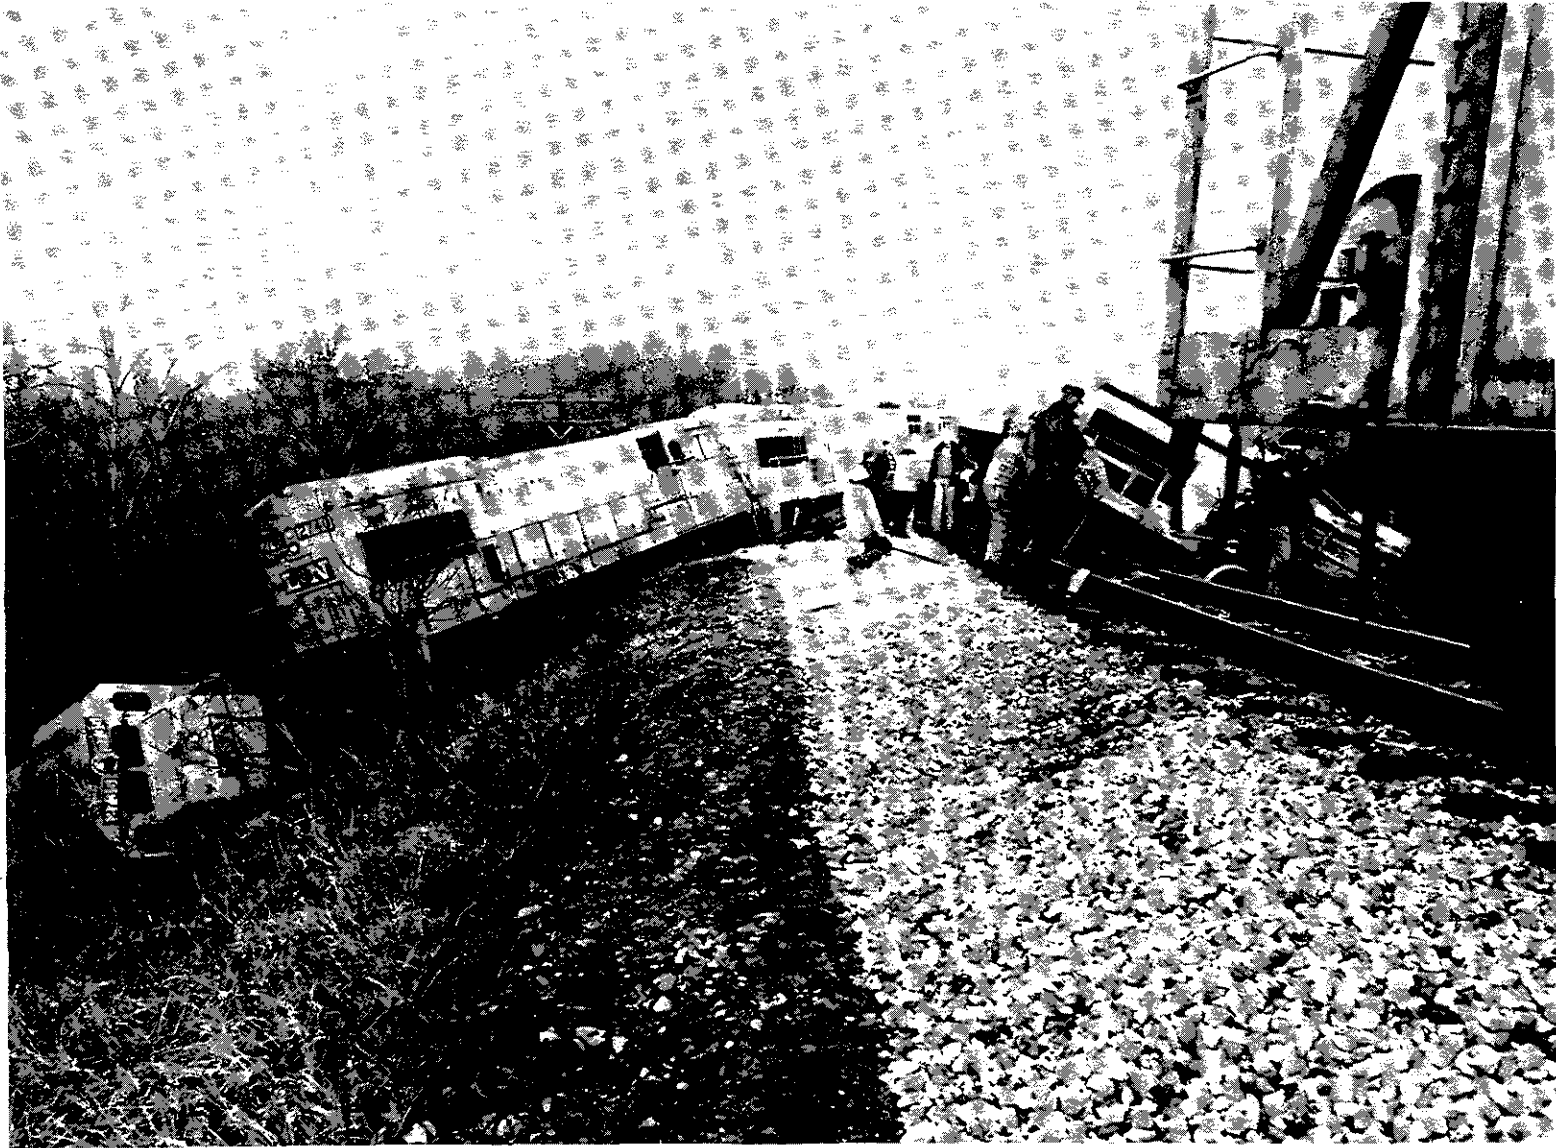
Figure 2.--Derailed locomotive units and cars in train No. 586.

When the locomotive of No. 586 struck the caboose of Extra 8072 North about 9:30 a.m., the caboose and the first, second, third, and fifth rear cars of Extra 8072 North went down a 45-foot embankment on the west side of the track. The fourth and sixth rear cars derailed but remained upright on the track structure. The caboose caught fire after the impact and burned. The conductor of Extra 8072 North, who was either on or near the caboose at the time of the collision, was killed.

The first locomotive unit of No. 586 overturned to the west side of the track and came to rest on its side at the foot of the embankment. The anglecock and an electrical jumper cable box on the front of the unit were broken when the collision occurred. The second unit derailed to the west side and stopped almost perpendicular to the main track with the trailing end near the track structure. The third unit came to rest on its right side on the east side of the track structure near the foot of the embankment. The fourth unit derailed to the east of the track but remained on the track structure at an angle of about 30 degrees to the track. The fifth unit derailed to the east and came to rest upright and across the track. The first car in the train derailed to the west of the track and remained upright on the track structure. (See figure 2.)

The lead locomotive unit of No. 586 was destroyed, the second and third units were substantially damaged, and the fourth and fifth units were moderately damaged. The first car was slightly damaged. About 200 feet of track was destroyed.

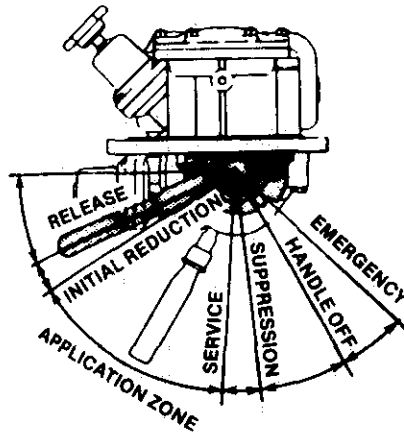
Figure 3.--Automatic brake valve handle positions on No. 26-L brake equipment.

The automatic brake handle being found in the handle off position and the dynamic brake control lever being found in the fully applied position do not comport with the head-end crew's testimony. The impact forces created by the locomotive's striking the rear of Extra 8072 North, which was standing with its airbrakes set in a heavy application, and the forces developed during the rolling and pitching of the unit could have caused the automatic brake handle and the dynamic brake control to have moved. Further, it is possible that a person in leaving the operating position hurriedly could have brushed against the automatic brake handle and moved it from the emergency position to the handle off position.
