## RAILROAD ACCIDENT REPORT

LOUISVILLE & NASHVILLE  
RAILROAD COMPANY FREIGHT TRAIN  
DERAILMENT AND PUNCTURE OF  
ANHYDROUS AMMONIA TANK CARS AT  
PENSACOLA, FLORIDA  
NOVEMBER 9, 1977

REPORT NUMBER: NTSB-RAR-78-4

LOUISVILLE & NASHVILLE RAILROAD COMPANY  
FREIGHT TRAIN DERAILMENT AT  
PENSACOLA, FLORIDA  
NOVEMBER 9, 1977

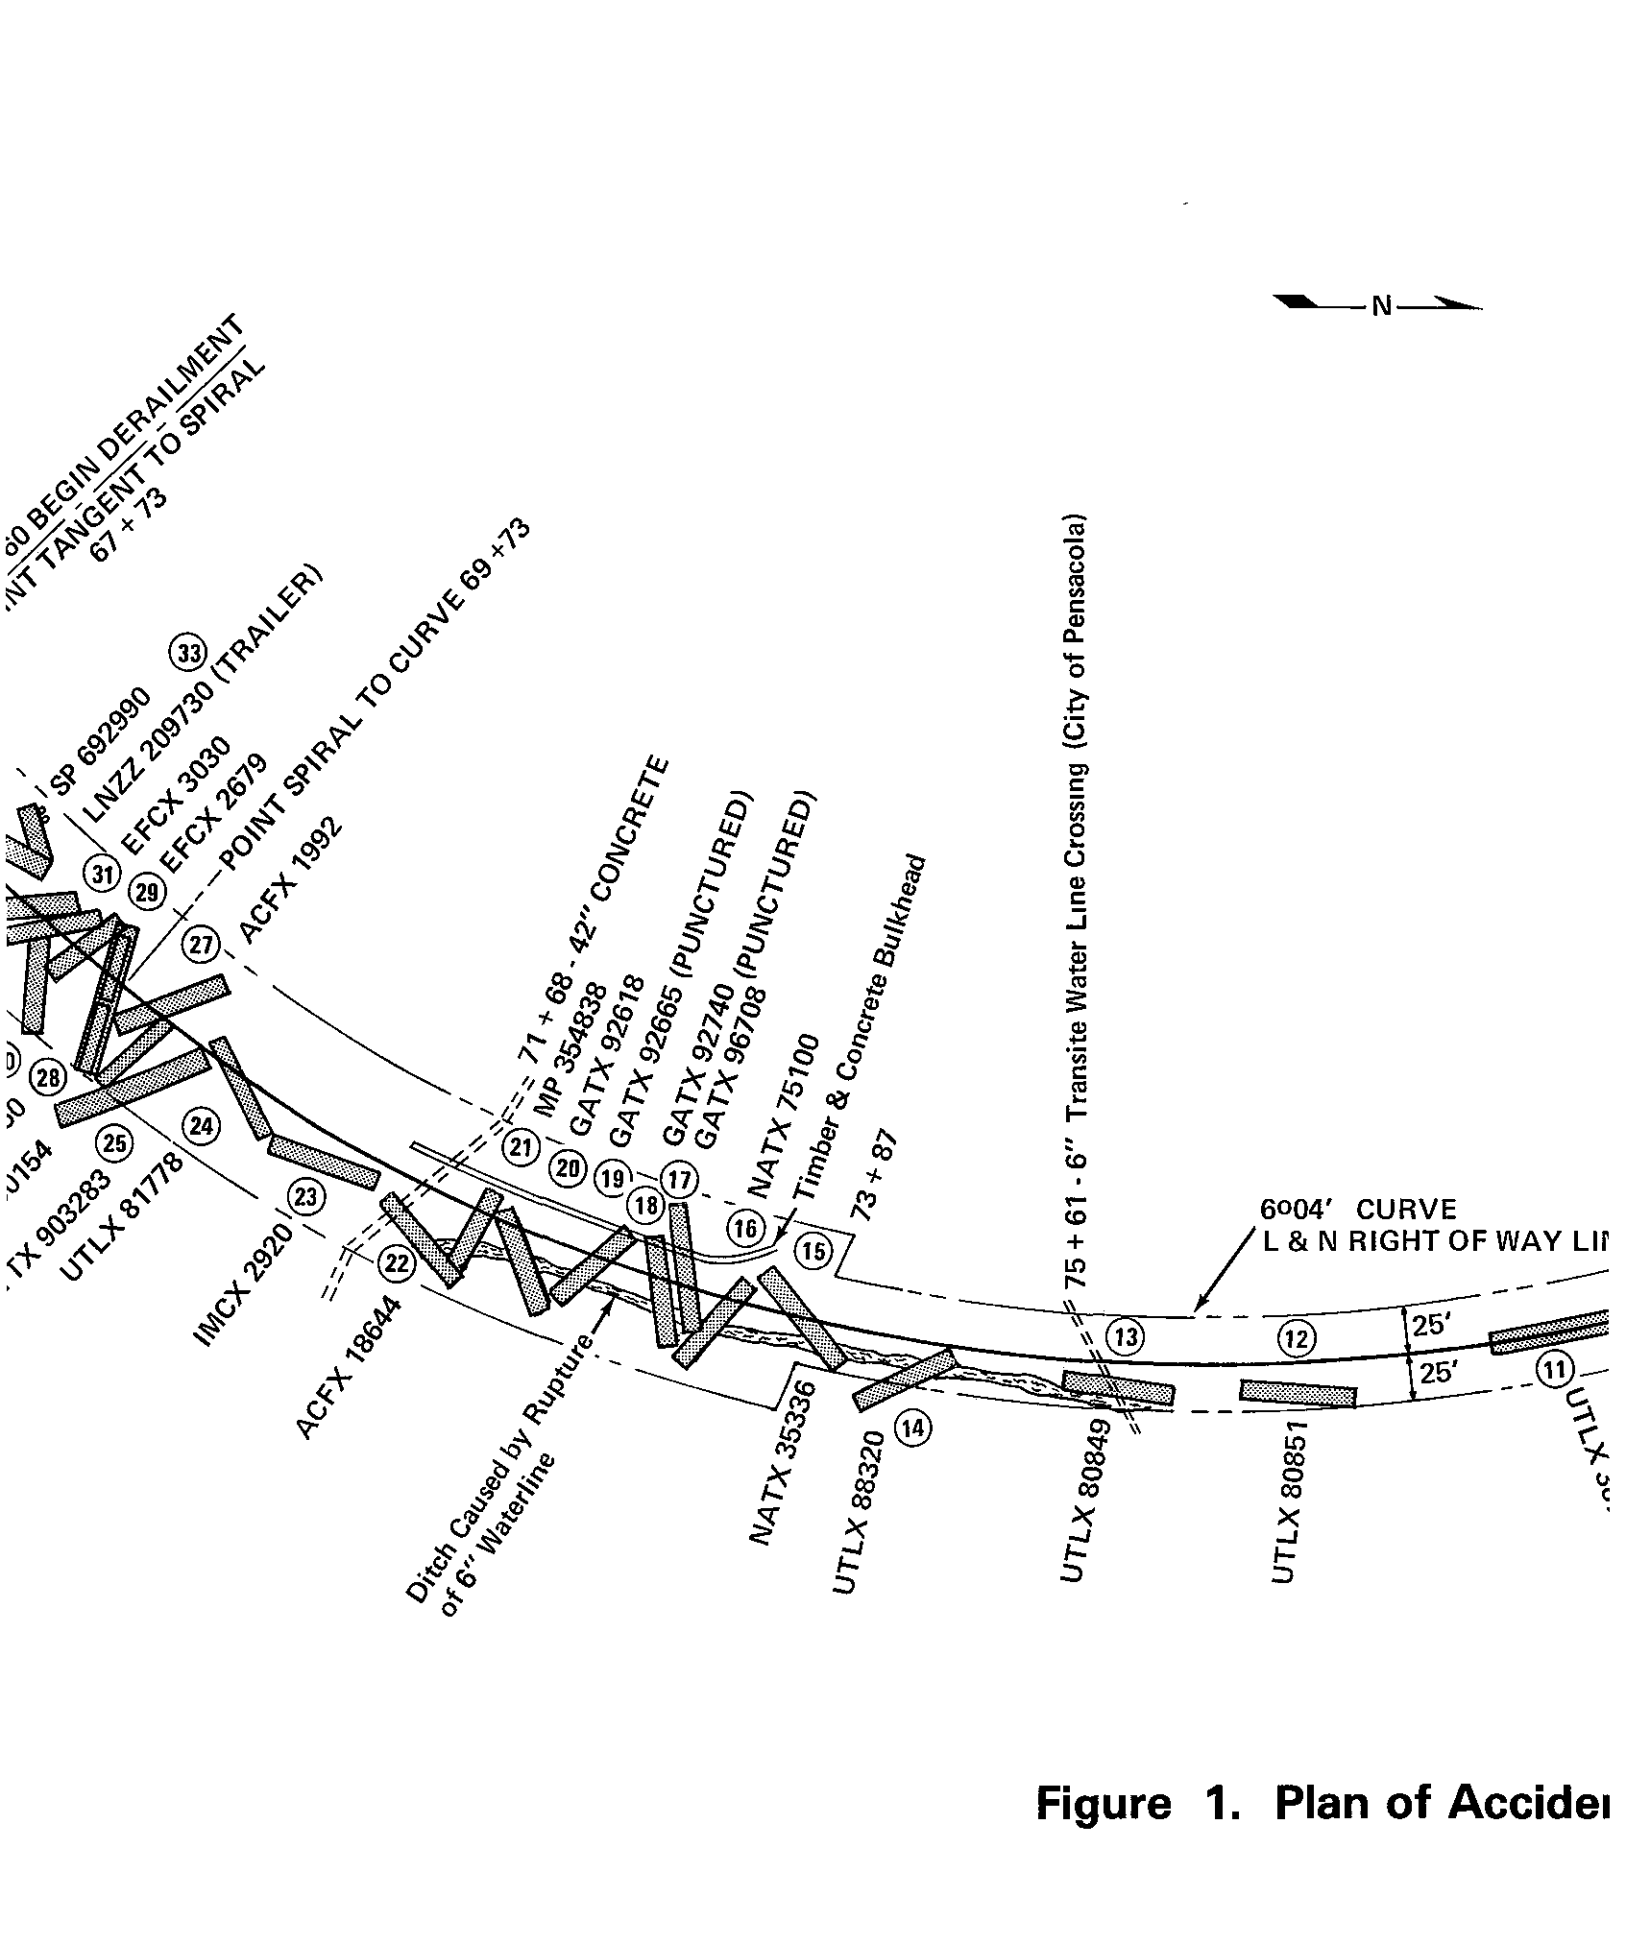
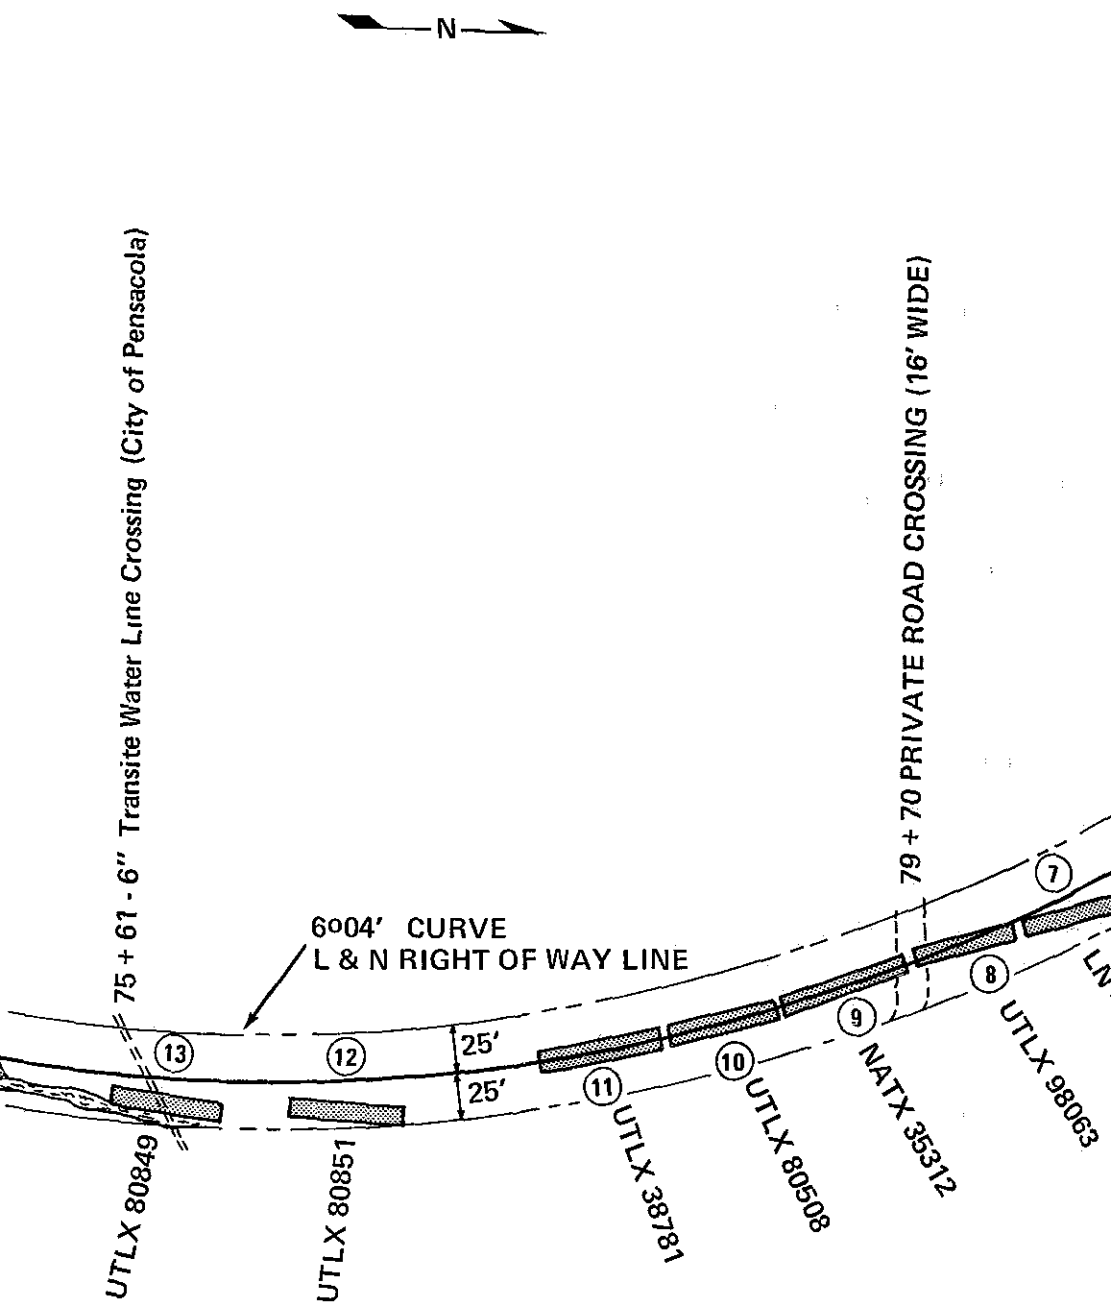
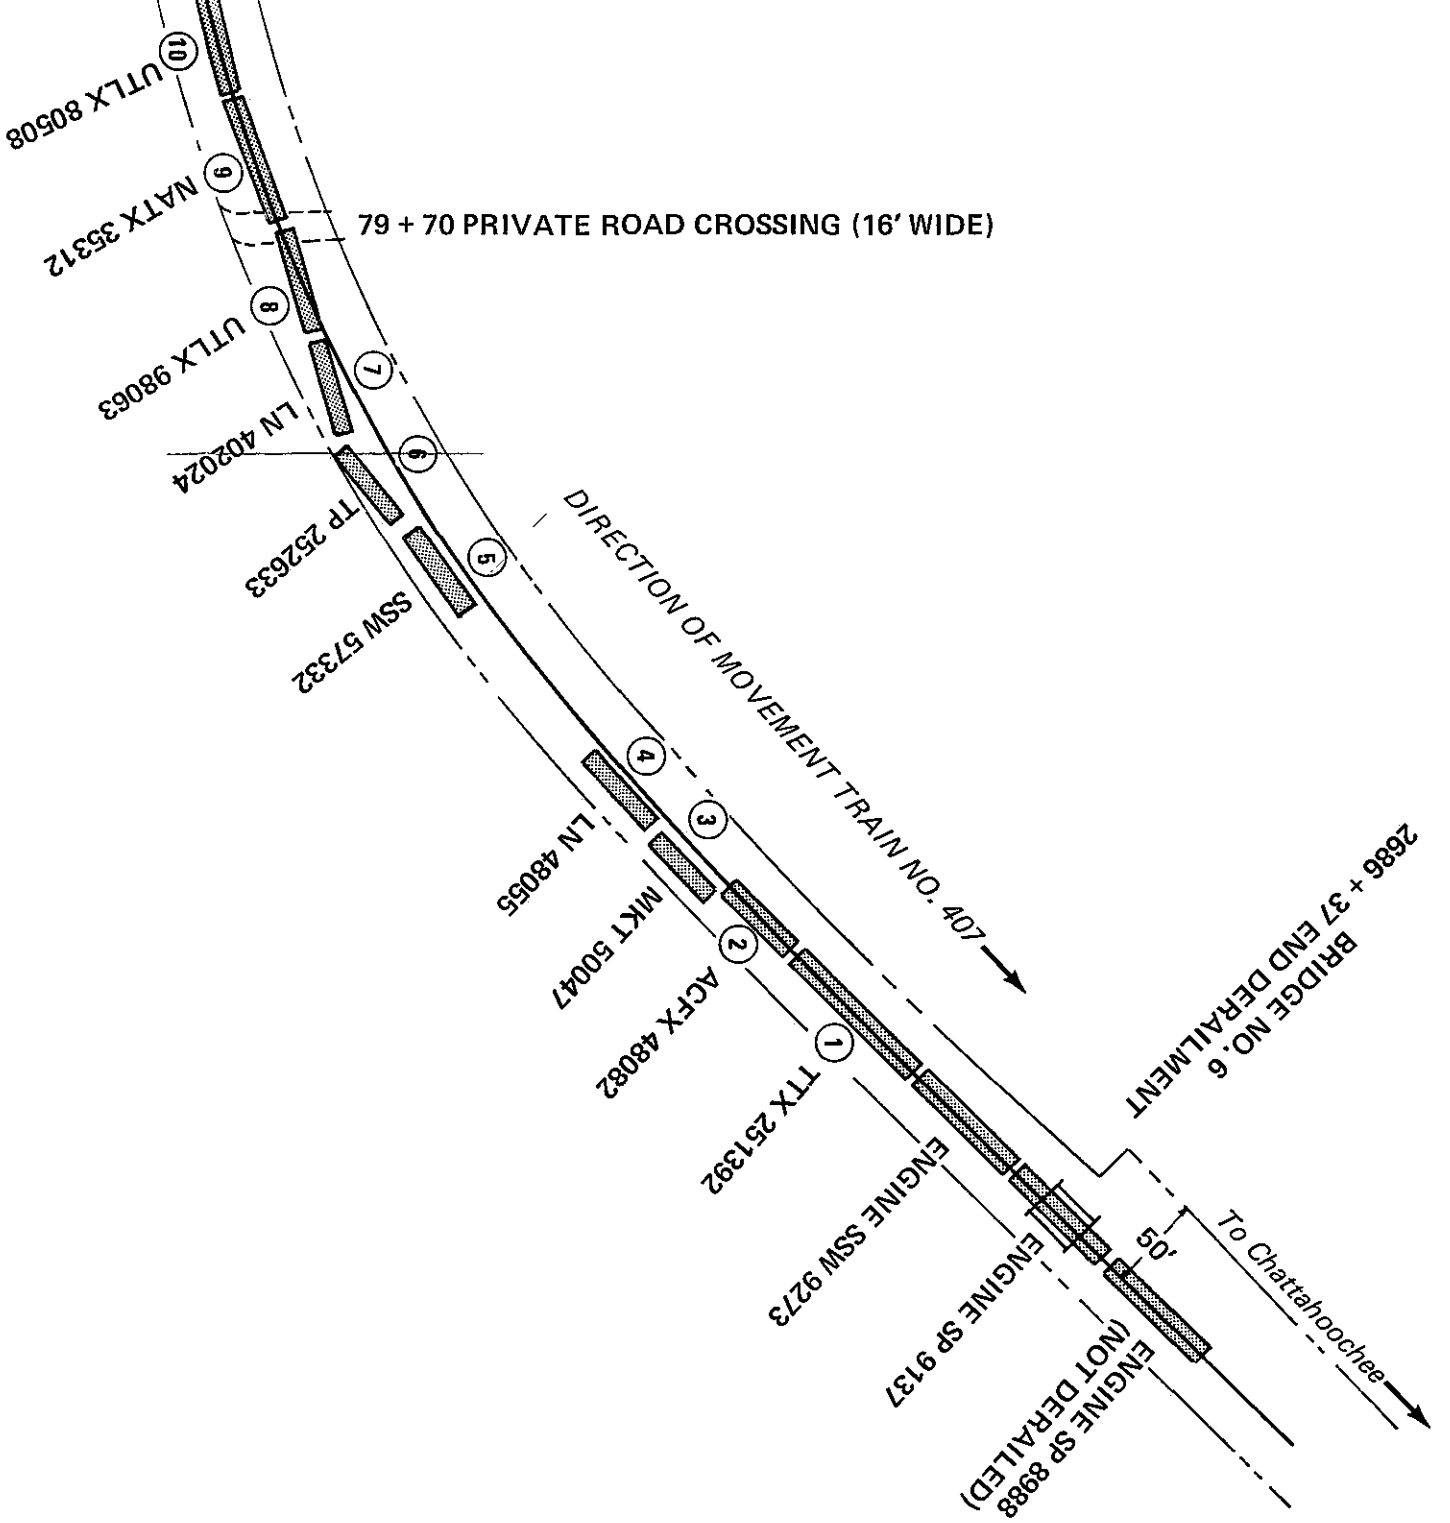
**Figure 1. Plan of Accident Site**

The locomotive and cars traveled 800 feet before stopping after the emergency brake application. The conductor and flagman, who were in the caboose at the rear of the train, stated that as the train stopped they noted no slack, jerking, or buff forces in the caboose. The conductor called the engineer on the radio when the train stopped at 6:06 p.m. and was told that the train had derailed. The first two cars, a long flat car loaded with one truck trailer and an empty covered hopper car, remained upright and coupled to the locomotive. The next 11 cars were tipped but remained in line along the following 900 feet of track. The 14th through 35th cars jack-knifed and piled up within the next 700 feet. (See figure 1.)

Ditch Caused by Rupture  
of 6" Waterline

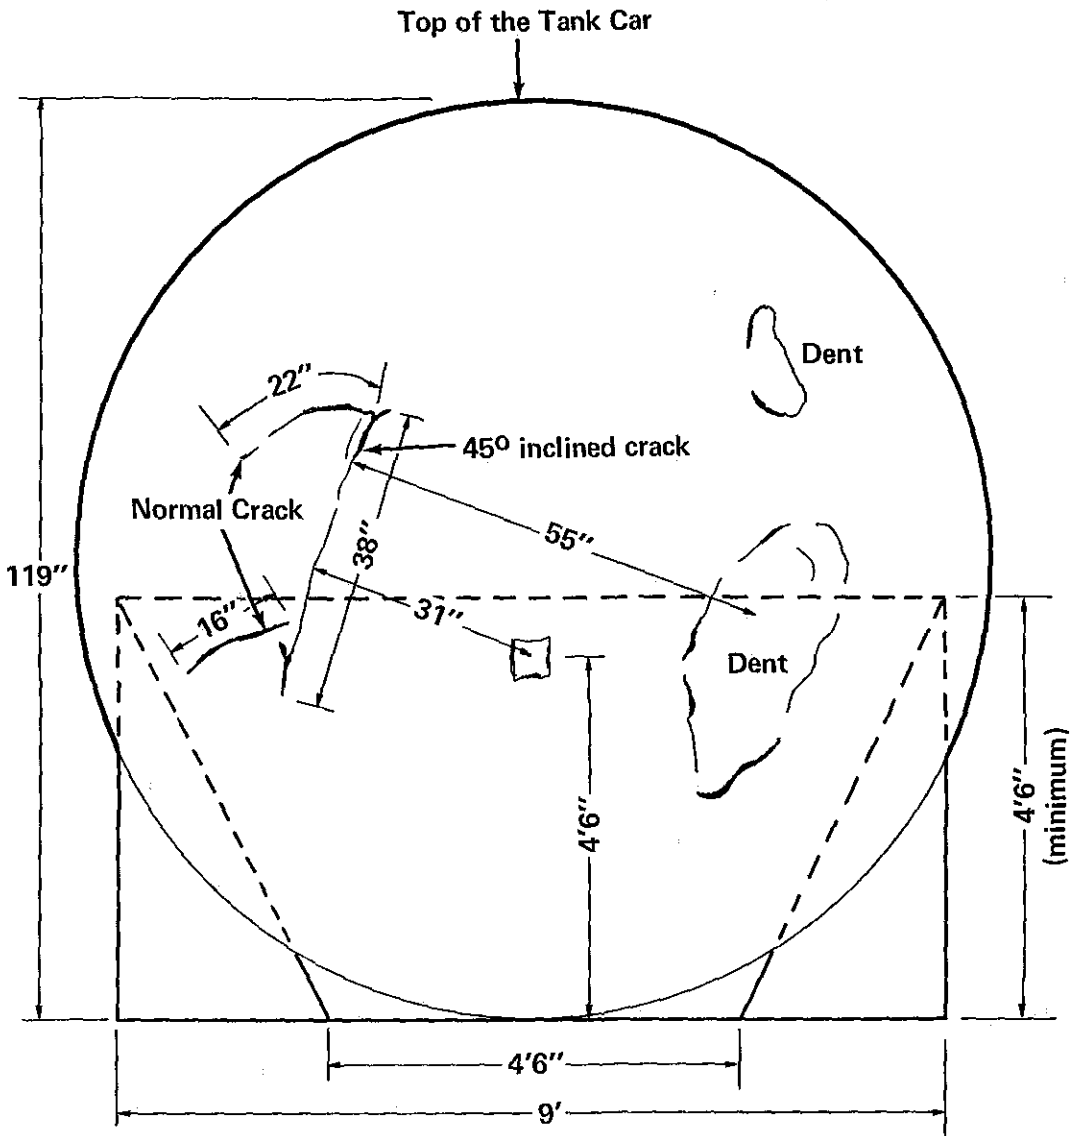
Figure 2. Tank car GATX 92665 head damage.

Sixteen of the 17 derailed tank cars contained anhydrous ammonia and were located between the 7th and the 28th cars. The 17th tank car contained solvent and was leaking slightly at a valve. The other derailed cars contained commodities such as feed, lumber, and automobiles. Twelve of the 35 derailed cars were destroyed and the others were heavily damaged. The 18th car was punctured on the right side near the junction of the head and shell of the tank. The puncture consisted of three parallel, 1/4-inch-wide, vertical cracks, about 6 inches apart, and located near the 4-o'clock position from the top of the tank. One 19-inch-long crack was adjacent to the weld of the head and shell. The other two cracks were 19 inches and 9 inches long respectively. The puncture of the 19th car was a 3-inch-wide by 38-inch-long tear in the leading tank head. It was located near the 10 o'clock position from the top and about 31 inches to the left of the vertical centerline. (See figure 2.)

The dashed lines show (approximately) the region which must be covered by the head shield being phased under current FRA regulations.

11. If the punctured tank cars had been equipped with head shields and T&B shelf couplers the punctures may have been averted and the severity of the accident reduced.
12. The local public safety personnel reacted promptly and effectively to the anhydrous ammonia emergency because of their development of an emergency plan and prior accident experiences.
13. Current DOT hazardous material guidelines for handling an emergency lack adequate information on how to determine the potential danger zone of exposure to the released hazardous materials.

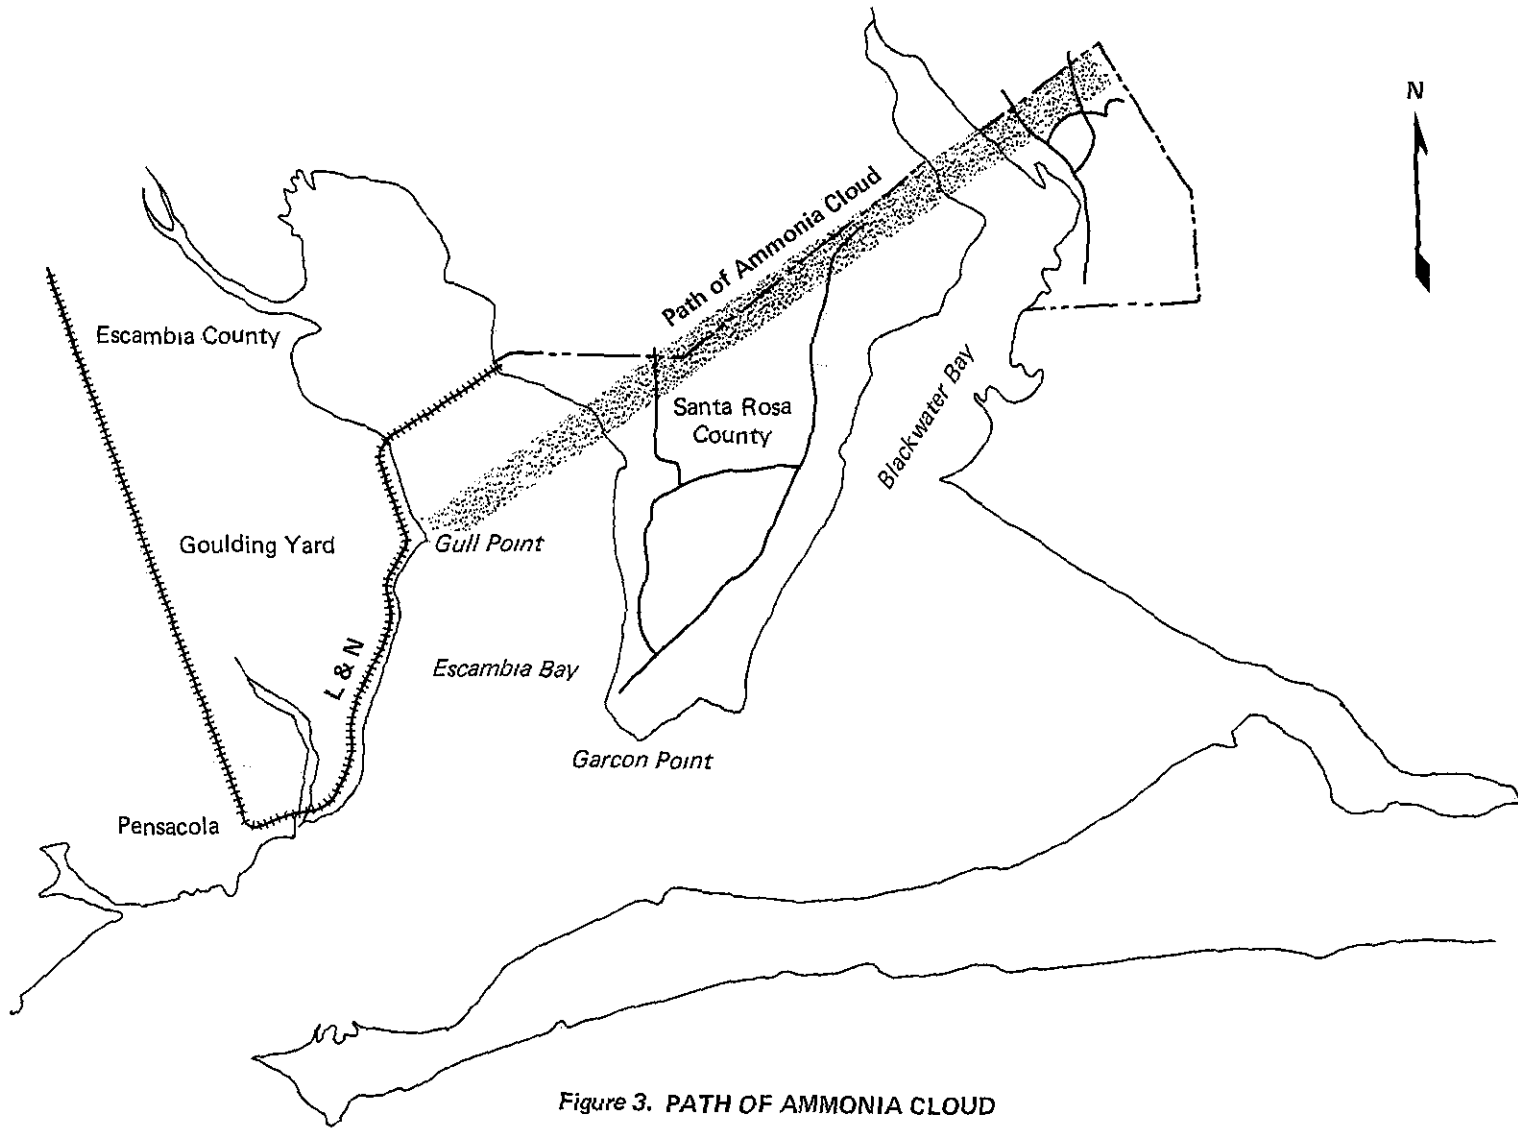
Figure 3. PATH OF AMMONIA CLOUD

The developing heavy dense ammonia fog deposited ammonium hydroxide particulates on exposed surfaces as the wind carried this fog over Escambia Bay. This cloud migrated as a single puff of fine ammonium hydroxide droplets with the prevailing wind speed across the bay, reaching landfall 4 miles eastward in Santa Rosa County, a sparsely populated area. The ammonium hydroxide in this cloud enabled the airport radar to track the migration across the bay; otherwise, ammonia could not have been observed on the radar screen. Within 60 minutes the cloud of ammonium hydroxide traveled 4 miles over the bay and 5 miles over land in Santa Rosa County, before dissipating. The wind direction kept the number of injuries low; an eastern wind would have blown the lethal cloud through a heavily populated urban area of Pensacola.
