RAILROAD ACCIDENT INVESTIGATION

Report No 3781

LOUISVILLE AND NASHVILLE RAILROAD COMPANY

WHITESIDE, TENN

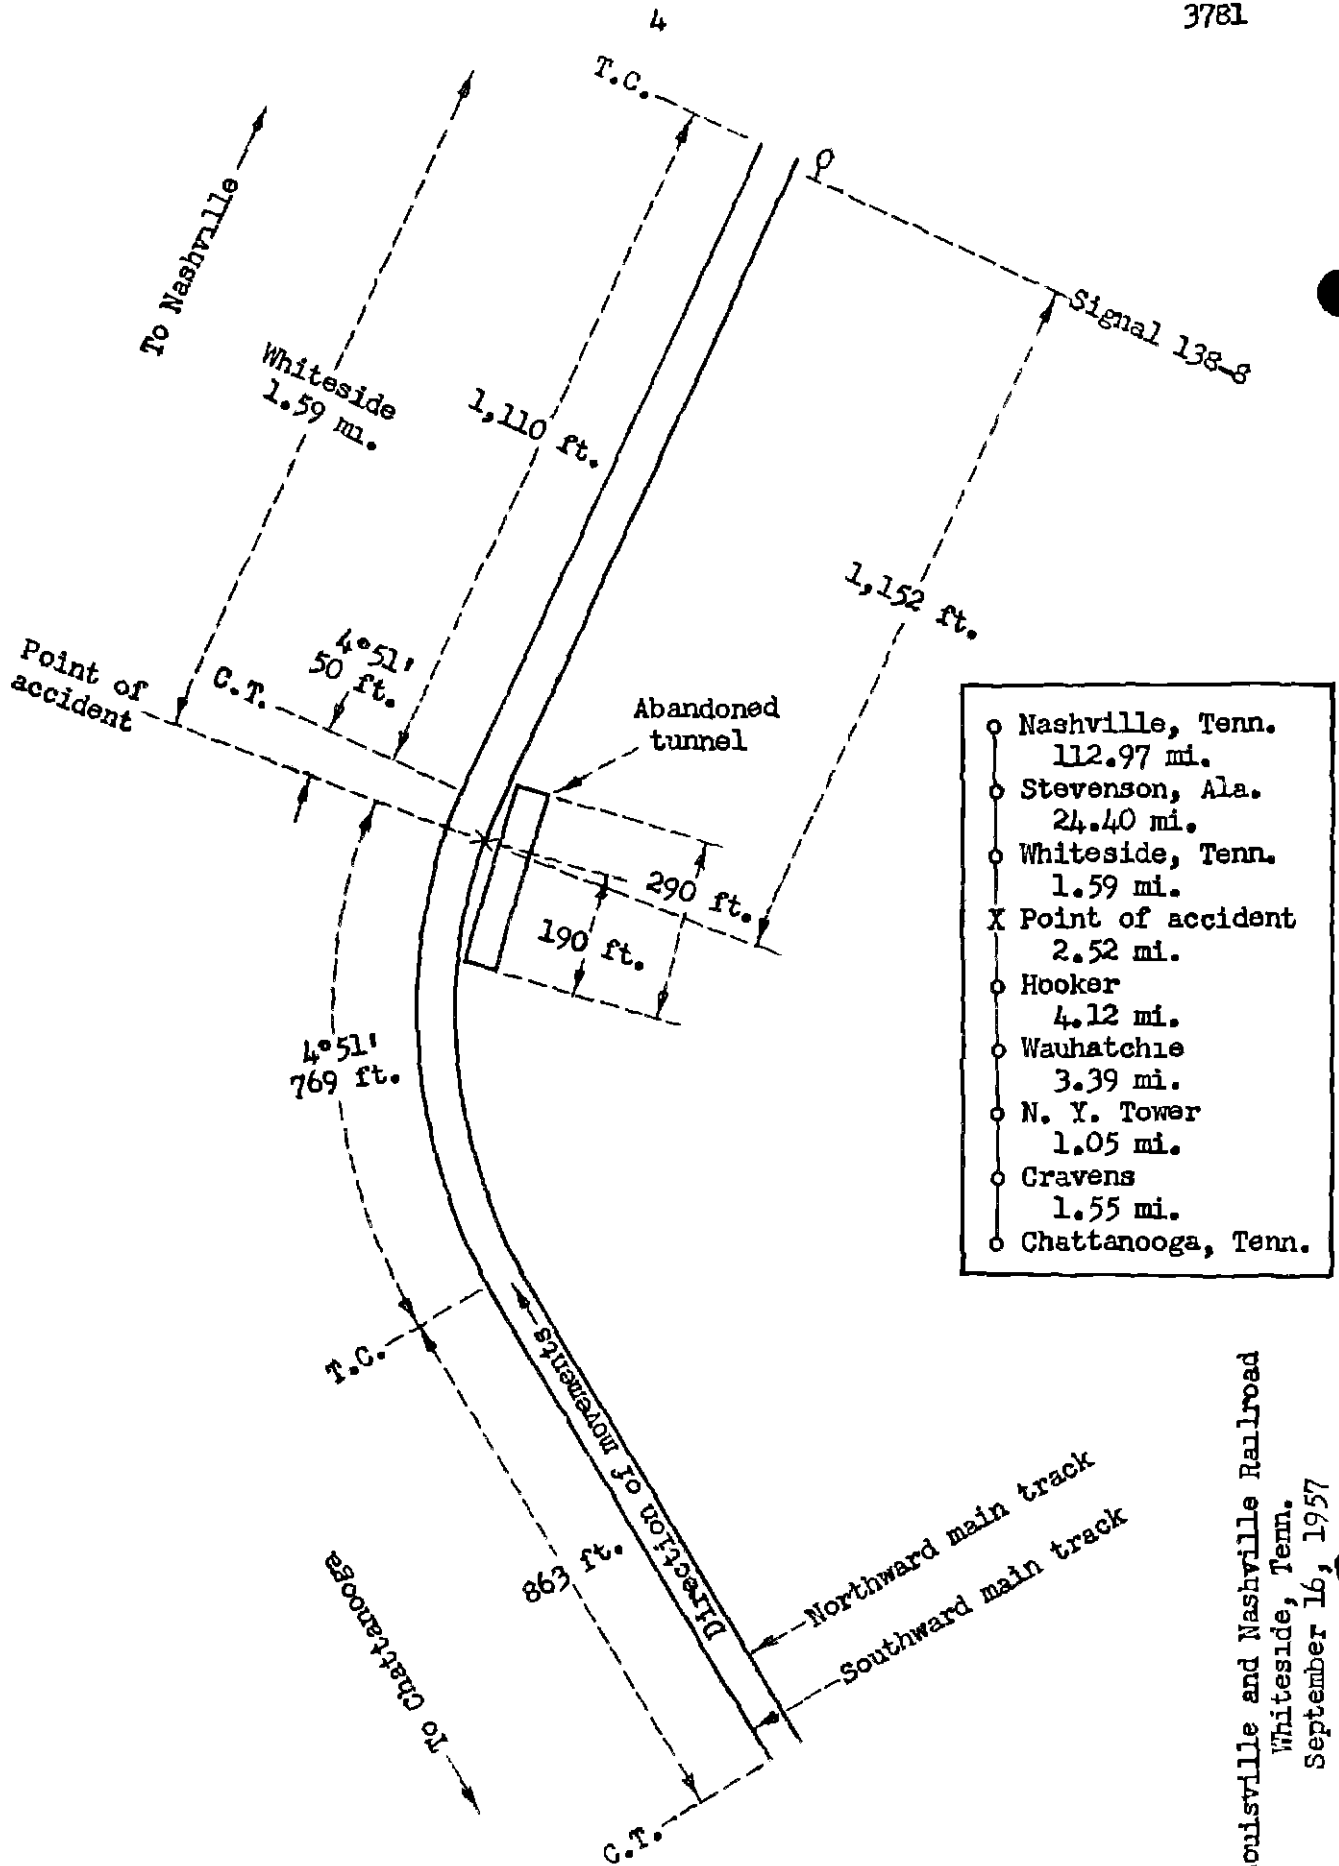
Location of Accident and Method of Operation

In the immediate vicinity of the point of accident an abandoned tunnel 290 feet in length and 20 feet in height parallels the main tracks on the east. The south end of the tunnel is 190 feet south of the point of accident. The base and the top of the west wall of the tunnel are, respectively, 13 feet and 25 feet east of the centerline of the northward main track.

Automatic signal 138-8, governing northbound movements on the northward main track, is located 1,152 feet north of the point of accident. This signal is of the color-light type and is approach lighted. It displays three aspects.
