ACCIDENT ON THE
LOUISVILLE & NASHVILLE RAILROAD

ALTRO, KY.

NOVEMBER 7, 1936

INVESTIGATION NO. 2109

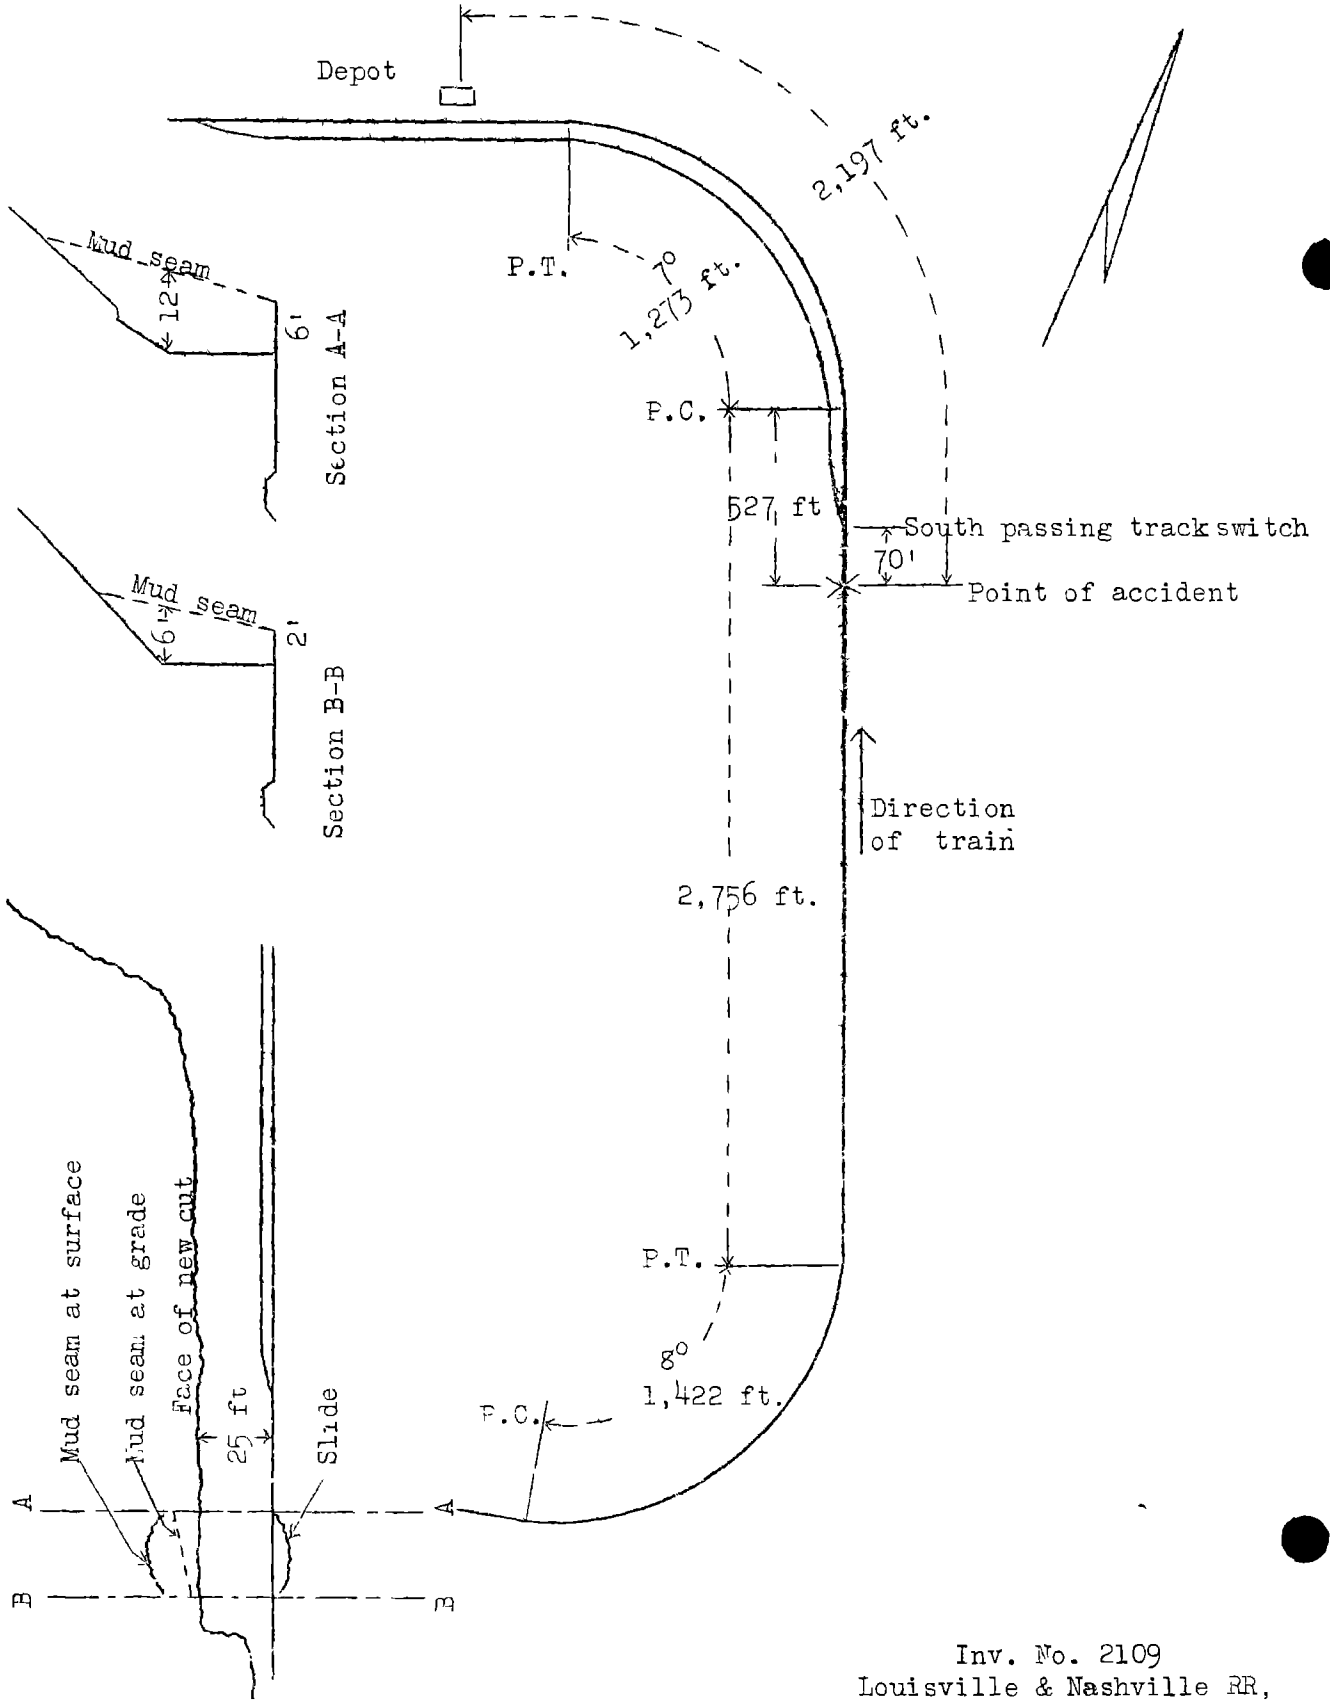
Inv. No. 2109
Louisville & Nashville RR,
Altro, Ky.
Nov. 7, 1936

Section Foreman Nunley arrived at the scene of the accident about 1 hour 15 minutes after its occurrence. The slide appeared to him to consist of about 160 cubic yards of a mixture of soapstone and small sandstone rock, which extended about 45 feet along the track and was about 4 feet deep on the west side of the track and about 2 feet deep on the east rail. This slide occurred

Division Engineer Frenberg stated that the slide consisted of about 250 cubic yards of material; it was 45 feet in length, the north end being about 45 feet south of the switch and the debris was approximately 18 inches above the rail on the west side and a lesser depth on the east rail. The slide was approximately 10 feet deep at its back edge, and extended with a surface slope of about 15 feet and then sloped steeply to a point east of the main track. The heaviest rock was at the bottom of the slide and west of the track. Examination of the material between the rails showed no evidence of rock of any size, the material consisting of pieces of sand or slate and pieces of thin bedded sandstone weighing less than 10 pounds and mixed with much small sandy loam and material from the soil covering. At the time of the accident the work of grading had progressed from a point 150 feet north of the south switch to a point about 105 feet south of the switch. This grading extended back to a vertical wall 25 feet from the center of the main track. The cut was approximately 25 feet deep between the north end of the slide and the south switch and about 20 feet deep at the south end of the slide. Examination developed that behind the face of the excavation made by the contractor there was a seam several inches in width and discolored with mud. This seam practically paralleled the track, being approximately 31 feet from the center of the main track at grade and sloped away from the track as it extended upward so that at the top of the cut made by the contractor, it was 12 feet from the wall of the cut and 37 feet from the center of the main track. As the surface of the ground above the cut is on a steep two to one slope, the seam reached the surface at the north end of the slide, at a point approximately 35 feet above the grade line of

A slide consisting of about 250 cubic yards of material fell from the side of a rock cut, filling the 25-foot space between the wall of the cut and the track, and extending beyond the main track to a depth of from 18 inches to 2 feet on the west rail and a lesser depth on the east rail. The heaviest rock was west of the track while the material on the track consisted of pieces of slate and thin bedded sandstone, mixed with sandy material and loam. The slide did not disturb the track in any way, but as

the engine ploughed through it the pilot was bent under the engine truck, which rode upon the slide and became derailed to the right, and upon encountering the switch a short distance beyond the entire engine became derailed.

During the process of excavation, which was being done for the purpose of extending the passing track, on the day of the accident a vertical mud seam was encountered and a small slide occurred. At the north end of the slide this mud seam was 6 feet behind the face of the cut and at the south end of the slide it was 2 feet from the face of the cut; this seam extended upward and in a slight backward slope toward the hillside. Construction Foreman Cluggish was aware of the possibility of another slide due to this mud seam, but he thought that the area between the wall of the cut and the track would take care of any material that might fall. Night Watchman Gambill, employed by the construction company, patrolled this track about twice every hour, he had last passed the point of accident about 30 minutes prior to the accident, and was just leaving the tool house about 600 feet north of the point of accident, he heard the engine whistle sounded, immediately followed by the noise of the slide; there was not sufficient time in which to flag the train. Foreman Cluggish, although aware of the conditions and the possibility of a further slide, did not notify the representatives of the railroad, so as to enable them to take any further precautions necessary to prevent an accident.

This accident was caused by a land and rock slide.
