INVESTIGATION NO. 2826
THE LOUISVILLE & NASHVILLE RAILROAD COMPANY
REPORT IN RE ACCIDENT
AT BIRMINGHAM, ALA., ON
SEPTEMBER 4, 1944

Accident at Birmingham, Ala., on September 4, 1944, caused
by a crossover switch not being lined for the intended
movement of a yard engine.

Inv. No. 2826
Louisville & Nashville Railroad
Birmingham, Ala.
September 4, 1914

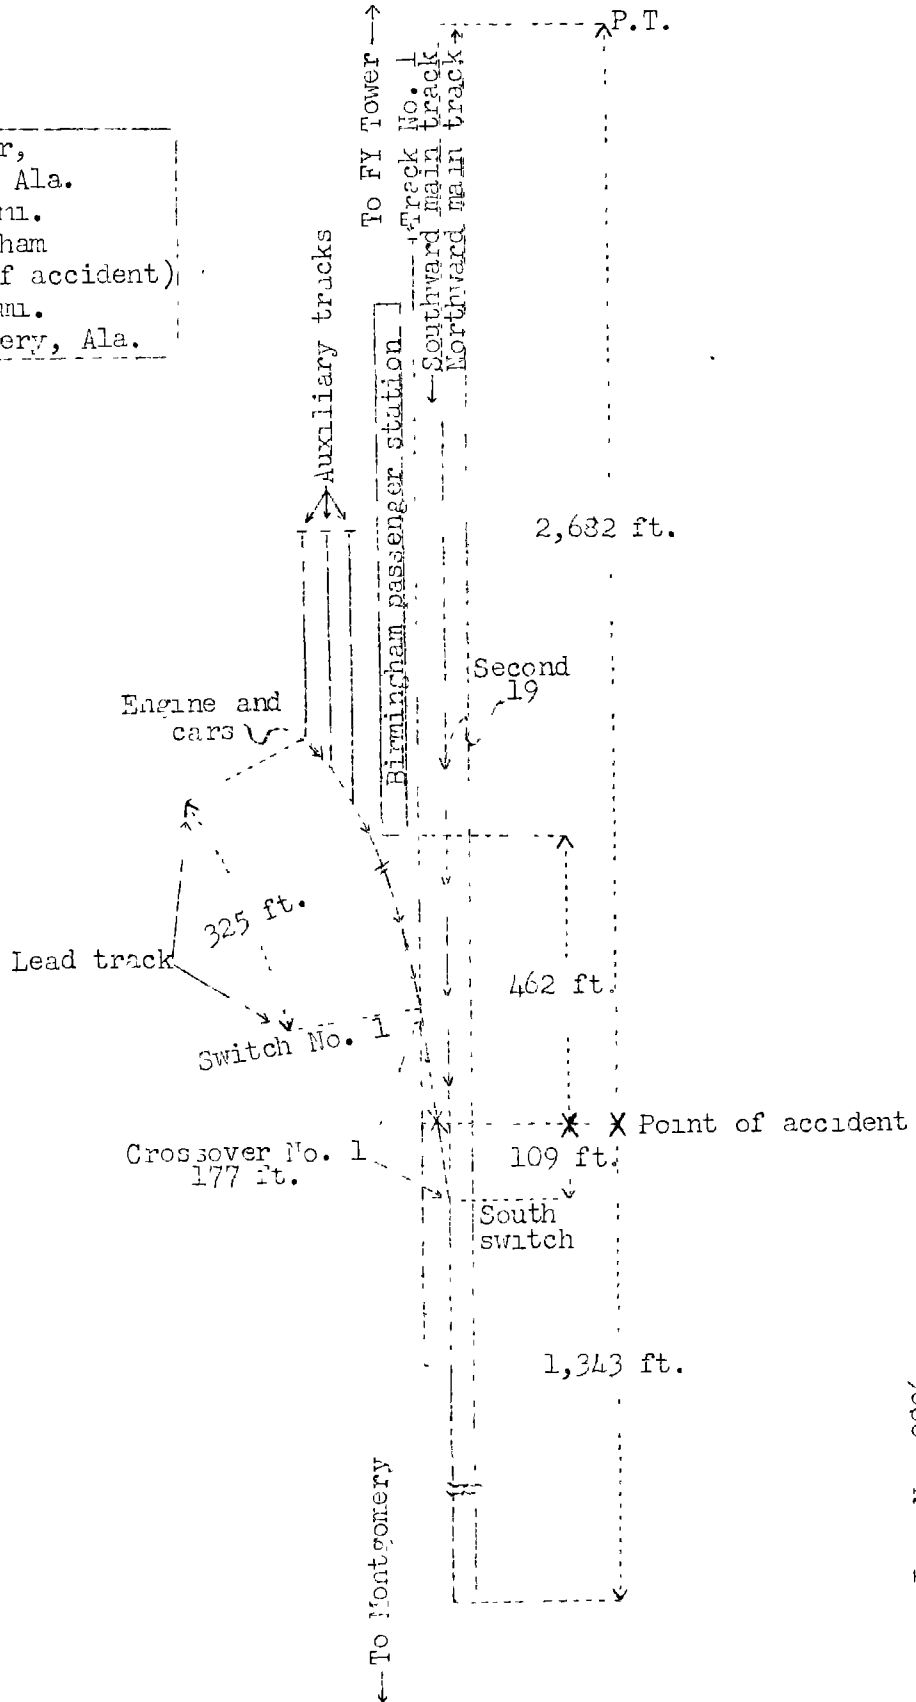
Location of Accident and Method of Operation

This accident occurred on that part of the Birmingham Division extending southward from FY Tower, Boyles, to Montgomery, Ala., 100.18 miles. In the immediate vicinity of the point of accident this was a double-track line, within yard limits, over which trains were operated by timetable and train orders. There was no block system in use. In the vicinity of the passenger station at Birmingham, 3.5 miles south of FY Tower, an auxiliary track, designated as track No. 1, paralleled the main tracks on the west. The south switch of a crossover 177 feet long, hereinafter referred to as crossover No. 1, which connected the southward main track and track No. 1, was 571 feet south of the south end of the passenger station. Crossover No. 1 was facing-point for movements from track No. 1 to the southward main track. A lead track 325 feet long connected track No. 1 and several auxiliary tracks, which paralleled track No. 1 on the west. Movements from the lead track to track No. 1 or to the southward main track through crossover No. 1 were made through a single-slip switch, hereinafter referred to as switch No. 1. The accident occurred at the fouling point of the southward main track and crossover No. 1. The main tracks were tangent throughout a distance of 2,682 feet north of crossover No. 1 and 1,343 feet southward. The grade for south-bound trains was 0.40 percent descending.

The switch-stand for switch No. 1 was on the west side of the southward main track, and was of the hand-throw low-stand type. The switch-stand was provided with an oil lamp, and the center of each lens was 2.1 feet above the ties. When the switch was lined for movement from the lead track to track No. 1 a yellow light was displayed. When the switch was lined for movement from the lead track through crossover No. 1 to the southward main track a green light was displayed. No switch lock was provided.

Second 19, a south-bound second-class freight train, consisting of engine 1803, 48 cars and a caboose, departed from FY Tower about 10:10 p. m., 4 hours 10 minutes late, and while it was moving at a speed of about 10 miles per hour the thirty-sixth car was struck by yard engine 2086 at the fouling point of crossover No. 1.

Yard engine 2086 was engaged in switching operations at the passenger station at Birmingham. While this engine, headed southward, was pulling a cut of 4 passenger-equipment cars it entered crossover No. 1 at an estimated speed of 8 miles per hour and struck Second 19.
