INVESTIGATION NO. 2952
LOUISVILLE AND NASHVILLE RAILROAD COMPANY
REPORT IN RE ACCIDENT
AT CHATSWORTH, GA., ON
DECEMBER 4, 1945

Accident at Chatsworth, Ga., on December 4, 1945, caused
by a defective switch frog.

Inv. No. 2952
 Louisville and Nashville Railroad
 Chattanooga, Ga.
 December 4, 1945

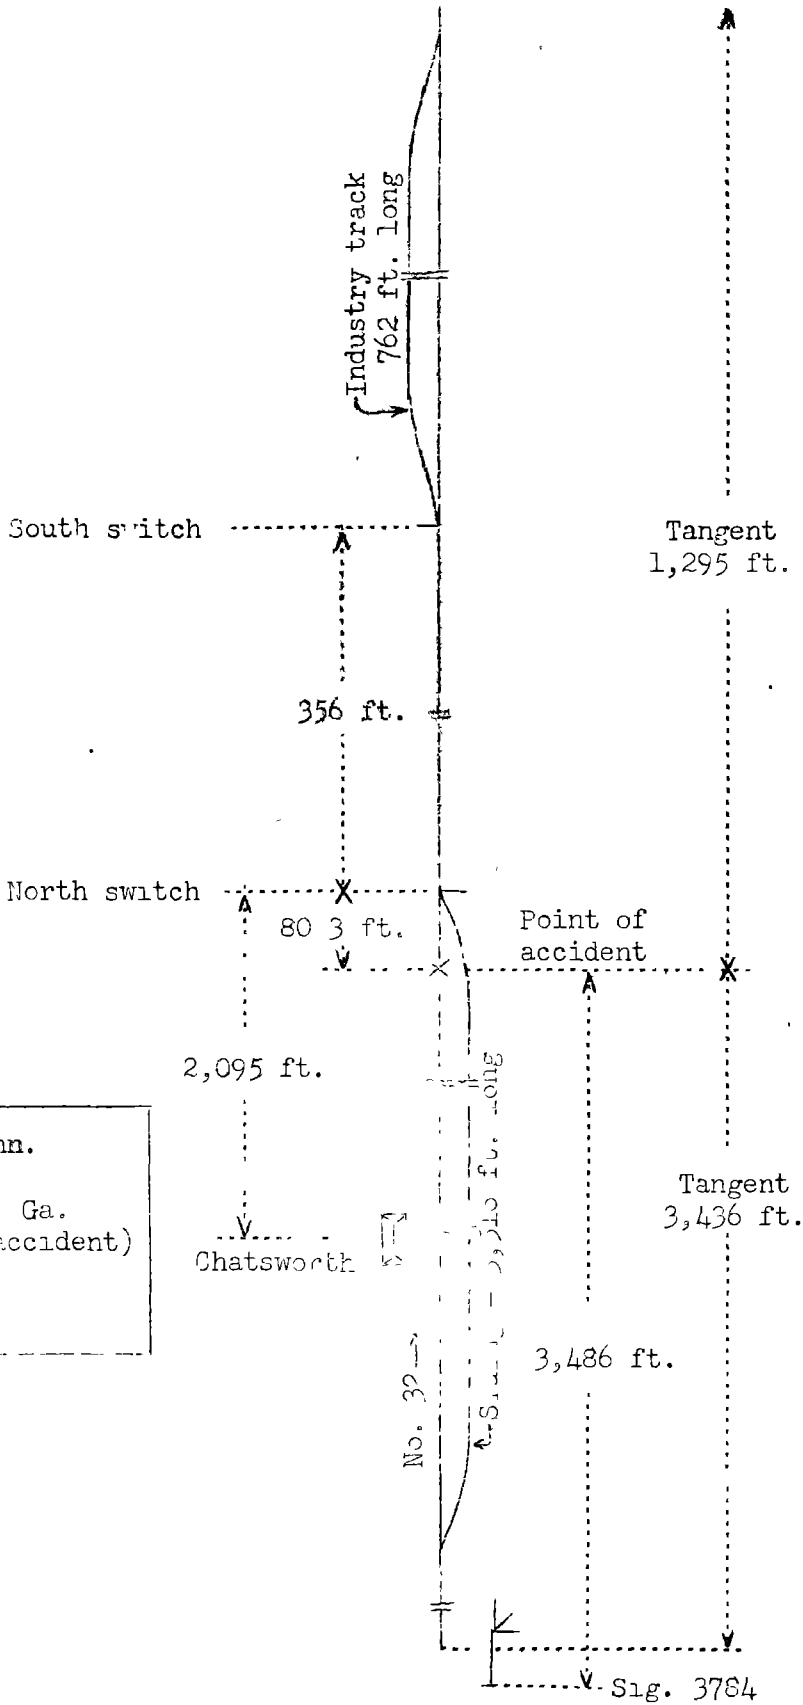
Examination of the frog of the north siding-switch disclosed that base-stops No. 1 and No. 3 and the cuff of hold-down No. 1 were broken off, and the cuff and the stop-bar of hold-down No. 2 were missing. The break in base-stop No. 3 was new, but about 75 percent of the break in the cuff of hold-down No. 1 and about 80 percent of the break of base-stop No. 1 were old fractures. The gage side of the wing rail bore heavy batter marks. The outer side of the rim of the right front wheel of the rear tender truck bore marks indicating that this wheel dropped into the throat of the frog at a point about 9 inches north of the frog-point.

The missing cuff and stop-bar of hold-down No. 2 permitted excessive lateral and vertical movement of the spring rail, and this action in turn caused the partial fractures in the cuff of hold-down No. 1 and base-stop No. 1. The complete failure at these fractures and the new break in base-stop No. 3 occurred when the wheels of the engine of No. 32 were moving over the frog, then the spring wing rail shifted outward far enough for a wheel to drop into the throat of the frog.
