REPORT OF THE DIRECTOR
BUREAU OF SAFETY

ACCIDENT ON THE
LOUISVILLE & NASHVILLE RAILROAD

CRESTWOOD, KY.

OCTOBER 15, 1937

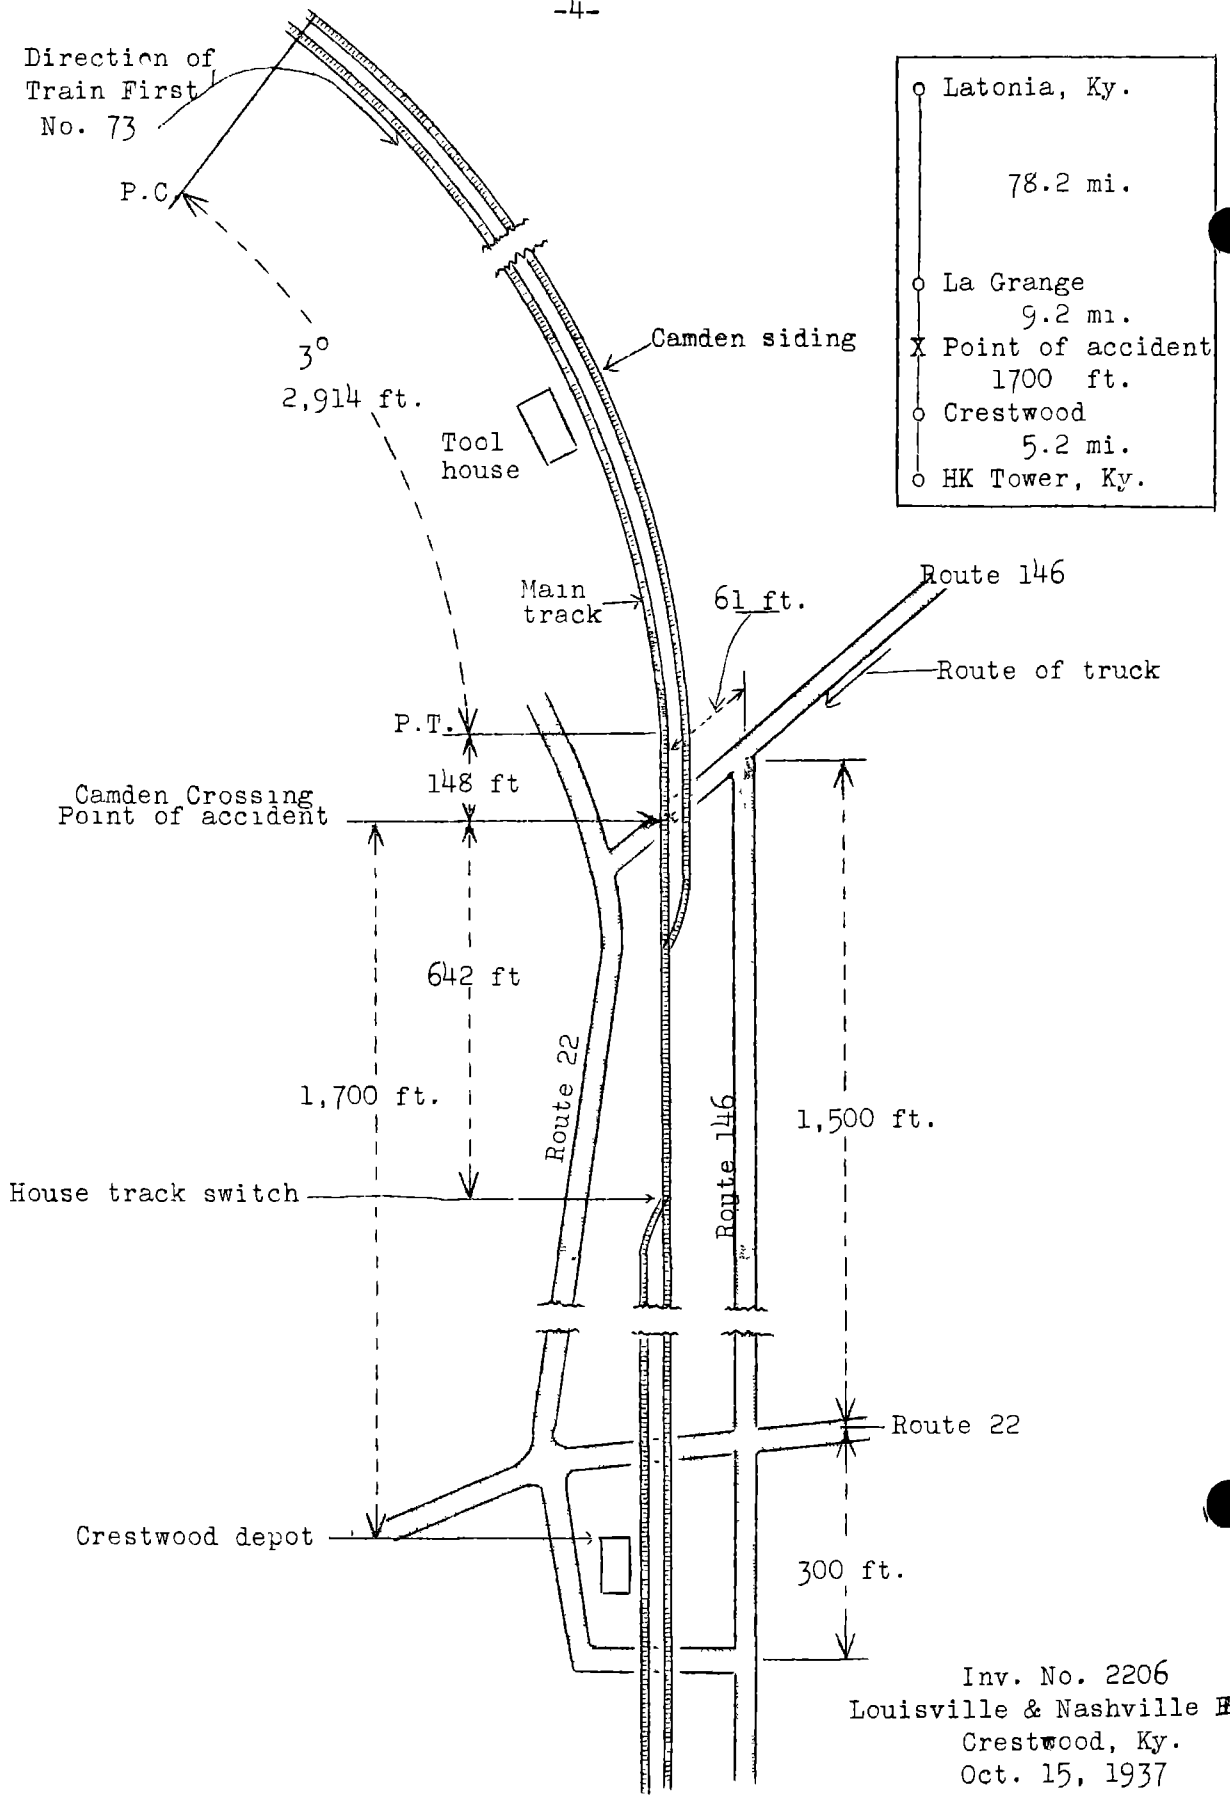
Inv. No. 2206
 Louisville & Nashville RR
 Crestwood, Ky.
 Oct. 15, 1937

In the vicinity of the point of accident State Highway 22 from the north runs along the west side of the railroad, following its alinement in a general way. State Highway 146 approaches the railroad from the northeast at an angle of about 40° until it reaches a point about 50 feet east of the railroad and 1,700 feet north of the station at Crestwood; from this point it parallels the railroad southward through the town. From the point where route 146 makes the curve to parallel the tracks, a branch road continues straight along the line followed by route 146 in approaching the railroad. It is 61 feet from its point of divergence from route 146 to the east rail of the L. & N. R.R., and after crossing the railroad this highway connects with route 22 on the west side of the tracks.

This crossing, called Camden crossing, is 39 feet wide; it has a smooth surface of non-skid asphalt, and crosses 2 tracks at an angle of about 40° from northeast to southwest. Approaching the crossing from the northeast the grade of the highway is approximately 1% ascending. The crossing is equipped with a standard cross-bar sign about 8 feet high located on the north side of the road at a point 15 to 18 feet east of the railroad. The word "Railroad" is painted on one bar of this sign, and the word "Crossing" appears on the other bar, there being no signal devices at this crossing to indicate the approach of train. State Highway 22 crosses the tracks and also State Highway 146 about 200 feet north of Crestwood station, and there is a third grade crossing just south of the station which also affords passage between routes 146 and 22; both of the two latter crossings, in the vicinity of the station, are protected by electric bell, light and wig-wag signals, and traffic if governed by highway signs and numbers would cross the tracks on the crossing just north of the station.

An average of over thirty trains per day move over the crossings at Crestwood; a traffic check of Camden crossing showed an average of less than seven vehicles per hour using this crossing with a maximum of eighteen vehicles in any one hour. Since two other crossings which are protected by automatic warning devices are available to the public, the existence of this crossing constitutes a needless hazard to the railroad and the public alike and steps should be taken to eliminate it.
