ACCIDENT ON THE  
LOUISVILLE & NASHVILLE RAILROAD

EAST BERNSTADT, KY.

MAY 23, 1937

INVESTIGATION NO. 2174

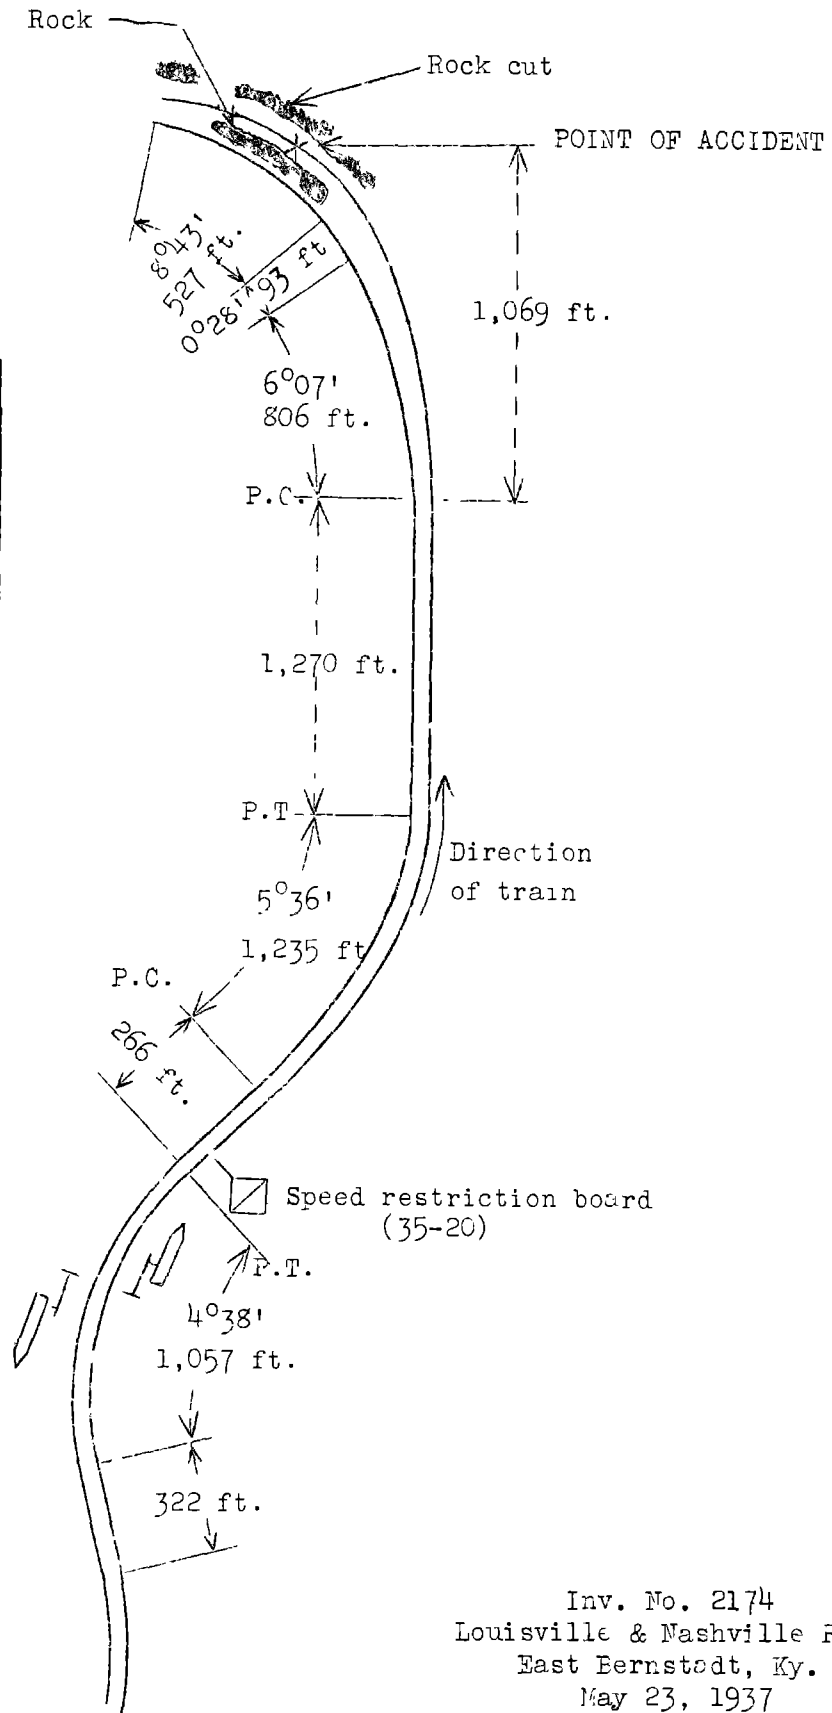
Inv. No. 2174  
 Louisville & Nashville R.R.  
 East Bernstadt, Ky.  
 May 23, 1937

On the  $8^{\circ}43'$  curve on which the accident occurred the northward track is laid in a jagged rock cut about 30 feet high and 16 feet wide at the base, and the main tracks are separated by a natural wall of rock about 275 feet long and 50 feet wide. North of the rock wall there is an open space having a maximum width of about 75 feet and tapering with the convergence of the tracks to the usual width of a double track line. To the east of the open space the mountainside has a gradual slope for a distance of about 150 feet north of the rock wall, after which a precipitous rocky formation overhangs the northward main track. The track is laid with 100-pound rails, 39 feet in length, with 23 treated ties to the full length, double-spiked on the outside and single-spiked on the inside, fully tieplated and equipped with 5 gauge rods and from 6 to 12 rail anchors

Division Engineer Nickerson stated that the first mark of derailment was a wheel mark on top of the guard rail  $3\frac{1}{2}$  inches from the gauge side of the low rail. At a point  $7\frac{1}{2}$  feet from this mark the first mark on the outside of the right or high rail appeared; it was on the head of a spike and was followed by a mark on the tieplate. At a point 25 feet beyond the first mark the derailed equipment left the ties on the east side. At a point 26 feet beyond, some part of the wreckage struck the side of the cut, tearing out some of the rock, and 47 feet from this point the side of the cut was struck again. From the point of derailment the guard rail was in its proper position for about 50 feet northward but from that point to where the wreckage stopped the track was completely destroyed. The southward track was knocked slightly out of line and damaged to the extent that it was necessary to remove two rails. After the derailment the track was checked for gauge and elevation; the super-elevation varied from  $5\frac{1}{4}$  to  $5\frac{7}{8}$  inches, being  $5\frac{1}{4}$  inches at the point of derailment. This is standard on the L. & N. for a speed of 35 miles per hour. It was his opinion that the derailment was caused by excessive speed, which he estimated to have been about 60 miles per hour, and the fact that the brakes were applied when the train struck the sharpest part of the curve. The center of gravity on engine 419 would be 5 feet 4 inches above the rail, and according to the formula of the American Railroad Engineering Association the overturning speed on an 8°43' curve would be 69.3 miles per hour.

Inspector of Safety Bowling stated that the mark on the guard rail extended for a distance of 8 feet. From the south end of this mark to a point 13 feet southward some of the spikes on the gauge side of the east rail had been pulled about 3 inches and the heads of some of the other spikes had been bent back, releasing the base of the rail. Opposite the flange mark on the guard rail there was a mark on the outer end of the gauge rod near the right rail, the rod was bent downward and disengaged from the base of the rail. About 8 or 10 feet northward the track was torn up from the center of the ties to the east edge of the ties; from that point northward there were indications that the right flanges had run along the web on the gauge side of the rail. Measurements for a distance of 13 rail lengths southward indicated the gauge to be  $1/16$  inch tight due to the roll of the ball of the west rail. At the time of his inspection the rail where the spikes had been disengaged was back in its normal position and was resting on the ties. The next rail, however, showed indications of wheels running on the base of it and was still partly turned. The engine turned over at a point approximately 70 feet beyond the point of derailment.
