ACCIDENT ON THE  
LOUISVILLE & NASHVILLE RAILROAD

KIRKSTALL, TENN.

FEBRUARY 1, 1940

INVESTIGATION NO. 2413

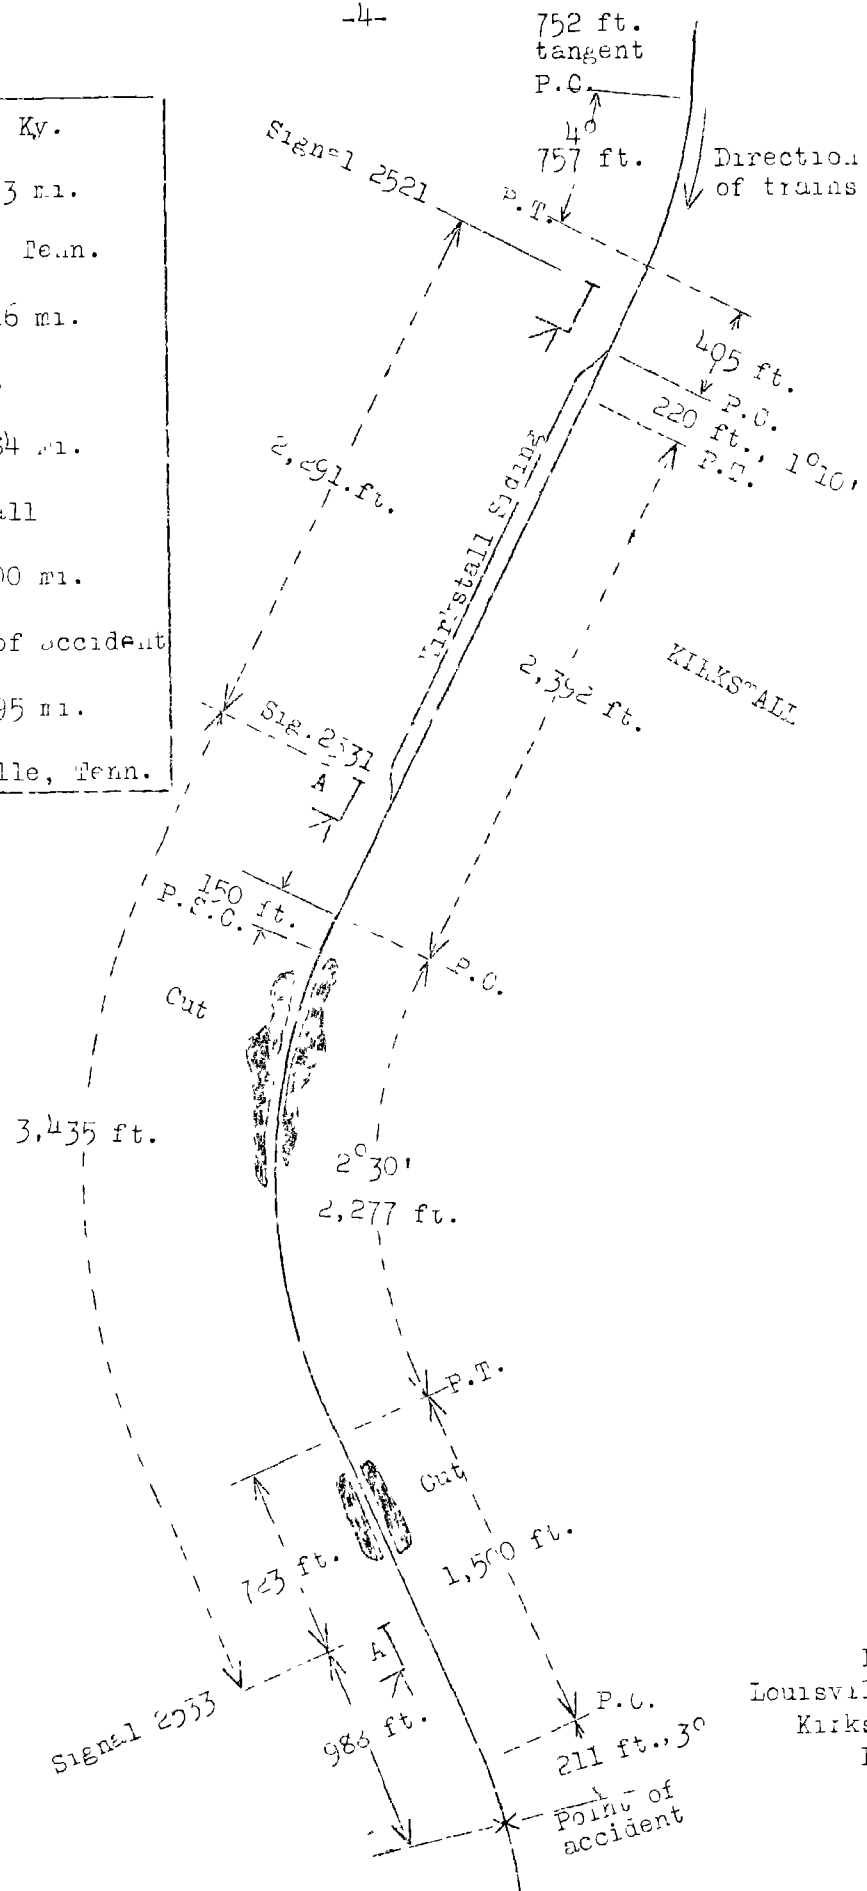
Inv. no. 2413  
 Louisville & Nashville R.P.  
 Kirkstall, Tennessee  
 Feb. 1, 1940

o	Corbin, Ky.
	33.73 mi.
o	Holton, Tenn.
	44.16 mi.
o	Dossett
	2.84 mi.
o	Kirkstall
	1.00 mi.
x	Point of accident
	22.95 mi.
c	Knorville, Tenn.
