REPORT NO 3312  
LOUISVILLE AND NASHVILLE RAILROAD COMPANY  
IN RE ACCIDENT  
NEAR LONG BEACH, MISS., ON  
FEBRUARY 18, 1950

Date.	February 18, 1950
Railroad	Louisville and Nashville
Location	Long Beach, Miss.
Kind of accident:	Derailment
Train involved:	Passenger
Train number:	99
Engine number.	Diesel-electric units 777 and 775
Consist.	19 cars
Estimated speed	55 m. p. h.
Operation:	Timetable, train orders, automatic block-signal, cab-signal and train-stop systems
Track:	Single, tangent; level
Weather	Hazy
Time:	7 a. m
Casualties	32 injured
Cause.	Broken rail

Accident near Long Beach, Miss., on February 18, 1950,  
caused by a broken rail.

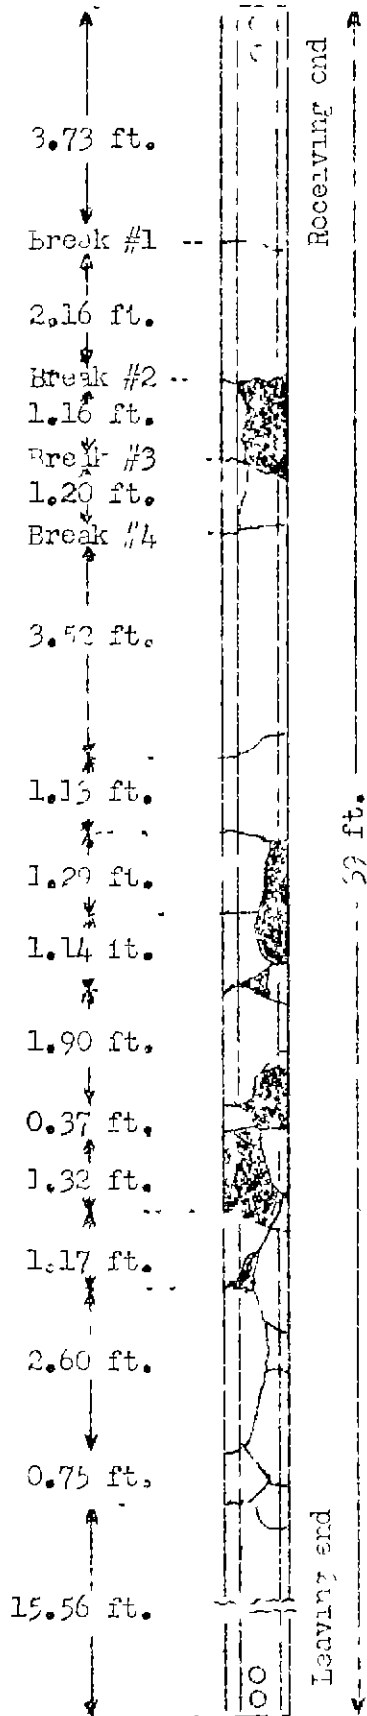
Shaded areas indicate missing portions of rail

Sketch showing broken rail - west side of track

After the accident occurred a broken rail was found on the west side of the track. This rail was broken into many pieces, 23 of which were recovered. The first break occurred at a point 3.73 feet south of the receiving end of the rail. The second, third and fourth breaks occurred at points 1.10 feet, 3.32 feet and 4.52 feet, respectively, from break No. 1. Then 15.19 feet of the rail was broken into at least 20 pieces varying in length from 0.37 feet to 3.52 feet. At breaks Nos. 2 and 4 there were transverse fissures which covered, respectively, 35 percent and 25 percent of the cross-sectional area of the head of the rail. Neither of these fissures extended to the surface of the rail. The other breaks were new and apparently occurred as a result of the derailment. Apparently the rail failed when the front portion of the train passed over it, then the broken pieces became displaced and the derailment followed. This rail was manufactured by the Tennessee Coal, Iron and Railroad Company in April, 1930. The heat number was 337204, Letter A, Ingot No. 13.

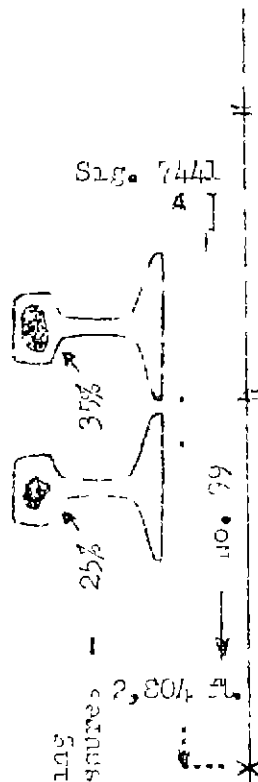
Sketch of end views showing locations of transverse fissure.
