REPORT OF THE DIRECTOR OF THE BUREAU OF SAFETY IN RE
INVESTIGATION OF AN ACCIDENT WHICH OCCURRED ON
THE LOUISVILLE & NASHVILLE RAILROAD AT OLIVE,
FLA., ON JUNE 24, 1931.

Inv. No. 1713
Louisville & Nashville R. R.
Olive, Fla.
June 24, 1931

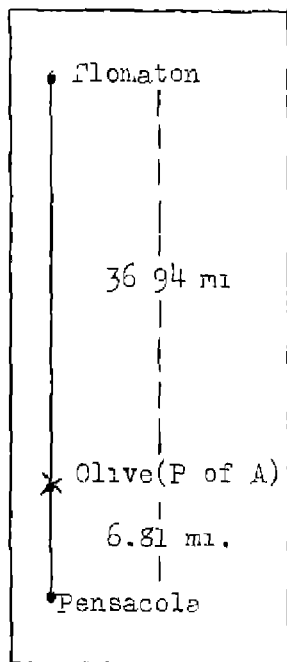
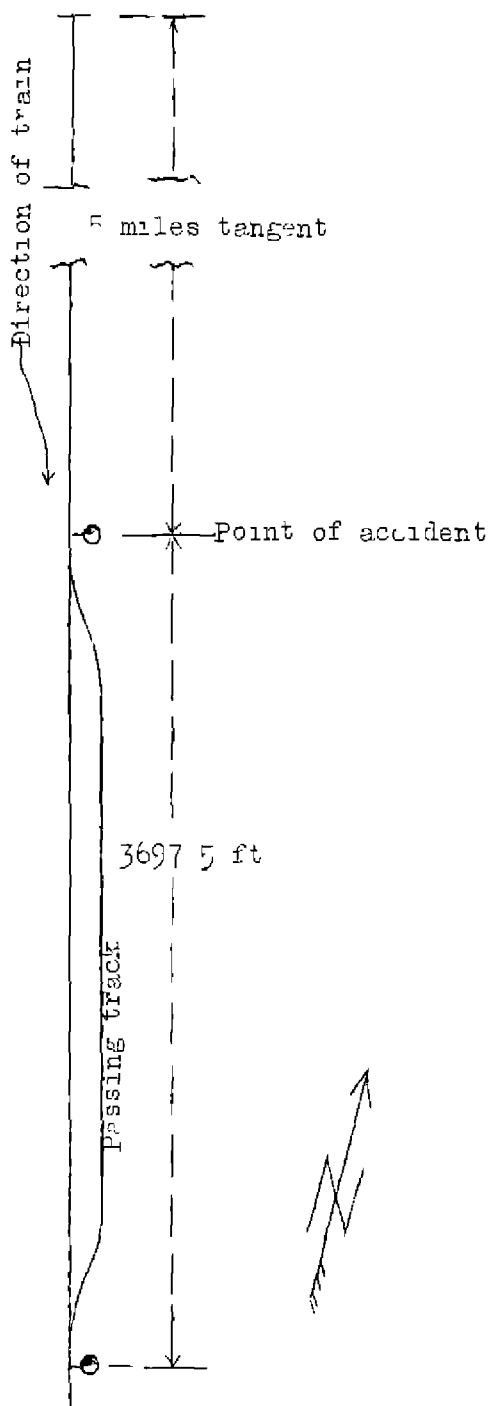
The entire train entered the passing track, the first mark of derailment appearing on a tie on the gauge side of the east rail of the passing track at a point 217 feet south of the north switch. Engine 190 stopped on its left side parallel with and about 45 feet east of the passing track, with its front end 233 feet beyond the first tie mark; the tender was just beyond the engine, fouling the passing track. The first five cars were derailed in line with and fouling both tracks, remaining upright and coupled with the head end of the first car 225 feet beyond the engine; the east side of the second car was torn out, evidently having sideswiped the tender as it passed. The employee killed was the engineman, while the employee injured was the fireman.

Examination of the track by the Commission's inspector after the wreckage had been cleared showed a mark, evidently caused by a wheel, on the east side of the east switch point; this mark was $6\frac{1}{2}$ feet in length along the outside of the ball of the rail and extended to within 4 feet of the tip of the point. The first mark on a tie, 6 inches wide, appeared on the gauge side of the east rail of the passing track at a point 217 feet south of the north switch; this mark showed on 30 ties, approximately 50 feet, being more pronounced on some ties than on others, and had the appearance of something dragging. At a point 8 feet beyond where the first tie mark appeared, a splice bar on the inside of this rail was marked, as was the next splice bar on the outside of the rail, and then at a point 10 feet farther south there appeared the first mark on a tie on the outside of the east rail, showing on about 8 ties. At points 38 feet, 45 feet, and 48 feet, south of the first tie mark on the outside of the east rail, there were very light marks on the ball of the rail, but no corresponding marks on the opposite side of the track, these marks being 36 inches, 12 inches, and 18 inches long, respectively, and it was doubtful whether they were flange marks. The condition of the engine and tender was such that it was impossible to determine whether any part of this equipment had been dragging prior to the accident. The break in the lug, or crank, had the appearance of a new break, but at the time of this examination, several days after the accident, the metal was corroded to some extent; in the center of the break there appeared to be a defect in the metal, but whether or not this apparent defect weakened the crank is questionable.
