INVESTIGATION NO. 2629  
THE LOUISVILLE & NASHVILLE RAILROAD COMPANY  
REPORT IN RE ACCIDENT  
NEAR PANA, ALA., ON  
SEPTEMBER 24, 1942

Accident near Pana, Ala., on September 24, 1942, caused by  
broken rail, as result of presence of transverse  
fissures.

Inv. No. 2629  
 Louisville & Nashville Railroad  
 Pana, Ala.  
 September 24, 1912

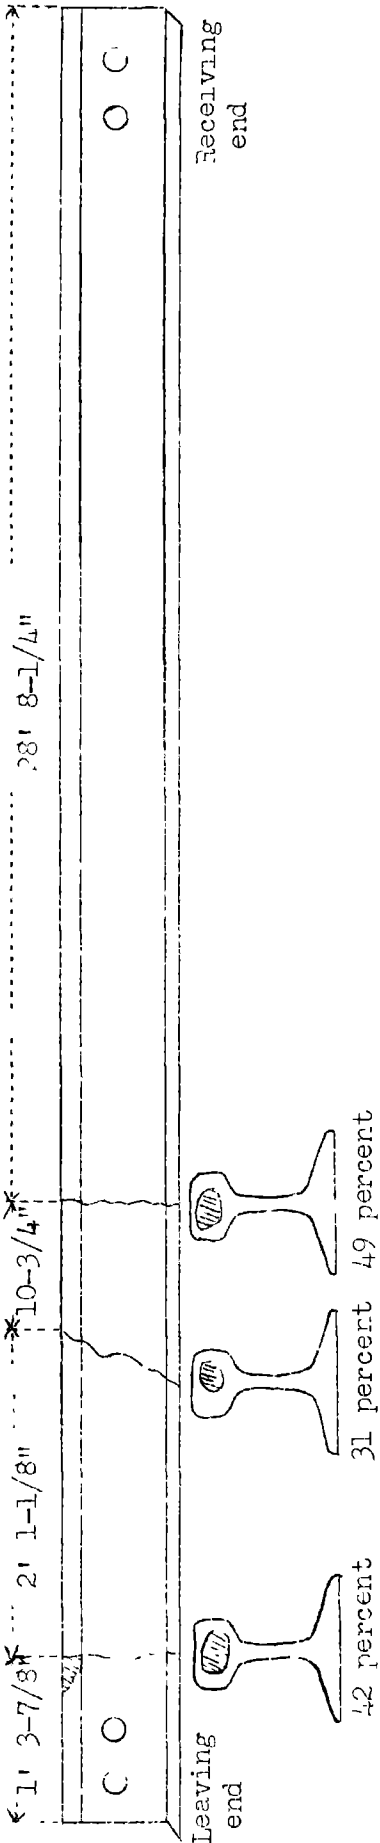
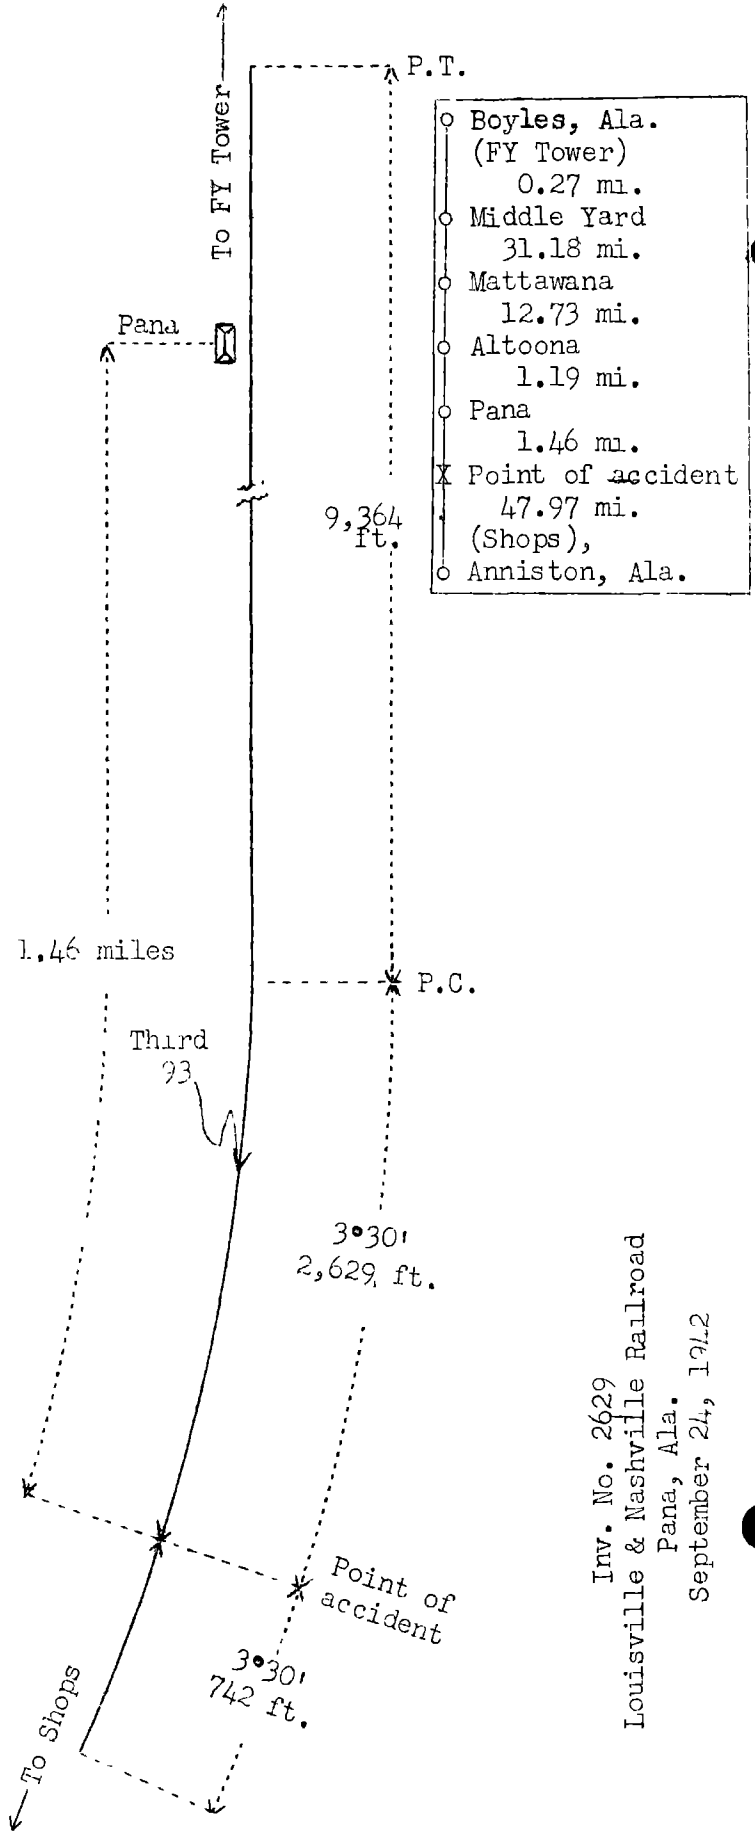
Sketch showing locations of fractures and transverse fissures

After the accident a broken rail was found on the west side of the track. The rail was broken into 4 pieces. The

first break occurred at a point 28 feet 8-1/4 inches south of the receiving end of the rail. At the first break there was a transverse fissure covering about 49 percent of the cross-sectional area of the head of the rail. At the second and third breaks, which occurred at points 29 feet 7 inches and 31 feet 8-1/8 inches south of the receiving end of the rail, there were transverse fissures covering, respectively, 31 percent and 42 percent of the cross-sectional area of the head. None of these fissures had progressed to the outer surface of the head of the rail. A section of the leaving end of the rail 1 foot 3-7/8 inches long remained in normal position. Wheel marks at the north end of this section of rail indicated that the derailment occurred at this point.

It is found that this accident was caused by a broken rail, as a result of the presence of transverse fissures.
