INTERSTATE COMMERCE COMMISSION

REPORT OF THE DIRECTOR OF THE BUREAU OF SAFETY CONCERNING
AN ACCIDENT WHICH OCCURRED ON THE LOUISVILLE & NASH-
VILLE RAILROAD AT SOUTH LOUISVILLE, KY., ON MARCH
3, 1932.

May 2, 1932.

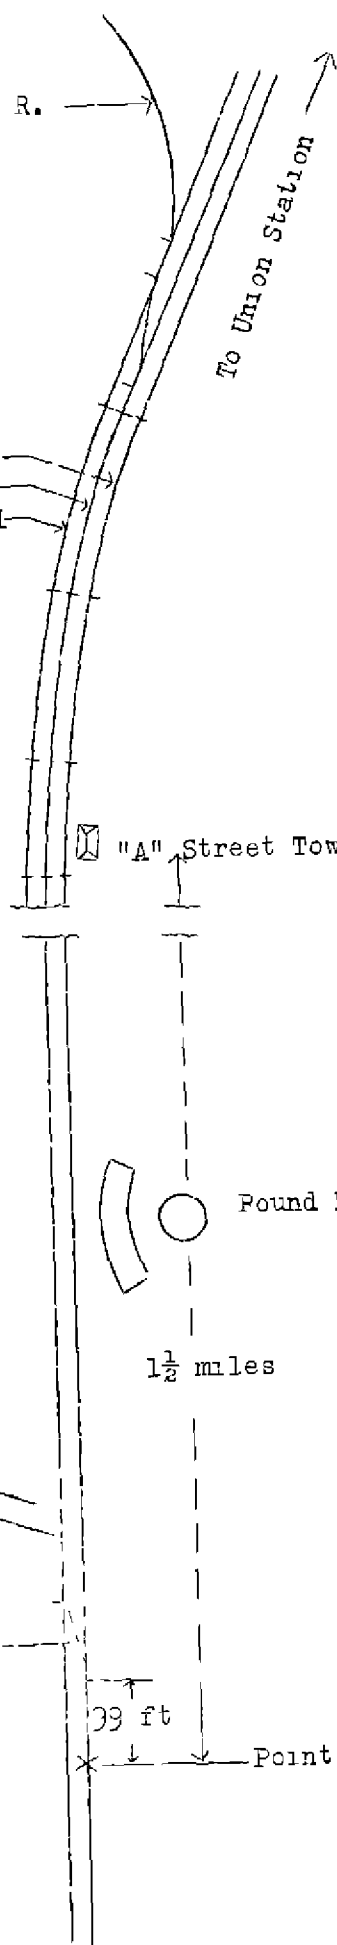
Inv. No. 1756
Louisville & Nashville R. R.
South Louisville, Ky.,
March 3, 1932

Point of accident
