INTERSTATE COMMERCE COMMISSION  
WASHINGTON

ACCIDENT ON THE  
LOUISVILLE & NASHVILLE RAILROAD

JULY 3, 1939

INVESTIGATION NO. 2368

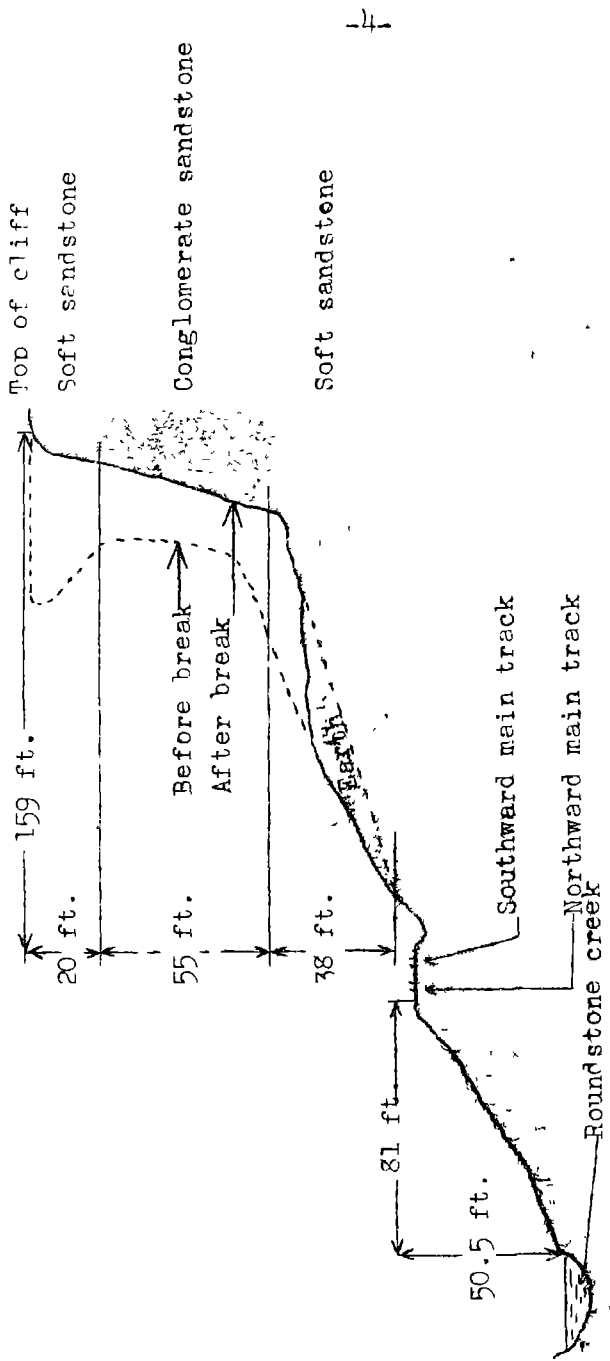
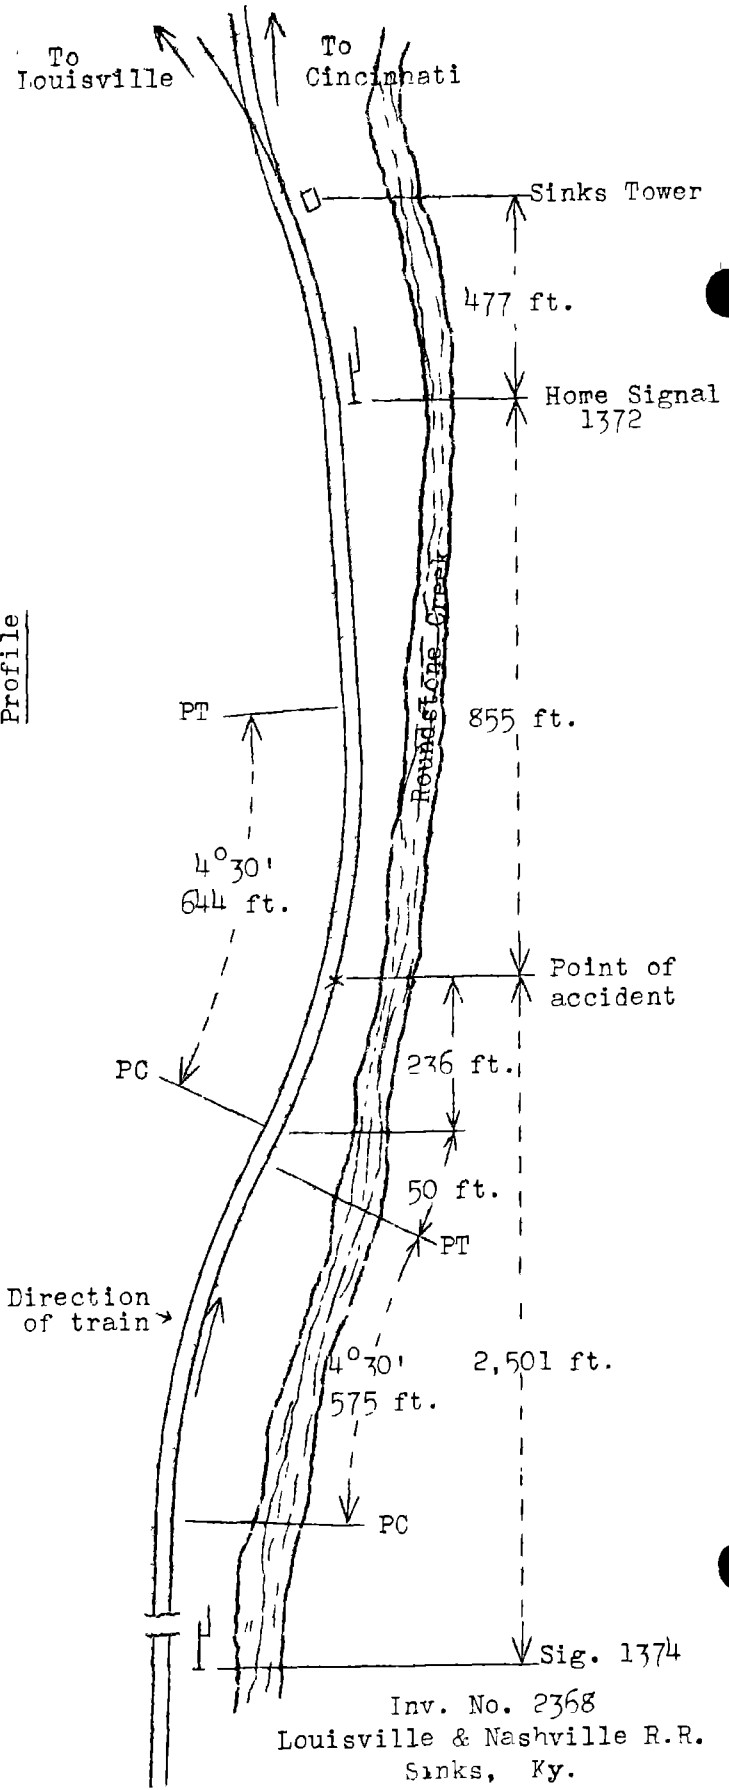
Inv. No. 2368  
Louisville & Nashville R.R.  
Sinks, Ky.  
July 3, 1939

In the vicinity of the point of accident the tracks are laid along a hillside paralleling and about 50 feet above the west bank of Roundstone Creek. The distance between track centers is 13 feet. The distance from the northward track-center to the ditch line on the west side of the southward track is 22 feet. The hill-slope rises westward at a gradient of about one to three a distance of 145 feet to a height of 52 feet above the track. This slope is composed of material that has fallen from the cliff above and become covered with a thin overburden of soil on which there is a growth of trees and vegetation. From the top of this slope a perpendicular wall of conglomerate sandstone, lying on a soft sandstone base, rises 48 feet; above this there is a ledge of soft sandstone 20 feet thick which extends beyond the face of the cliff a depth of 18 feet. The crest of this

ledge rises to a height of 120 feet above the track and parallels it northward a distance of 300 feet. Immediately south of the point of accident the pit of an abandoned rock quarry extends westward into the cliff a distance of 300 feet. The north wall of this pit is adjacent to the point from which rock fell upon the track shortly before the accident occurred.

Observation of the cliff by the Commission's inspectors disclosed that the mass of rock which fell extended approximately 150 feet in length, 80 feet in height, and from 18 to 35 feet in depth; these measurements included the overhanging sandstone ledge at the summit.

No slides or falling rocks had previously disturbed the tracks at this point. Subsequent examination disclosed that fissures in the cliff had weakened the formation and caused a portion of the wall to break away, and no doubt this condition was accentuated by recent rains.
