INVESTIGATION NO. 3259

LOUISVILLE AND NASHVILLE RAILROAD COMPANY

REPORT IN RE ACCIDENT

AT TAIT'S GAP, ALA., ON

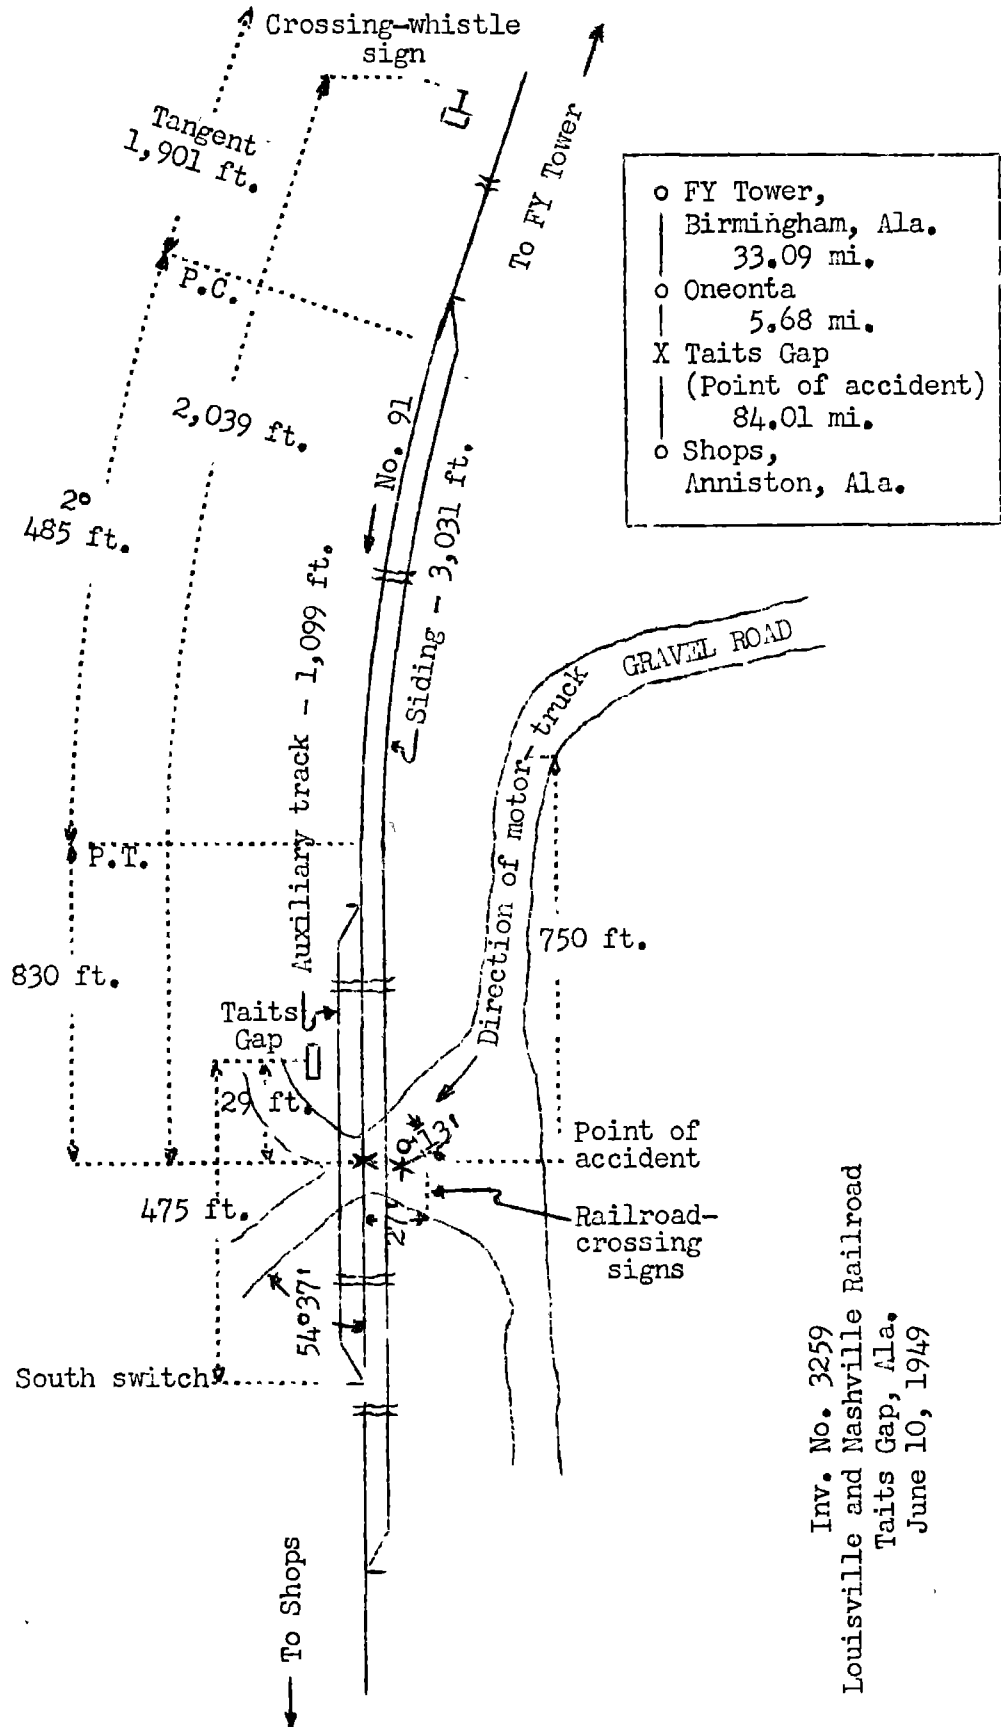
Inv. No. 3259
Louisville and Nashville Railroad
Taits Gap, Ala.
June 10, 1949

This accident occurred on that part of the Birmingham Division extending between FY Tower, Birmingham, and Shops, Anniston, Ala., 122.78 miles, a single-track line, over which trains are operated by timetable and train orders. There is no block system in use. At Taits Gap, 38.77 miles south of FY Tower, a siding 3,031 feet in length parallels the main track on the east, and an auxiliary track, 1,099 feet in length, parallels the main track on the west. The center-line of each of these tracks is 13 feet from the center-line of the main track. The south switch of the auxiliary track is 475 feet south of the station at Taits Gap. The accident occurred on the main track at a point 29 feet south of the station, where the tracks are crossed at grade by a gravel highway. From the north, on the railroad, there are, in succession, a tangent 1,901 feet in length, a 2° curve to the left 485 feet and a tangent 830 feet to the point of accident and a considerable distance southward. The grade is 1 percent ascending southward at the point of accident. From a point 750 feet north of the crossing to a point a considerable distance south of the crossing, a gravel highway parallels the railroad on the east. The center-line of this highway is about 55 feet distant from the center-line of the railroad. The surface of the highway is about 12 feet below the level of the tracks. At a point about 70 feet north of the point of accident a gravel highway diverges from the parallel highway and crosses the tracks at an angle of 54°37'. The grade for south-bound traffic on the parallel highway and thence westward over the crossing is practically level 635 feet, then it is 10 percent ascending 115 feet to the crossing, and is level over the crossing. The crossing is 17 feet 6 inches wide and is surfaced with asphaltum to the level of the tops of the rails. Flangeways 3 inches in width are provided for the main track and for the siding by planking laid parallel to the track rails. Planking is not provided for the auxiliary track.

A standard cross-buck railroad-crossing sign is located in the southeast angle of the intersection, 27 feet east of the center-line of the main track and 13 feet south of the center-line of the diverging highway. This sign is mounted on a mast 12 feet 4 inches above the level of the highway, and bears the words "RAILROAD CROSSING" in black letters on a white background. An octagon-shape sign, mounted on a mast 4 feet above the level of the highway, is located 2.2 feet north of the cross-buck sign, 26 feet east of the center-line of the main track and 11 feet south of the center-line of the diverging highway. This sign has a yellow background and a black border, and is divided into three sections by horizontal black lines 3/8-inch wide. The center section bears the word "STOP" in
