INTERSTATE COMMERCE COMMISSION

REPORT OF THE DIRECTOR OF THE BUREAU OF SAFETY CONCERNING AN
ACCIDENT ON THE LOUISVILLE & NASHVILLE RAILROAD AT
WADSWORTH, ALA., ON DECEMBER 26, 1933.

Inv. No. 1878
 Louisville & Nashville R.R.,
 Wadsworth, Ala.
 Dec. 26, 1933.

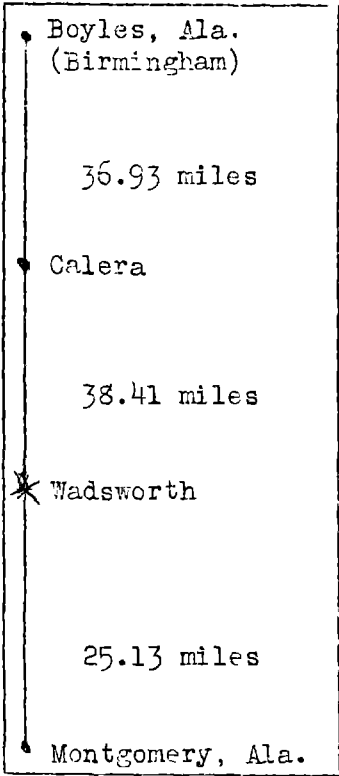
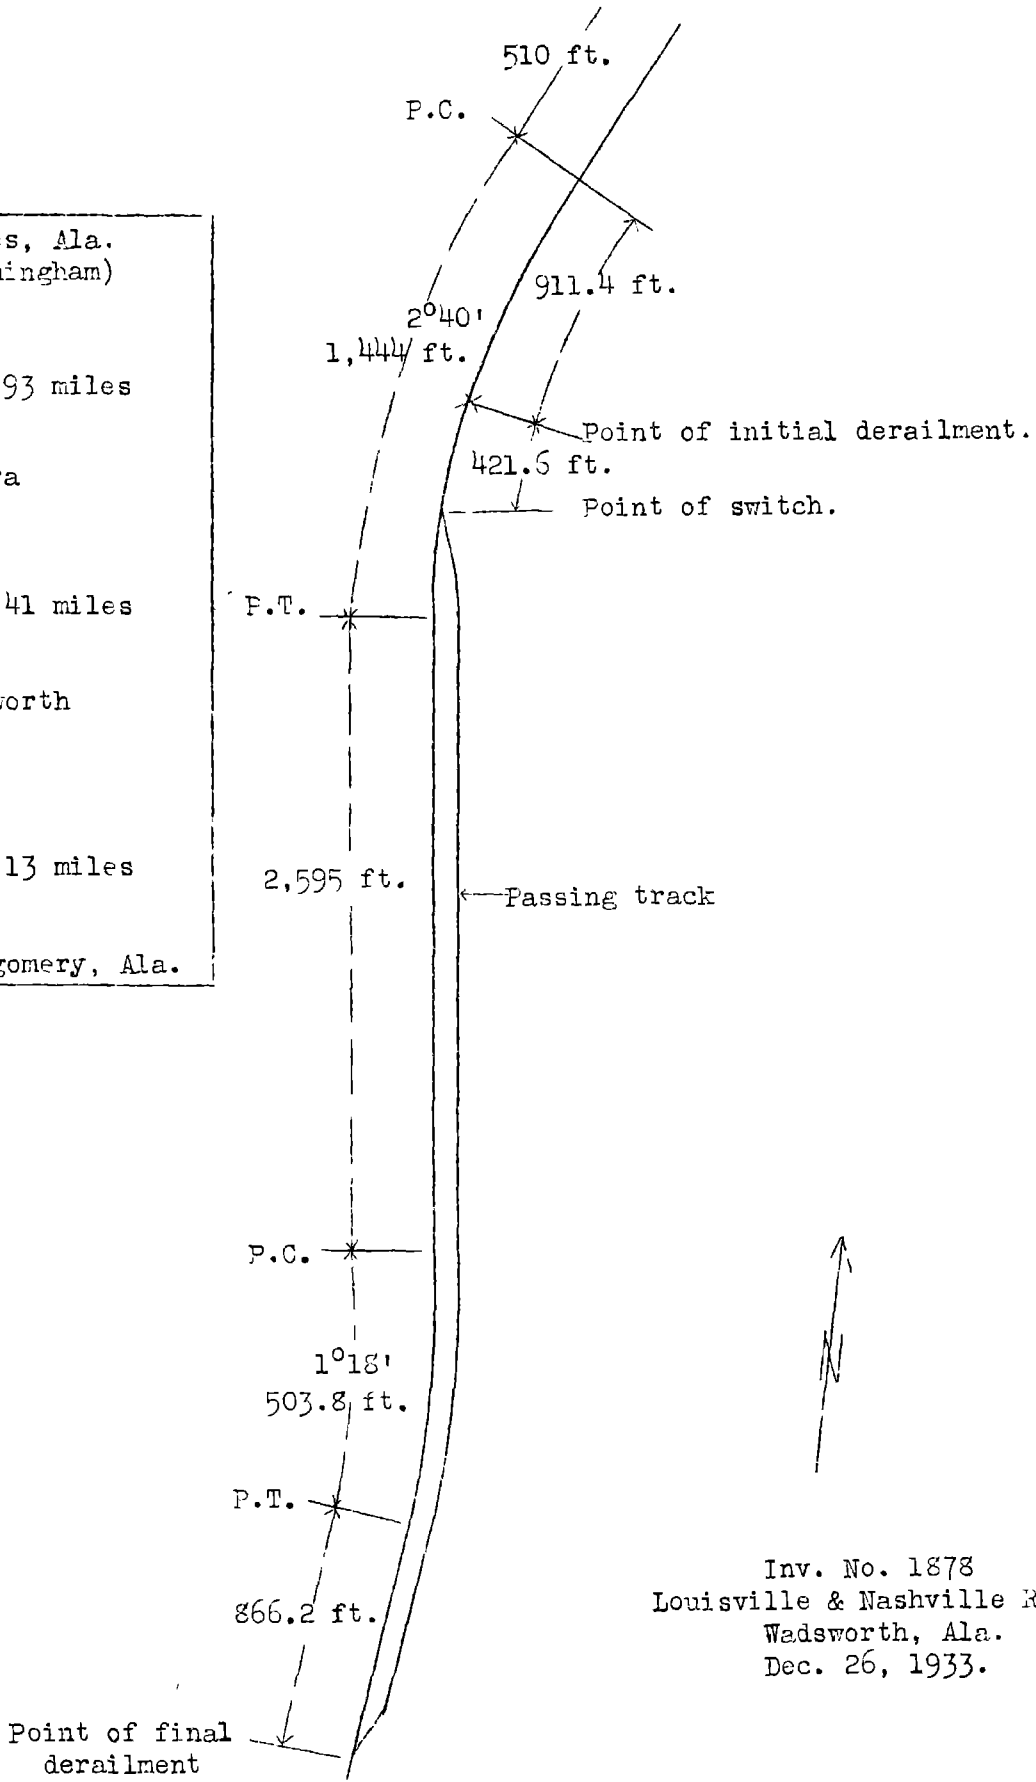
The engine and tender were overturned at the final point of derailment and stopped on their right sides with the front end of the engine 429 feet south of the south switch, with the first 22 cars piled back of it within a space of 387 feet. The employee injured was the fireman.

This accident was caused by engine wheels striking one or more pieces of wood on the high rail of a curve.

defects that could have contributed to the cause of the accident; however, at a point 514.6 feet north of the north passing-track switch there was adequate evidence to indicate that wood had been on the west rail, and from this point southward for a distance of 93 feet a mark appeared on the ball of the west rail to where the first marks appeared on the ties. The evidence indicates that the pony truck of the 2-8-2 engine was the first to be derailed, and that the derailed wheels followed the rails closely until they encountered the south switch, where the engine became entirely derailed.
