INTERSTATE COMMERCE COMMISSION

REPORT OF THE DIRECTOR OF THE BUREAU OF SAFETY CONCERNING AN
ACCIDENT WHICH OCCURRED ON THE LOUISVILLE & NASHVILLE
RAILROAD AT WALD, ALA., ON SEPTEMBER 29, 1932

November 4, 1932.

INV. NO. 1787
 LOUISVILLE & NASHVILLE R.R.
 WALD, ALA.
 September 29, 1932

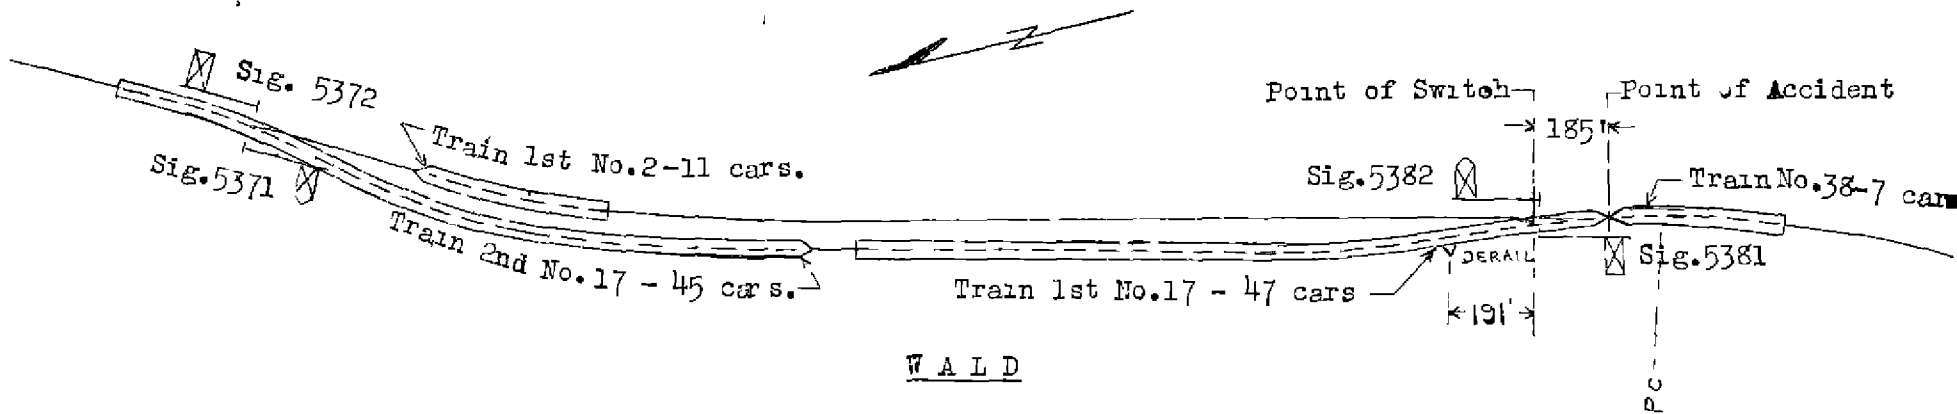
A. Approximate location of trains at time of accident.

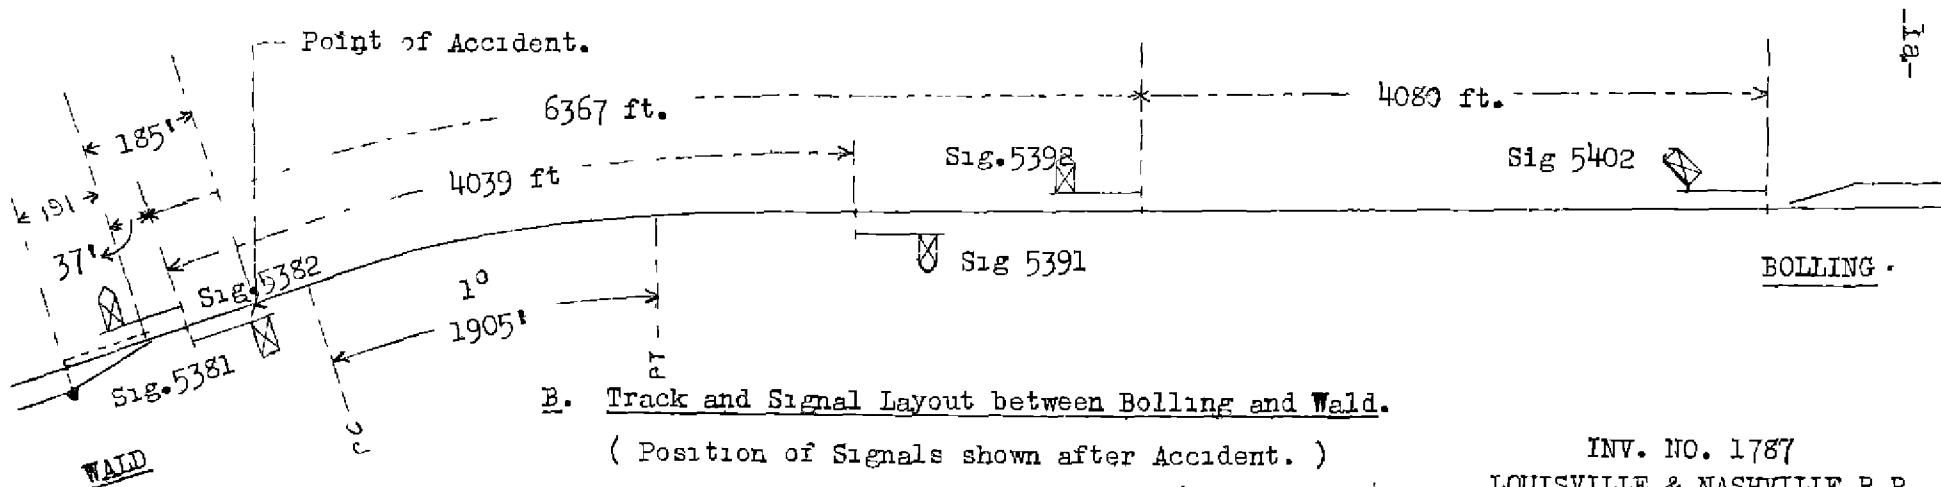
B. Track and Signal Layout between Bolling and Wald.

(Position of Signals shown after Accident.)
