# NATIONAL TRANSPORTATION SAFETY BOARD

## ✓ RAILROAD ACCIDENT REPORT.

REAR END COLLISION OF METRO-DADE  
TRANSPORTATION ADMINISTRATION  
TRAINS NOS. 172-171 AND 141-142  
MIAMI, FLORIDA  
JUNE 26, 1985

✓✓  
NTSB/RAR-86/03.

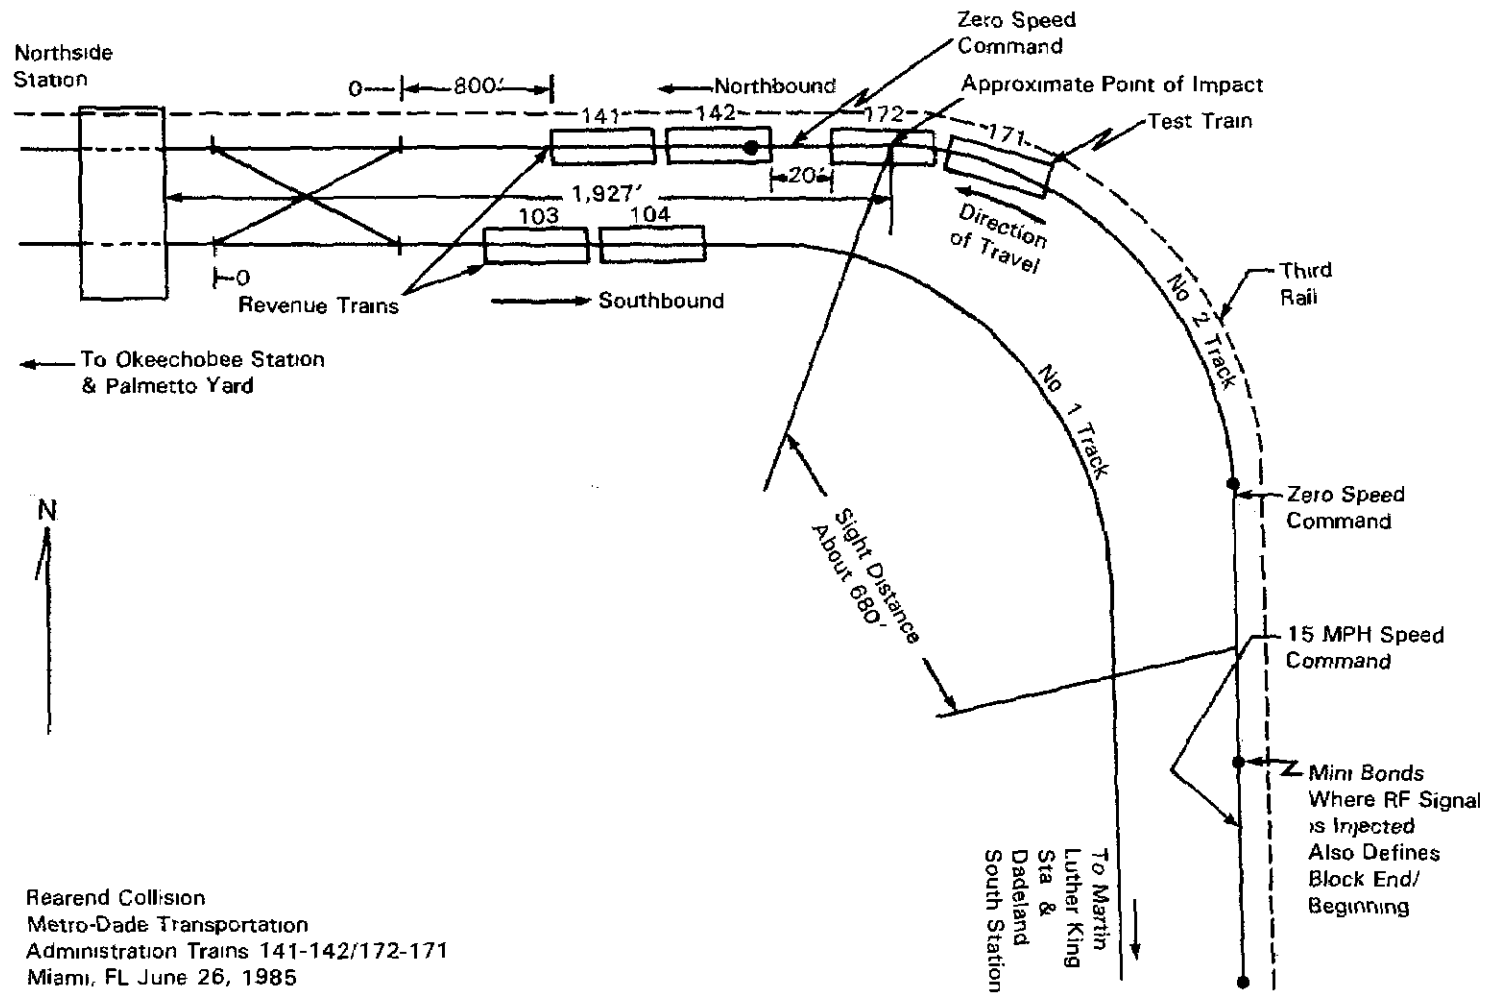
Figure 3.--Plan view of accident site.

About 11:35 p.m., train No. 172-171 struck the rear of standing train No. 141-142, about 1,927 feet south of the Northside Station interlocking. Train No. 141-142 was moved forward about 68 feet, and train No. 172-171 moved about 52 feet beyond the point of impact. Slide marks found on the rails indicated that the front and rear truck wheels of car No. 171 were locked and sliding for 44 feet and 64 feet, respectively, before the impact. After initially contacting train No. 141-142, train No. 172-171 separated from car No. 142 and stopped about 20 feet from the rear of that car. (See figure 3.)

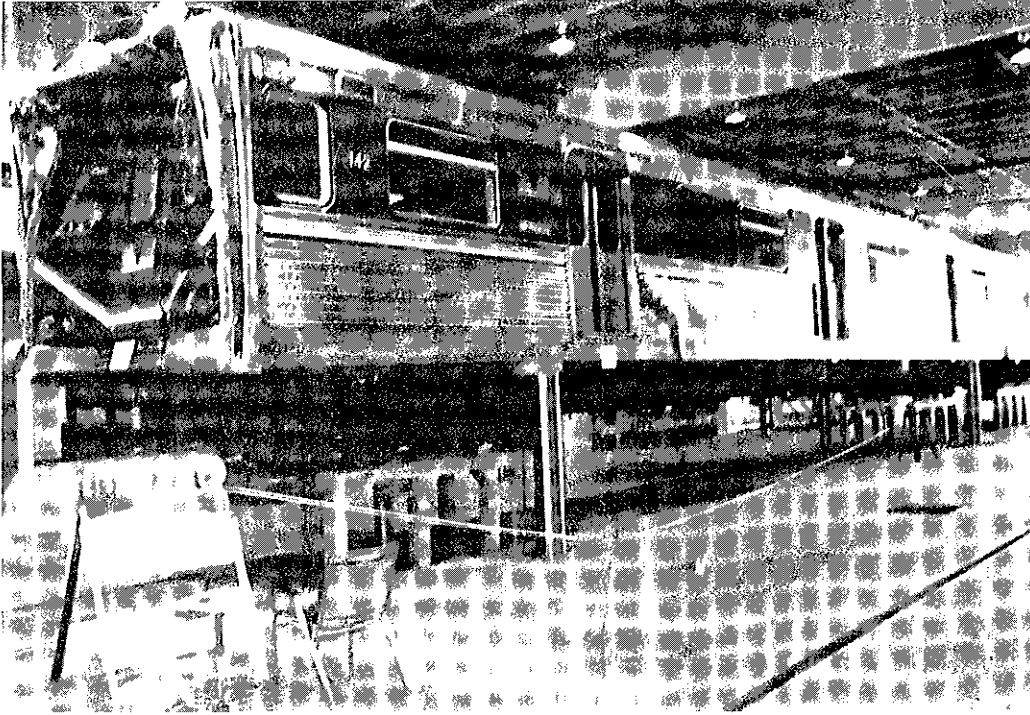
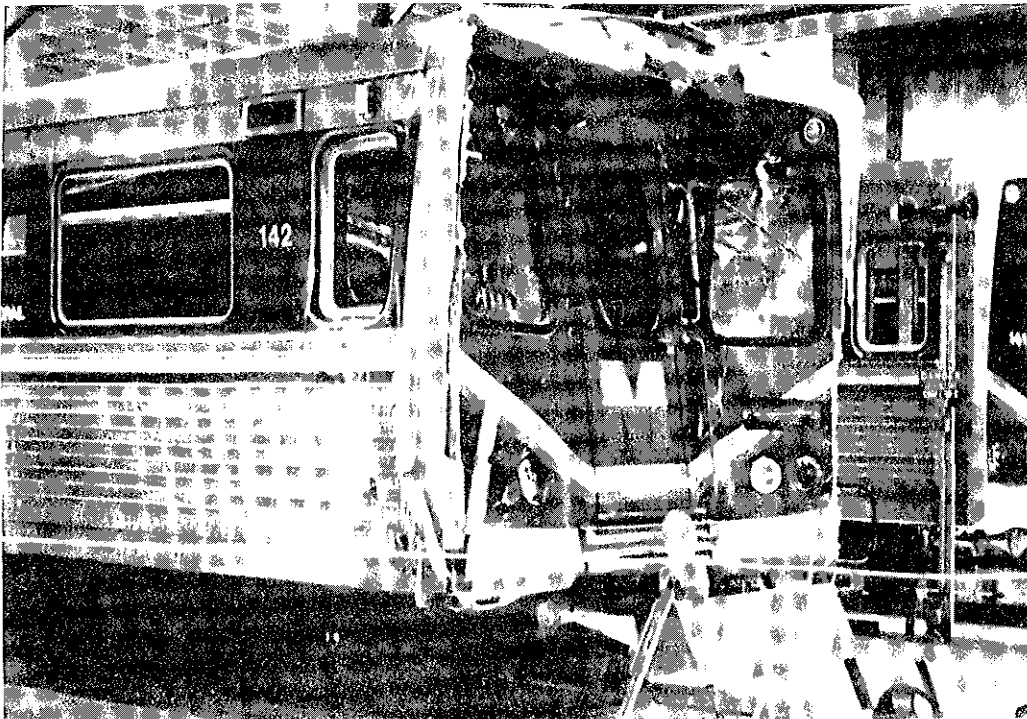
Car No. 142 was damaged severely. (See figures 4 and 5.) The front and rear car truck safety hanger welds broke, and the radius rods on the F-end (the impacted end) were bent on both sides. The coupler and draft gear on the F-end broke, and the draft gear tension bolts were sheared. The floor covering at each floor board joint buckled and an end window (windshield) was broken. Rescuers broke a right-rear side window through which passengers were evacuated. The side doors on both sides were buckled and the exterior shell had ripples throughout its length on both sides. The body bolster on the F-end was bent and twisted. Both sides of the side sill were buckled, and the buffer box and anti-climber was crushed 13 3/4 inches.

Figure 4.--F end of car No. 142.

Figure 5.--F-end of car No. 142.

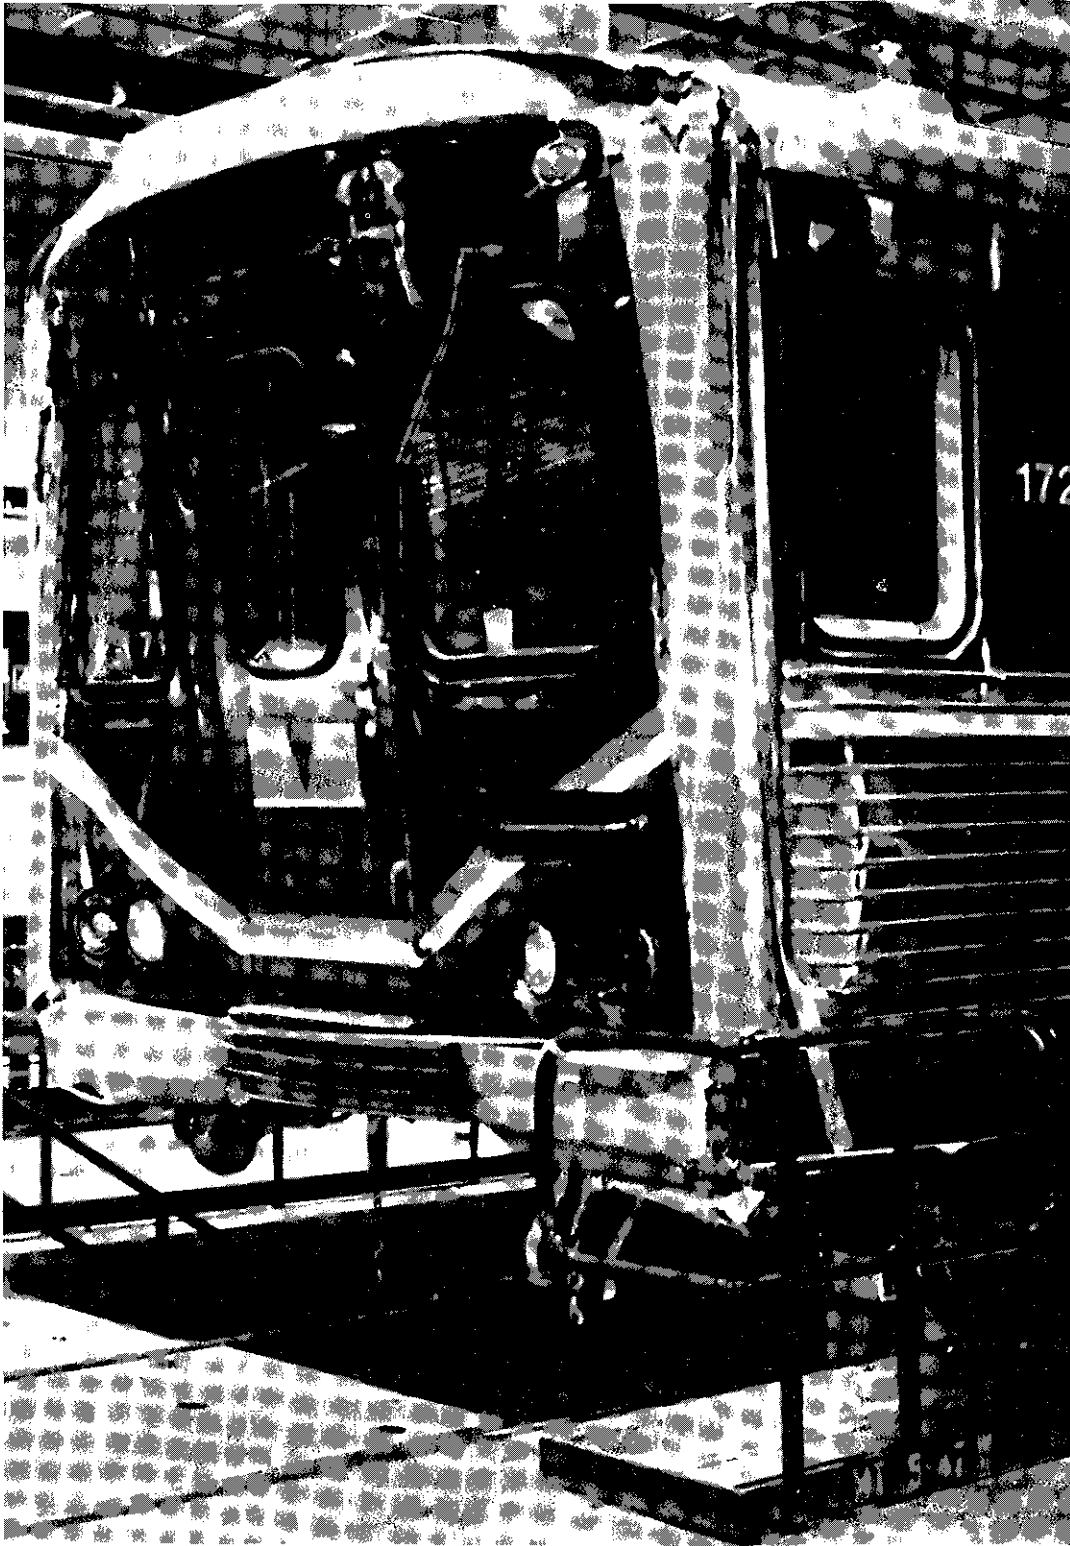
Damage similar to that of cars Nos. 142 and 141 was noted on cars Nos. 172 and 171, respectively. Car No. 172 was severely damaged (see figures 6 and 7) and car No. 171 was moderately damaged.

Figure 6.--F-end of car No. 172.

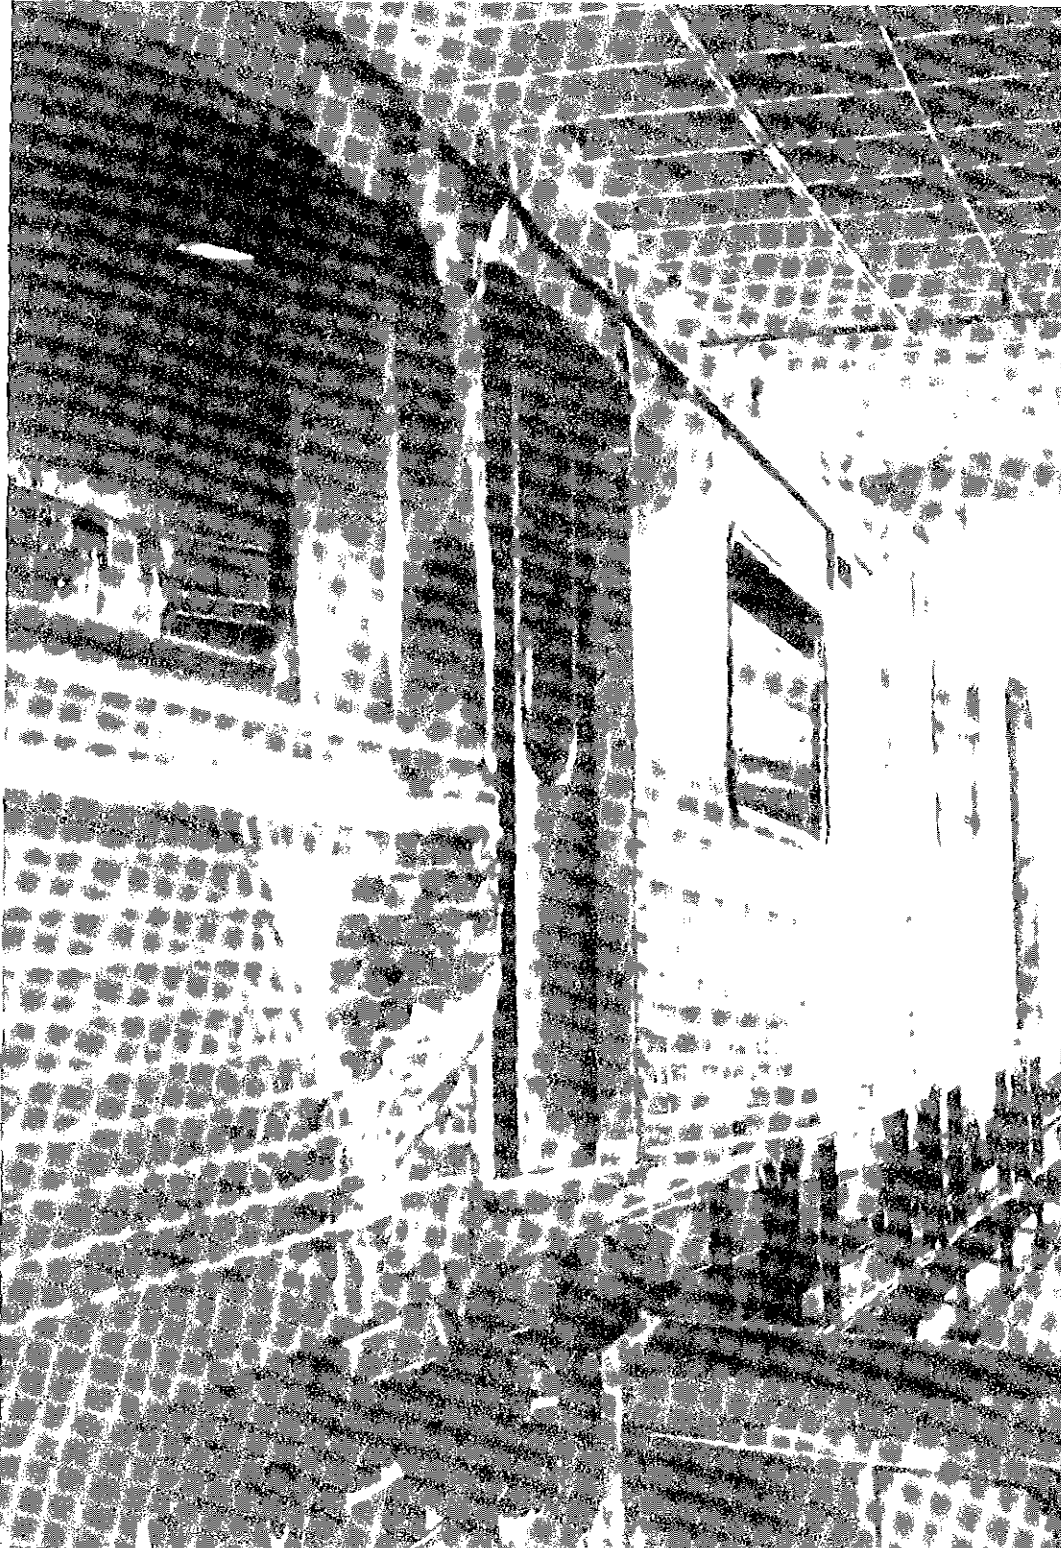
Figure 7.--R-end of car No. 172.
