INVESTIGATION NO. 3006
THE MICHIGAN CENTRAL RAILROAD COMPANY
REPORT IN RE ACCIDENT
AT FORT CUSTER, MICH., ON
JULY 22, 1946

Railroad: Michigan Central
Date: July 22, 1946
Location: Fort Custer, Mich.
Kind of accident: Head-end collision
Equipment involved: Engine and cars : Engine and cars
Engine numbers: 7514 : 6898
Consists: 12 cars : 36 cars
Estimated speeds: 15 m. p. h. : 8 m. p. h.
Operation: Operating rules
Track: Yard track; 3⁰ curve; 2.3 percent
descending grade eastward
Weather: Clear
Time: 2:06 p. m.
Casualties: 3 killed; 3 injured
Cause: Failure properly to control speed
of both movements on yard track

Inv. No. 3006
Michigan Central Railroad
Fort Custer, Mich.
July 22, 1946

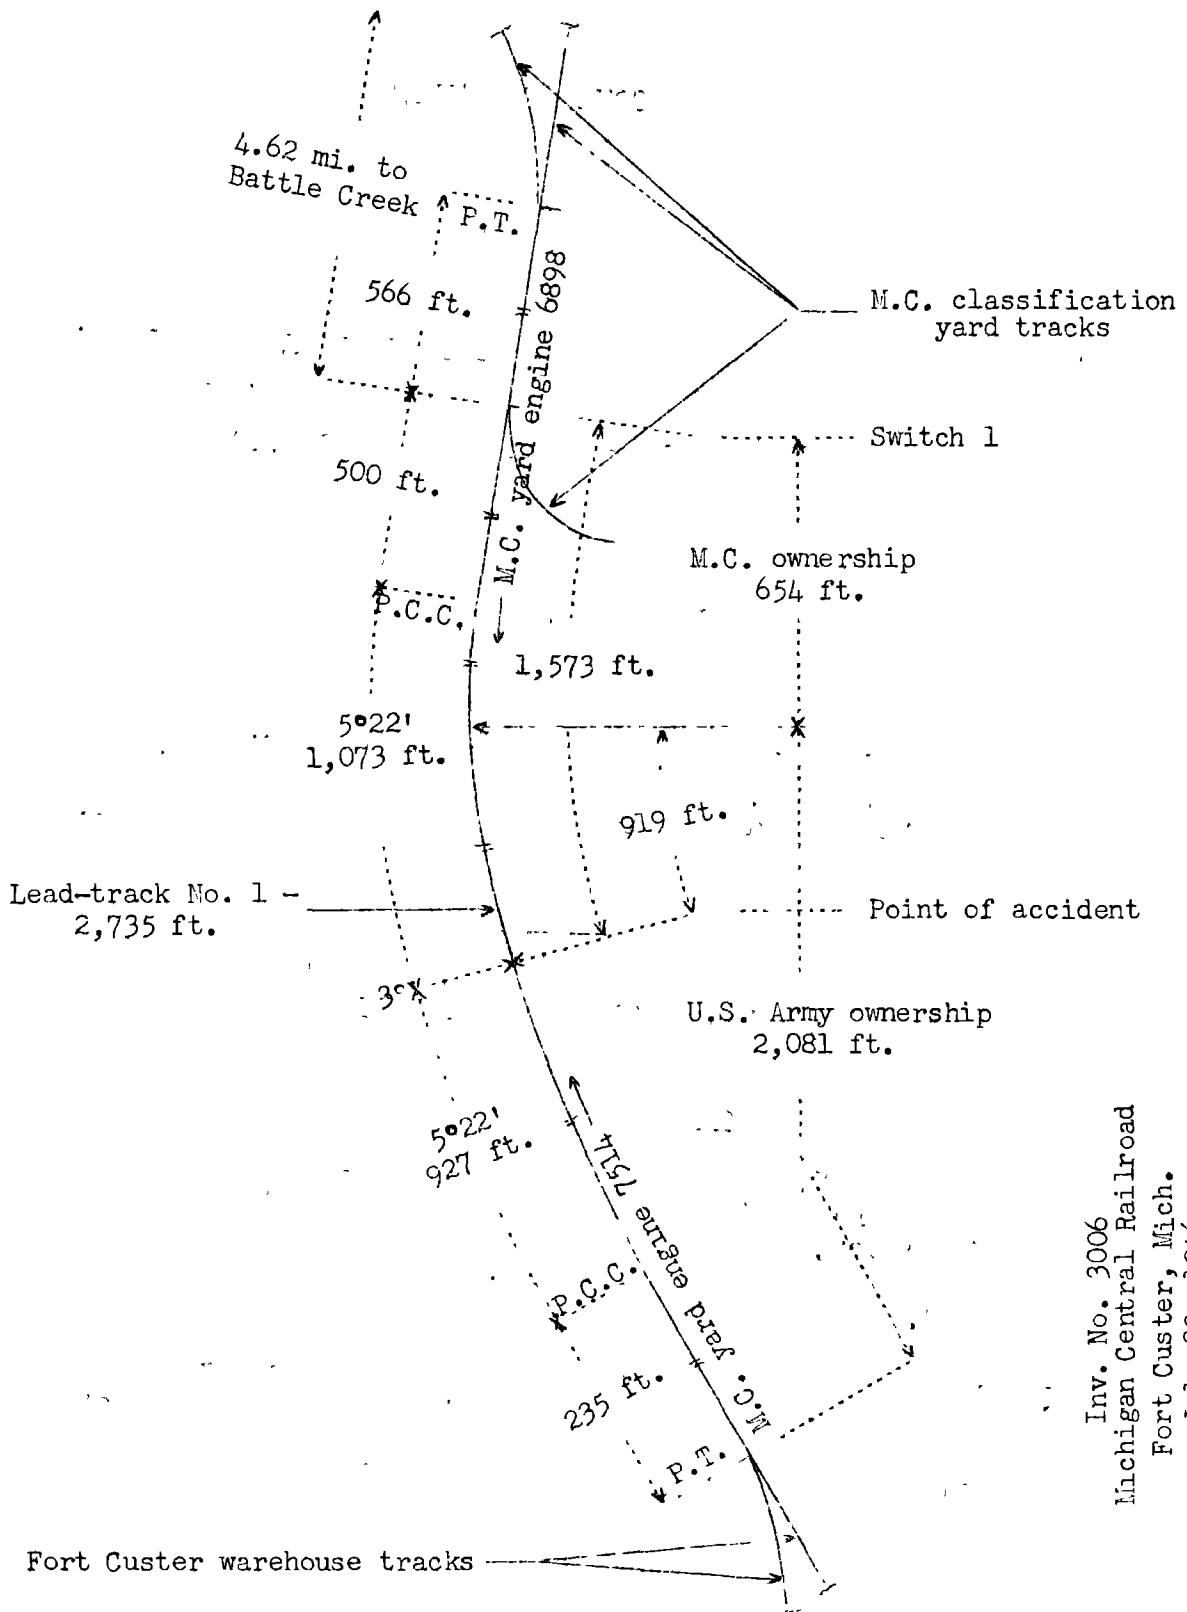
This accident occurred on a lead track at Fort Custer, Mich., which connects tracks of a classification yard of the Michigan Central Railroad and warehouse tracks of the United States Army. The lead track is 2,735 feet in length, and is hereinafter referred to as track No. 1. Movement of engines of the Michigan Central Railroad on track No. 1 are governed by operating rules of that railroad. The switch which connects the M.C. classification yard tracks and track No. 1, hereinafter referred to as switch 1, is 4.62 miles west of the M.C. station at Battle Creek, Mich. That part of track No. 1 extending 654 feet west of switch 1 is owned by the M.C., and the westward 2,081 feet of this track is owned by the United States Army. The accident occurred on track No. 1 at a point 1,573 feet west of switch 1 and 919 feet west of the west end of the portion owned by the M.C. From the west on track No. 1, there is a tangent 235 feet in length, which is followed by a compound curve to the right, the maximum curvature of which is 5° 22', 927 feet to the point of accident and 1,073 feet eastward. At the point of accident the curvature is 3°. From the east on the M.C. classification yard track to switch 1 thence on track No. 1 there is a tangent 1,066 feet in length, which is followed by the curve on which the accident occurred. At the point of accident the grade is 2.3 percent descending eastward.
