INTERSTATE COMMERCE COMMISSION

REPORT OF THE DIRECTOR OF THE BUREAU OF SAFETY IN RE INVESTIGATION OF AN ACCIDENT WHICH OCCURRED ON THE MICHIGAN CENTRAL RAILROAD AT TOWN LINE, MICH., ON MARCH 6, 1931.

April 13, 1931.

INV. NO. 1695
MICHIGAN CENTRAL R. R.
TOWN LINE, MICH.
March 6, 1931.

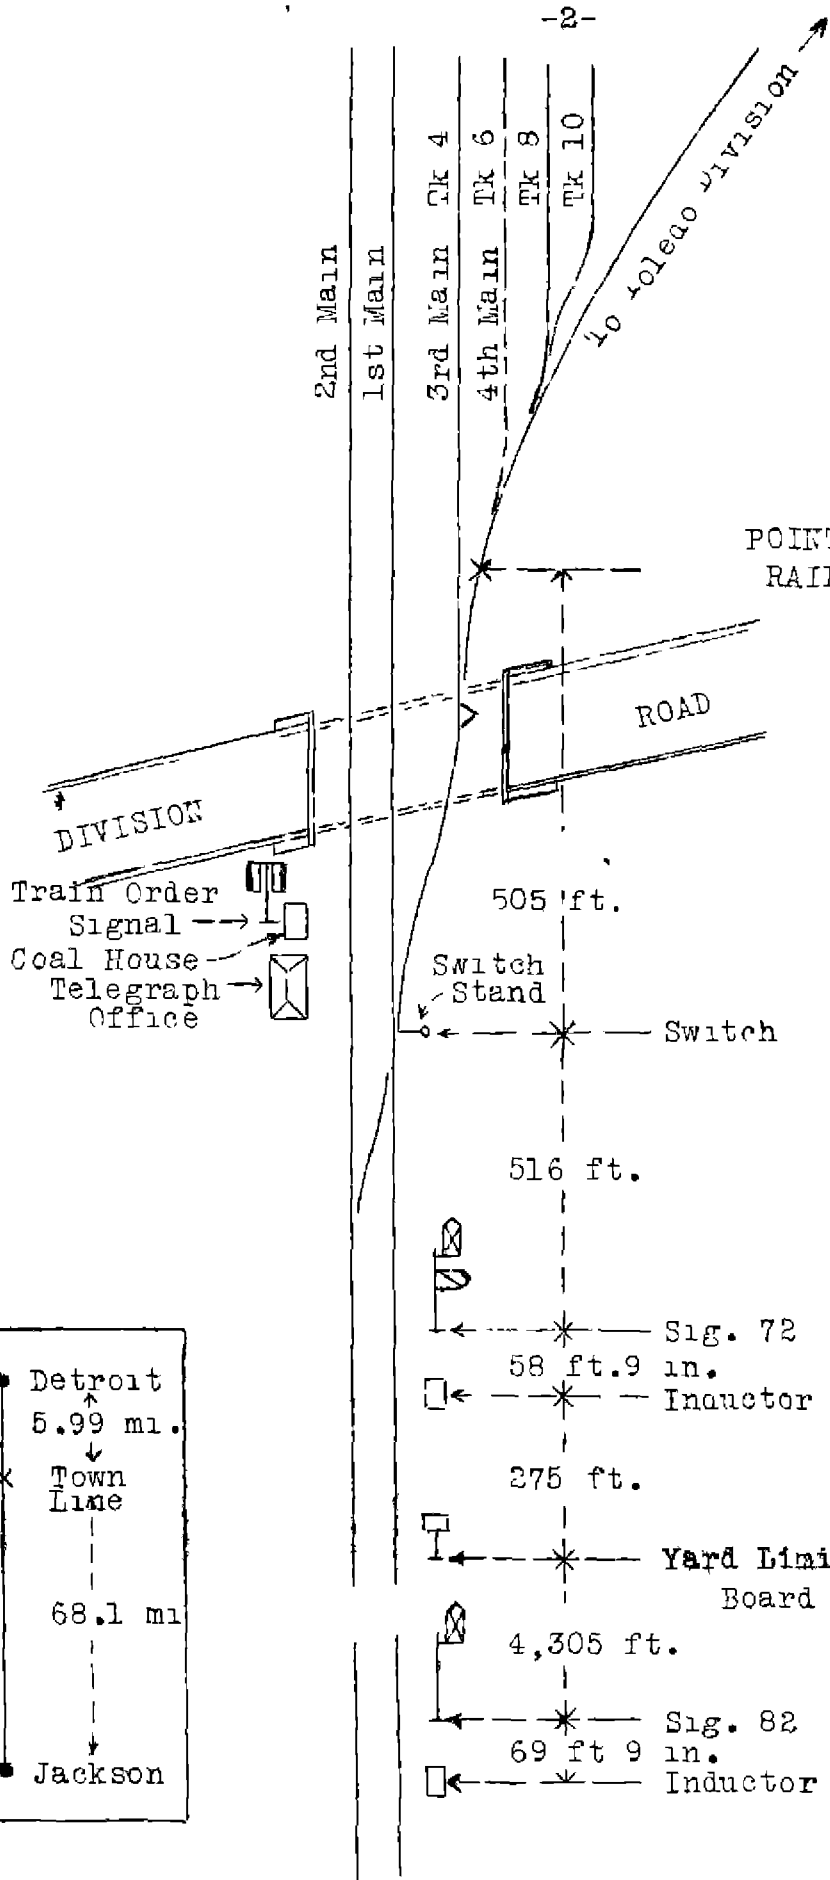
This accident occurred on that part of the Middle Division extending between Jackson and Detroit, Mich., a distance of 74.07 miles, over which trains are operated by time-table, train orders, an automatic block-signal system, and an automatic train-stop of the intermittent inductive type. West of the point of accident this is a double-track line, the westbound track being known as the second main and the eastbound track as the first main. At Town Line a switch connects the first main with yard tracks 4, 6, 8 and 10 and a wye track leading to the Toledo Division, tracks 4 and 6 paralleling the two main tracks on the south are also known as the third and fourth main tracks. The main line switch leading to these tracks is a facing-point switch for eastbound movements, a high switch stand controlling this switch is located on the south side of the track opposite the telegraph office. Approaching this switch from the west, the track is tangent for a distance of more than 2 miles, while the grade is slightly descending for a distance of about 4,000 feet, being 0.09 per cent descending at the point of accident. The derailment occurred on the lead track between the third and fourth main tracks at a point about 505 feet east of the main line switch.

The signals involved are signals 72 and 82, located 516 feet and 5,155 feet, respectively west of the main line switch. Signal 72 is of the two-arm, three-position, upper quadrant type, the top arm governing main-track movements and the lower arm controlling diverging movements, and the inductors for signals 72 and 82 are located 58.9 feet and 69.9 feet, respectively, west of these signals. The train-order board is located north of the main tracks and immediately east of the telegraph office. The maximum speed permitted for passenger trains is 60 miles per hour.

This accident was caused by a switch being opened directly in front of an approaching train, for which Operator Greenwood is responsible

The estimated speed of train No. 10 as it approached Town Line was about 60 miles per hour. The distance between signal 72 and the main line switch opposite the tower was 516 feet. At this rate of speed train No. 10 would have covered this distance in approximately six seconds. It would have been manifestly impossible for the operator to cross the tracks, open the switch and return to the platform in this short period of time. The operator must therefore at least have started across the track for the purpose of opening the switch when train No. 10 was some distance west of signal 72. It is believed that when he saw this train approaching some distance away, assuming it to be the local freight, he started across the track, opened the switch, returned to the platform and then discovered that the approaching train was the passenger train. This is not in conflict with the engineman's and fireman's statements. The engineman said he was watching the train-order signal for a distance of from 6 to 10 car-lengths west of signal 72 and during that interval did not observe the indication of signal 72. The fireman's view of signal 72 was cut off by the front end of his engine some distance west of signal 72, and it is entirely possible that this signal went to stop position during that interval.
