INTERSTATE COMMERCE COMMISSION

REPORT OF THE DIRECTOR OF THE BUREAU OF SAFETY IN RE
INVESTIGATION OF AN ACCIDENT WHICH OCCURRED ON
THE MICHIGAN CENTRAL RAILROAD AT WEST DETROIT,
MICH., ON MARCH 19, 1931.

April 22, 1931.

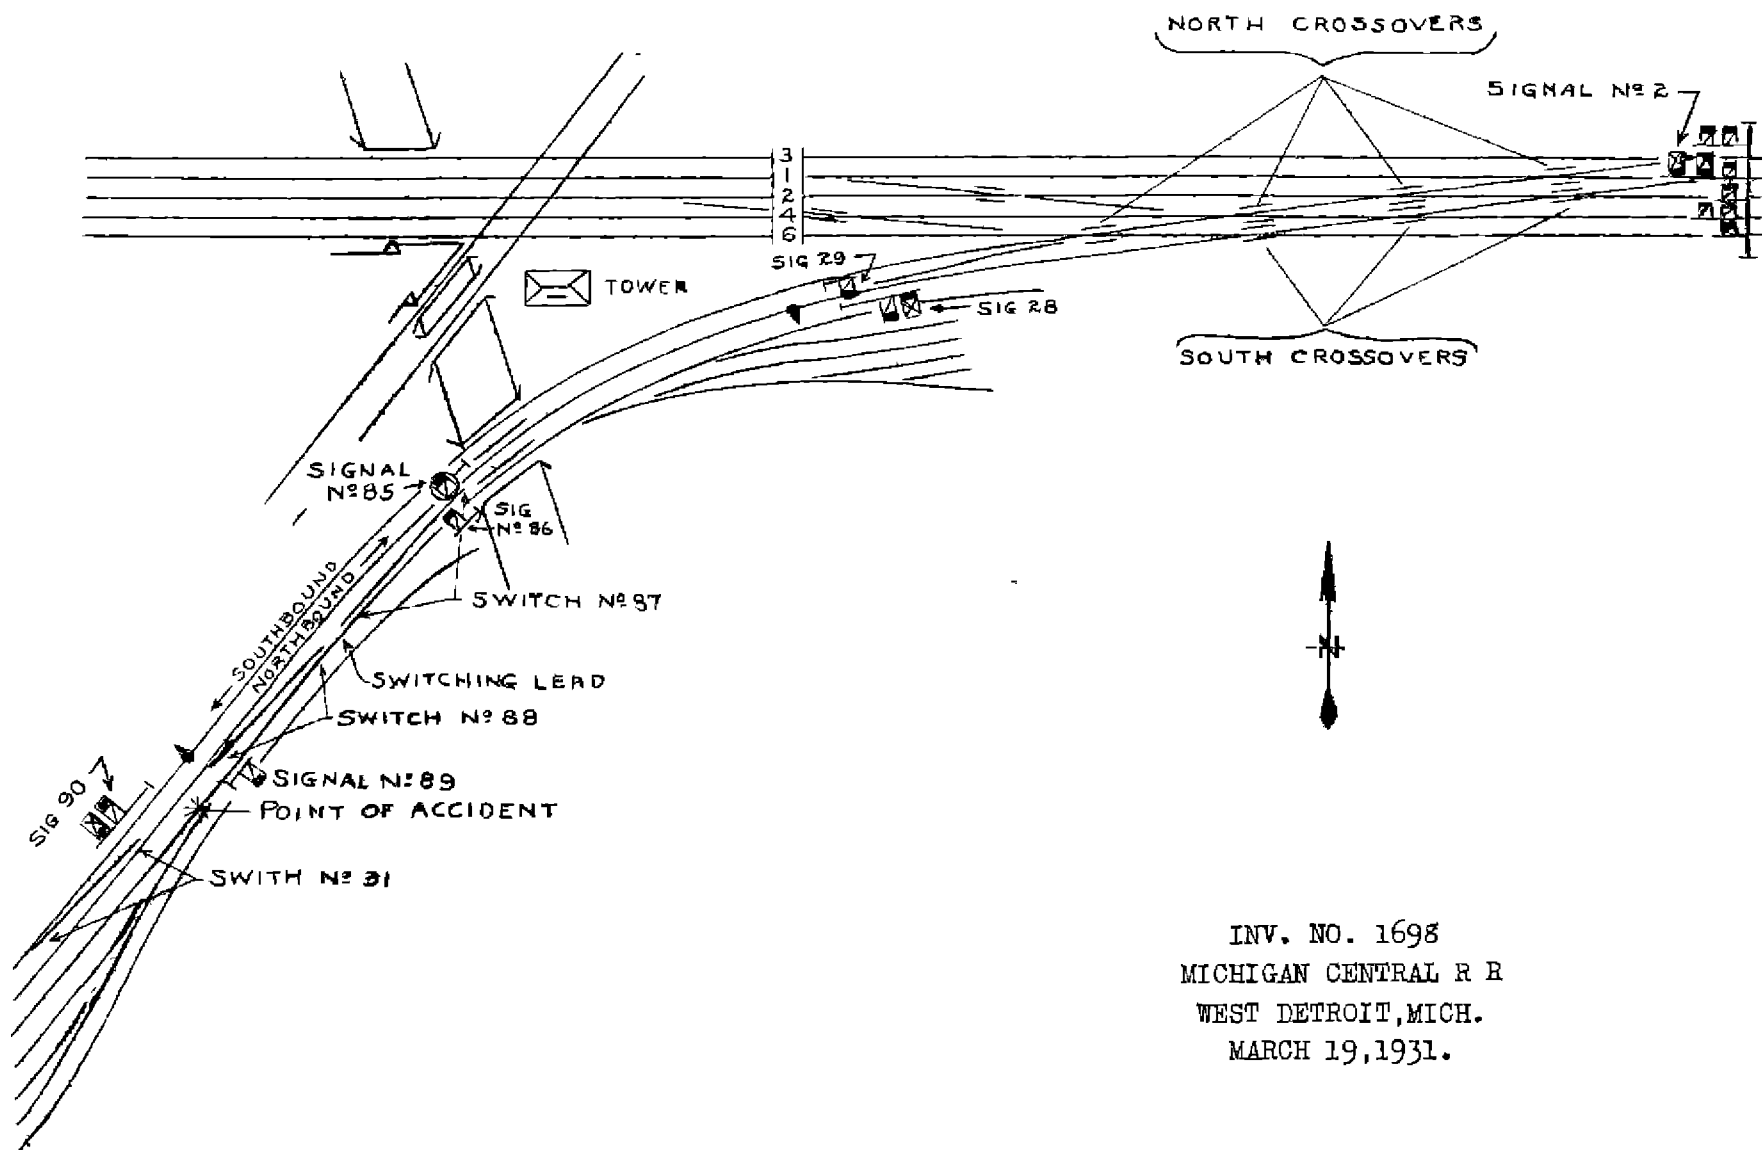
INV. NO. 1698
 MICHIGAN CENTRAL R R
 WEST DETROIT, MICH.
 MARCH 19, 1931.

This accident occurred within the territory known as Detroit Yard, at the southern end of interlocking limits. Approaching from the eastern end of the interlocking limits, there is a four-track main line, the tracks being numbered from north to south as follows: 1, westbound passenger, 2, eastbound passenger, 4, westbound freight, and 6, eastbound freight. These tracks were paralleled on the north by a running track, known as track 3. There are two sets of cross-overs, herein referred to as the north and south cross-overs, respectively, which connect these tracks and extend toward the left or south to the double-track line of the Toledo Division. Train movements on the Toledo Division, beginning in the immediate vicinity of where this accident occurred, are governed by timetable, train orders, an automatic block-signal system, and an automatic train stop device of the intermittent inductive type. The interlocking tower is located in the angle formed by the diverging tracks, at a point approximately 1,200 feet west of the eastern limits of the interlocking plant. At the southern limits of the interlocking plant the tracks of the Toledo Division are paralleled on the east by a series of yard tracks and a switching lead. The accident occurred on this lead track at a point approximately 650 feet south of the tower and about 21 feet outside the western or southern end of interlocking limits, at a switch leading from the lead track to the yard tracks.
