ACCIDENT OF THE  
MINNEAPOLIS, ST. PAUL & SAULT STE. MARIE RAILWAY

FOND DU LAC, WIS.

MARCH 28, 1933

INVESTIGATION NO. 2263

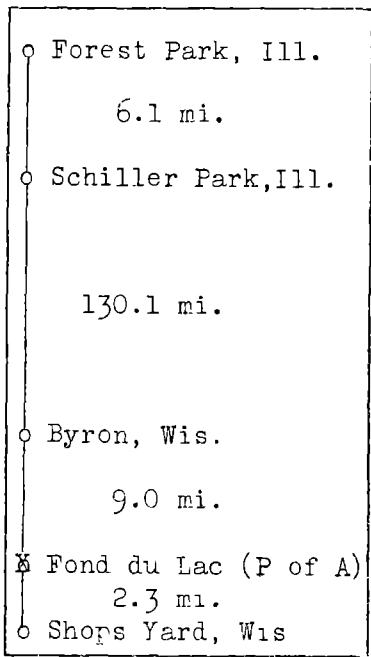
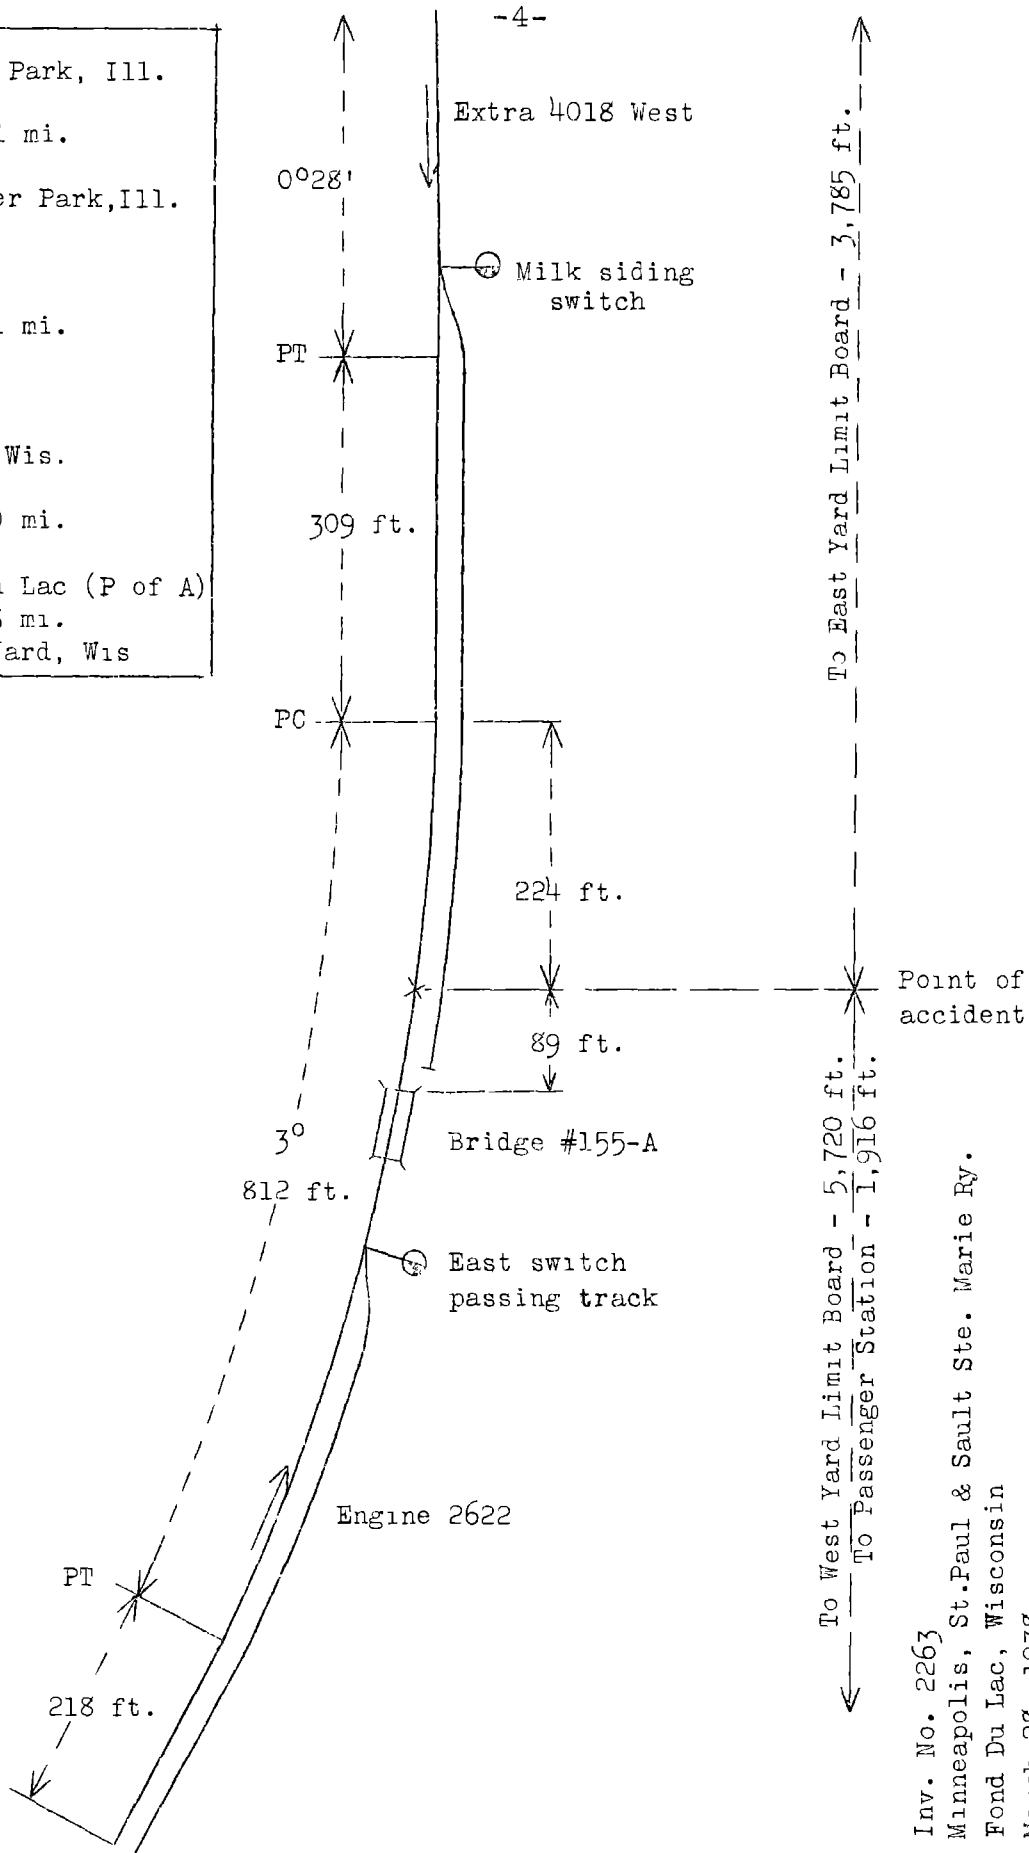
Inv. No. 2263  
 Minneapolis, St. Paul & Sault Ste. Marie Ry.  
 Fond Du Lac, Wisconsin  
 March 28, 1938

On account of curvature, buildings and trees, the view when approaching the point of accident from either direction is restricted to about 650 feet.
