INTERSTATE COMMERCE COMMISSION

REPORT OF THE DIRECTOR OF THE BUREAU OF SAFETY CONCERNING AN
ACCIDENT ON THE MISSOURI PACIFIC RAILROAD AT ALIX, ARK.,
ON AUGUST 23, 1934.

October 27, 1934.

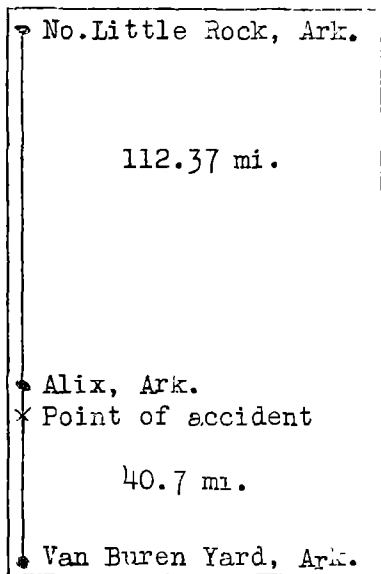
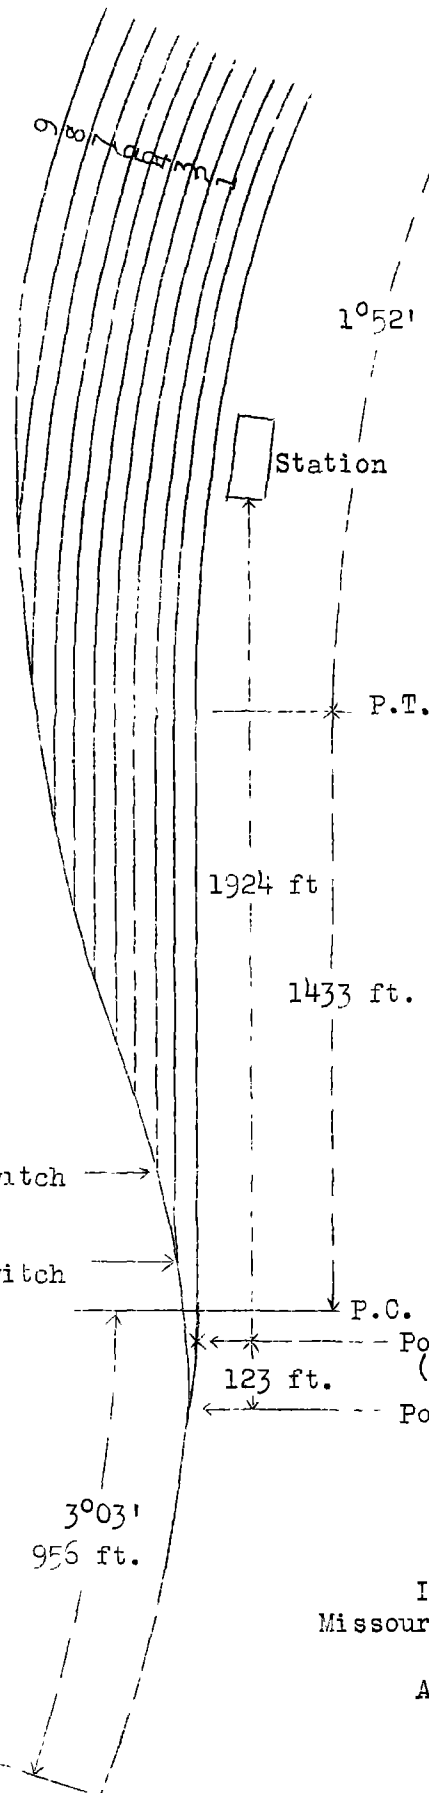
Inv. No. 1926
Missouri Pacific Railroad
Alix, Ark.
August 23, 1934.

The four cars being handled by the engine passed the first car of the portion of the train left standing on the main track, but the left rear corner of the tender struck the right front corner of that car while moving at a low rate of speed.

The left side of the tender was raked by the car at a point more than 8 feet above the rails and the left side of the engine cab was practically demolished. The lead car on the main track was shoved back a distance of approximately 4 feet and the engine stopped with the front air pump opposite the front end of that car. None of the equipment was derailed. The employee killed was the fireman.
