ACCIDENT ON THE
MISSOURI PACIFIC RAILROAD

BENTON, A.K.

FEBRUARY 19, 1938

INVESTIGATION NO. 2254

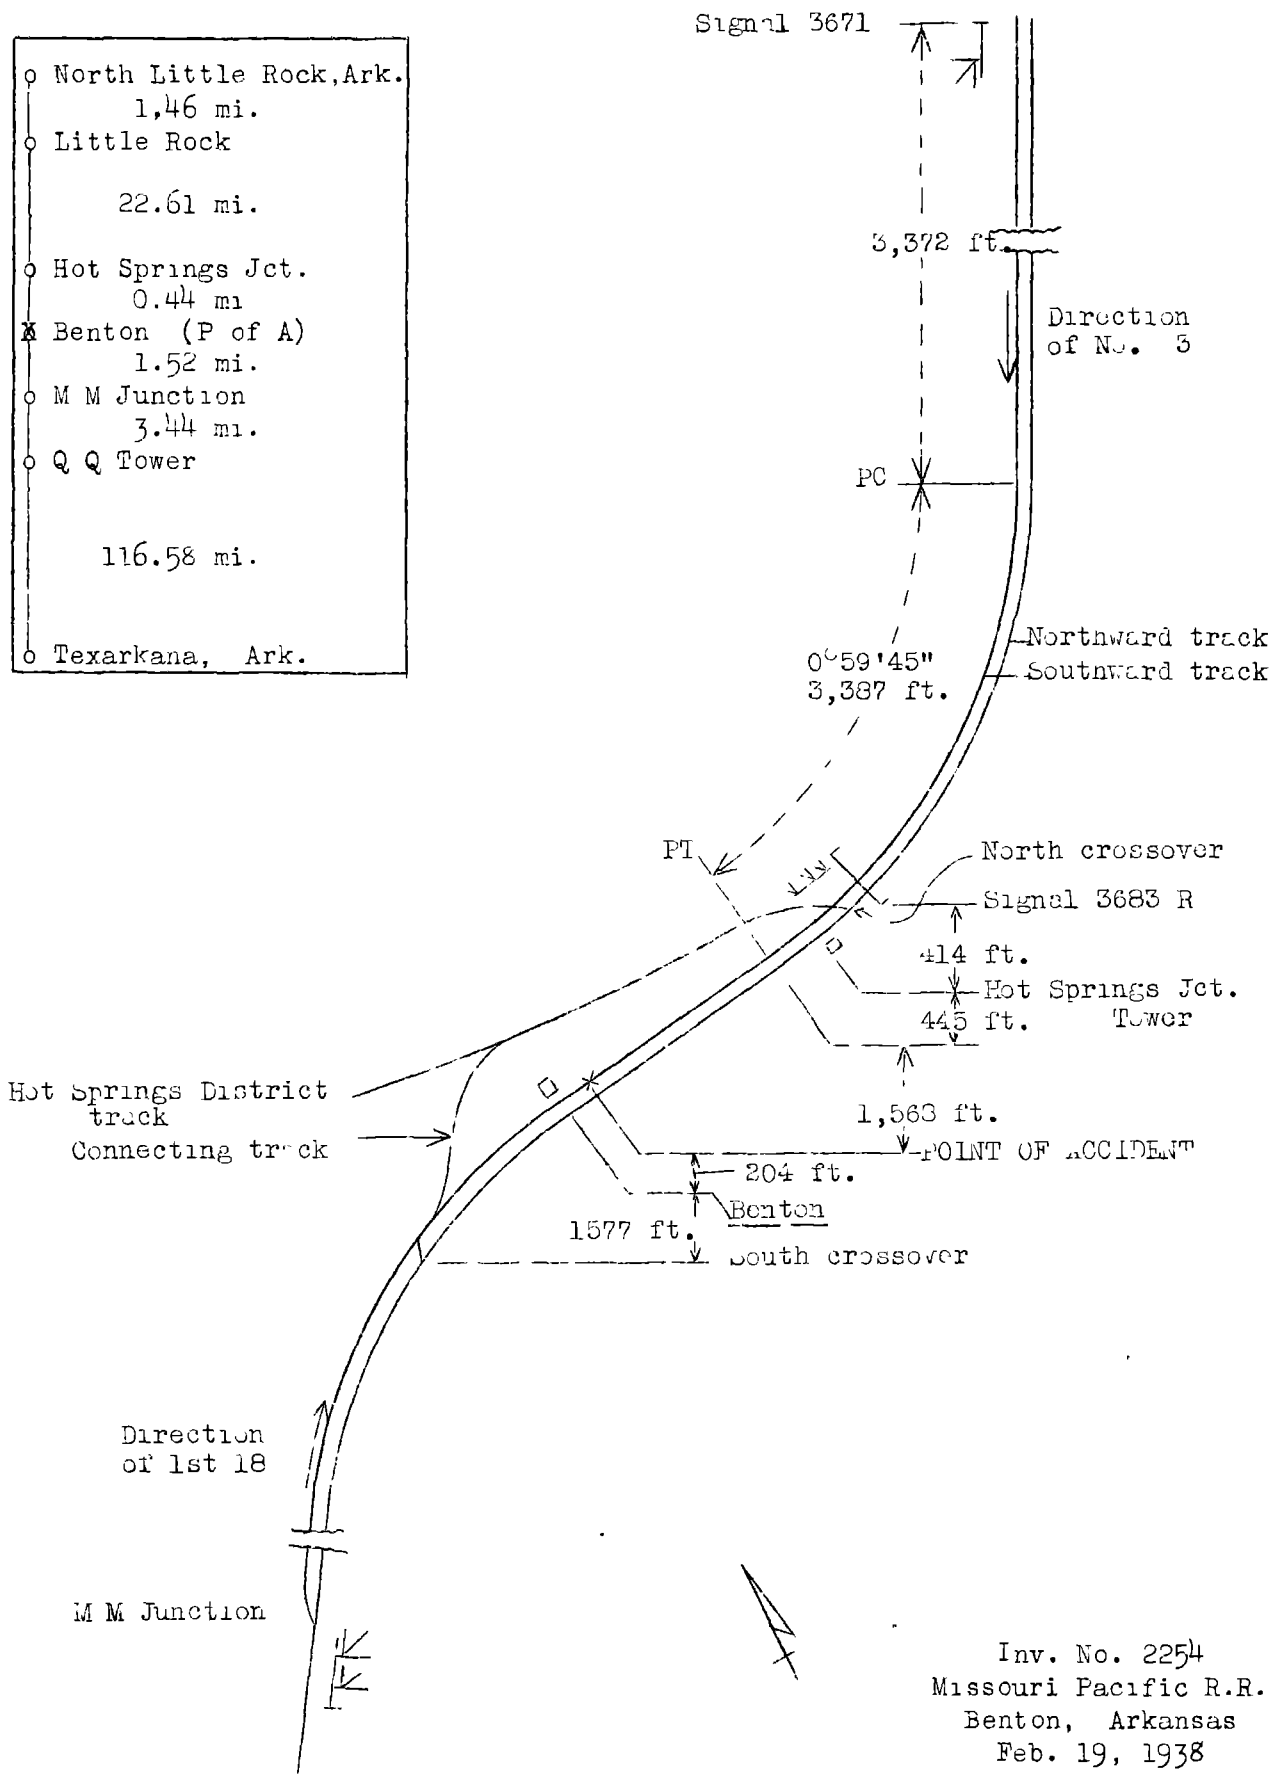
Inv. No. 2254
 Missouri Pacific R.R.
 Benton, Arkansas
 Feb. 19, 1938

The accident occurred on the southward main track at a point 203 feet north of the station at Benton, and 2,109 feet south of Hot Springs Junction. Approaching this point from the north on the southward main track there is tangent track for a distance of 13,600 feet, followed by a $0^{\circ}59'45''$ curve to the right, 3,387 feet in length, then 1,772 feet of tangent track; the accident occurred on this tangent at a point 204 feet from its southern end. The grade varies from 0.596 to 0.388 percent descending for southward trains, being 0.388 percent for a distance of 394 feet approaching the point of accident.

The north switch of a trailing-point crossover, 183 feet in length, is located 212 feet north of Hot Springs Junction. The Hot Springs District Line leads off the southward main track by means of a facing-point switch at a point 83 feet south of the south switch of this crossover and parallels the southward main track on the west side to the vicinity of the station where it diverges to the west. The south switch of a facing-point crossover, 183 feet in length, is located about 1,600 feet south of the station, and about 1,230 feet south of the station a track connecting with the Hot Springs District Line leads off the southward main track in a northwesterly direction through a switch which is facing-point for northward movements.
