INTERSTATE COMMERCE COMMISSION

ACCIDENT ON THE
MISSOURI PACIFIC RAILROAD

CHESTER, ILL.

INVESTIGATION NO. 2370

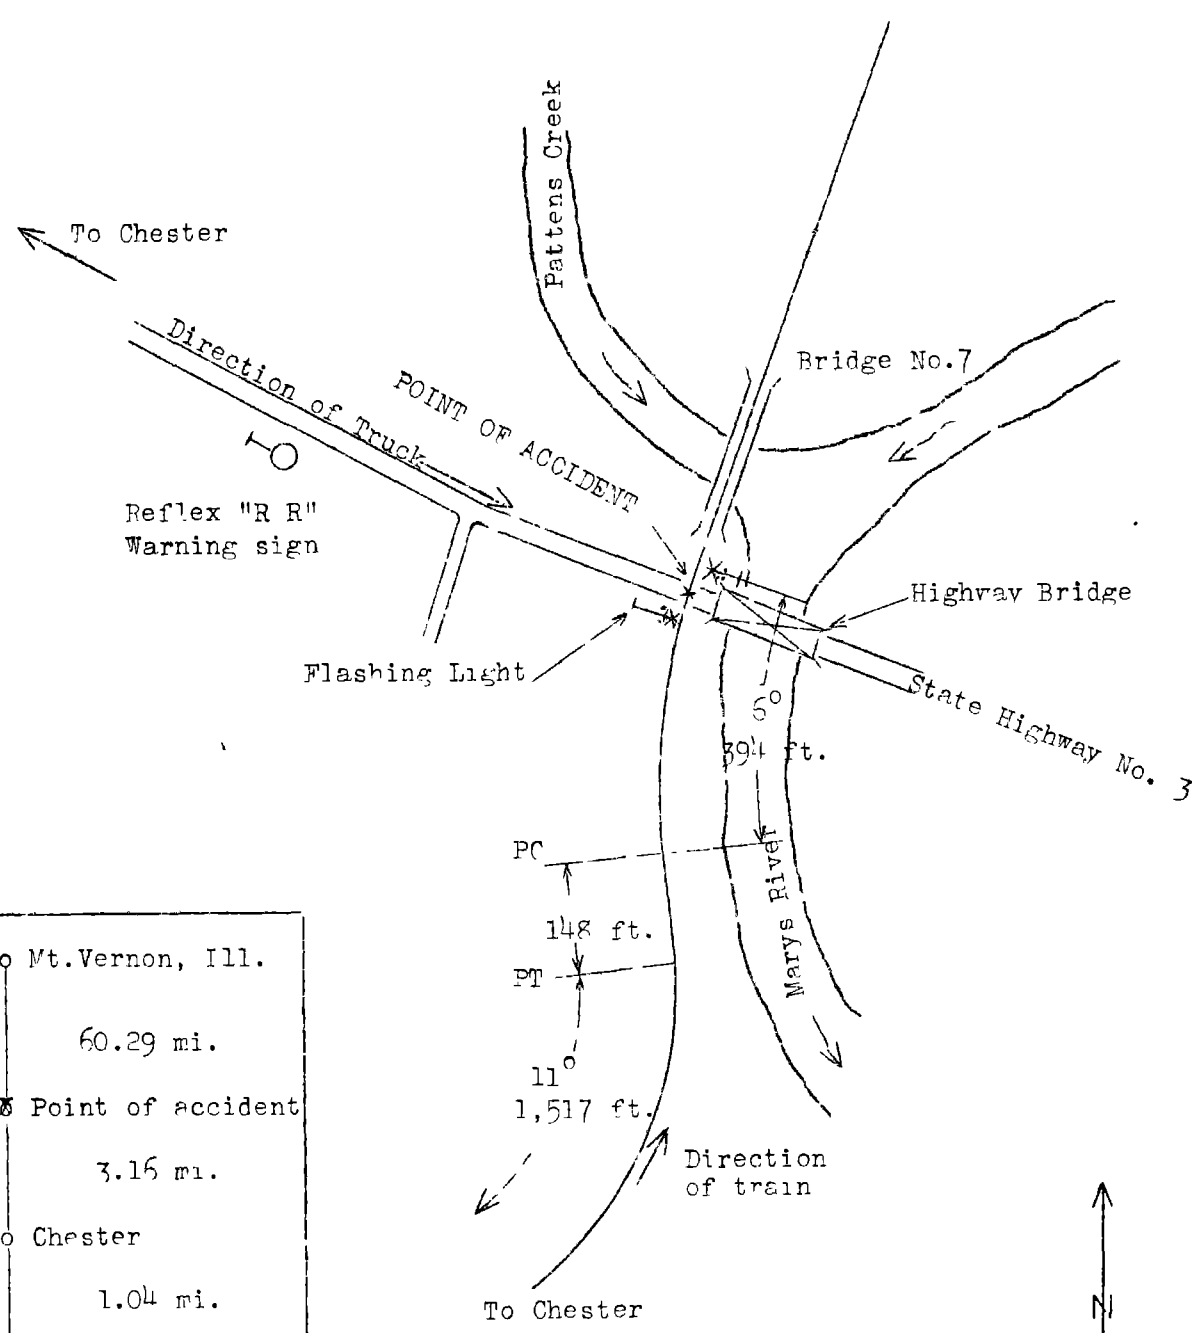
Inv. No. 2370
 Missouri Pacific R.R.
 Chester, Ill.
 July 13, 1939

Approaching the crossing from the south on the railroad there is a compound curve to the left 1,517 feet in length having a maximum curvature of 11° , then a tangent of 148 feet, followed by a 6° curve to the right which extends 356 feet to the point of accident and 38 feet beyond. The grade for trains moving northward over the crossing is 0.15 percent descending. A 15 mile-per-hour speed-restriction sign and a whistle post are located 2,235 and 1,295 feet, respectively, south of the crossing; a resume-speed sign is located 33 feet 6 inches north of the center-line of the highway.

Approaching from the west on the highway there is a $1^{\circ}45'$ curve to the left 944 feet in length, and then a tangent which extends 156 feet to the crossing and beyond. The grade for vehicles moving eastward is about 7 percent descending a distance of 3,200 feet to within a short distance of the crossing and practically level over the track. The highway is a concrete road 18 feet wide; the crossing is 24 feet wide and is laid with planks covered with asphalt.
