RAILROAD ACCIDENT REPORT

Collision Of
Missouri Pacific Railroad Company
Freight Train Extra 615 South
With A Standing Locomotive

Cotulla, Texas
December 1, 1973

REPORT NUMBER: NTSB-RAR-74-3

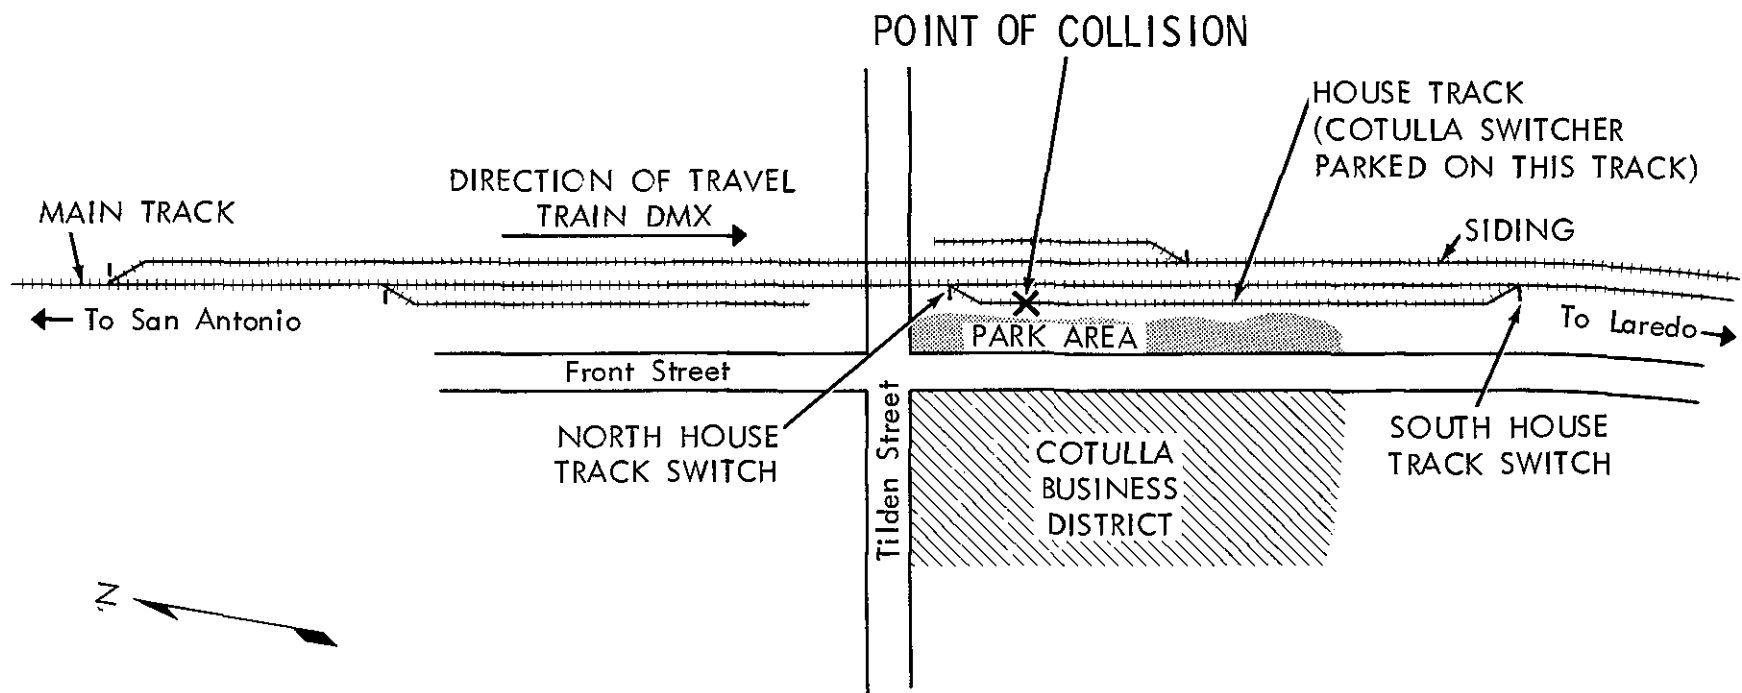
Figure 1. Sketch of Accident Area, Cotulla, Texas

The collision. Since the 6-mile section of track from Gardendale to Cotulla generally was on a downgrade, train DMX was able to accelerate to 35 to 40 mph when it reached Cotulla at 8:30 a.m. The train's whistle was sounded for the northernmost grade crossing in Cotulla and again as the train approached the crossing with Tilden Street. (See Figure 1.) Just after the lead locomotive passed the Tilden Street grade crossing, train DMX was diverted through a switch onto a house track adjacent to the main track. The north switch of the house track was 45 feet south of the center of the grade crossing. While the last two locomotive units of train DMX were still on the grade crossing, the brakes of the train were applied. Sparks between the locomotive wheels and the rails indicated that braking had become effective just before the lead locomotive unit collided head-on with an unoccupied locomotive which was standing on the house track, approximately 310 feet south of the center of the Tilden Street crossing.

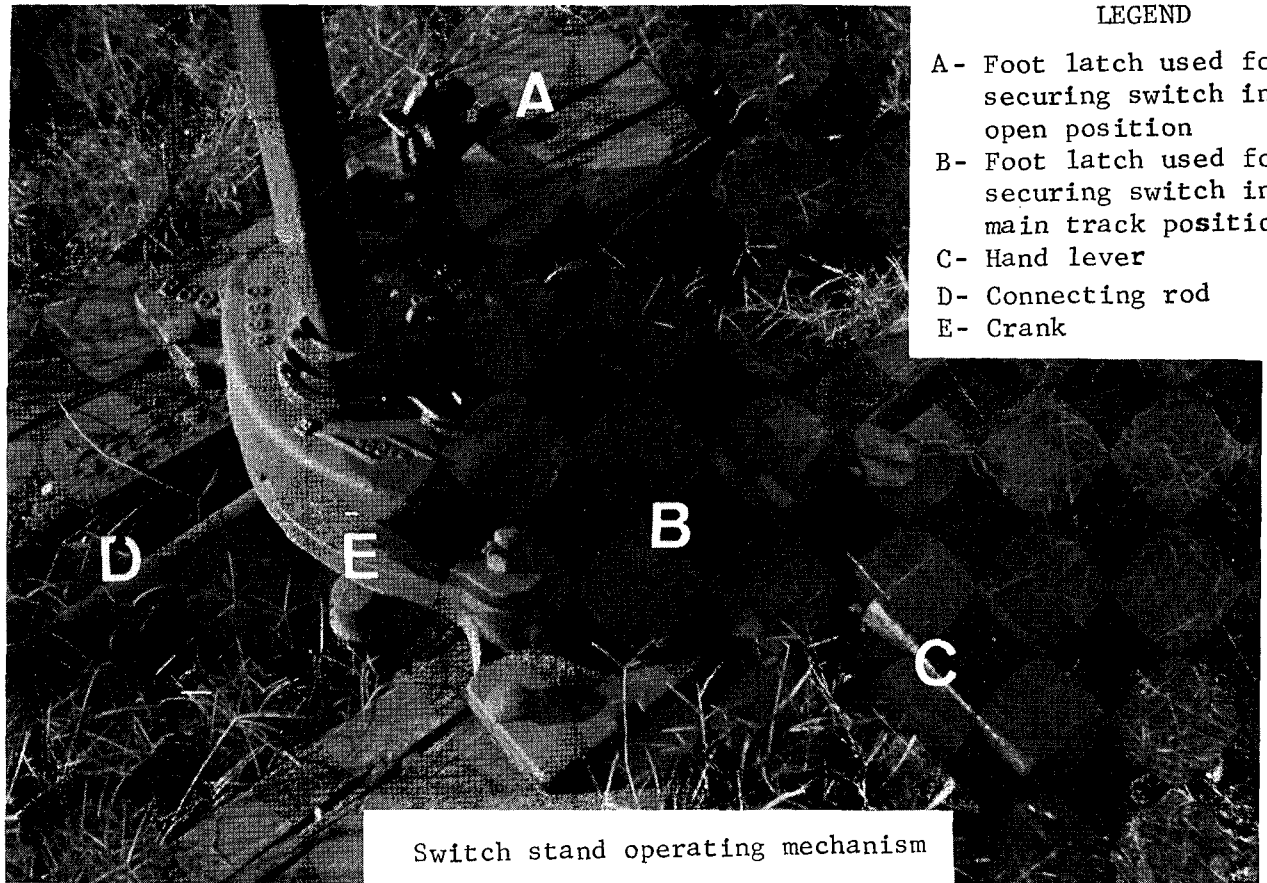
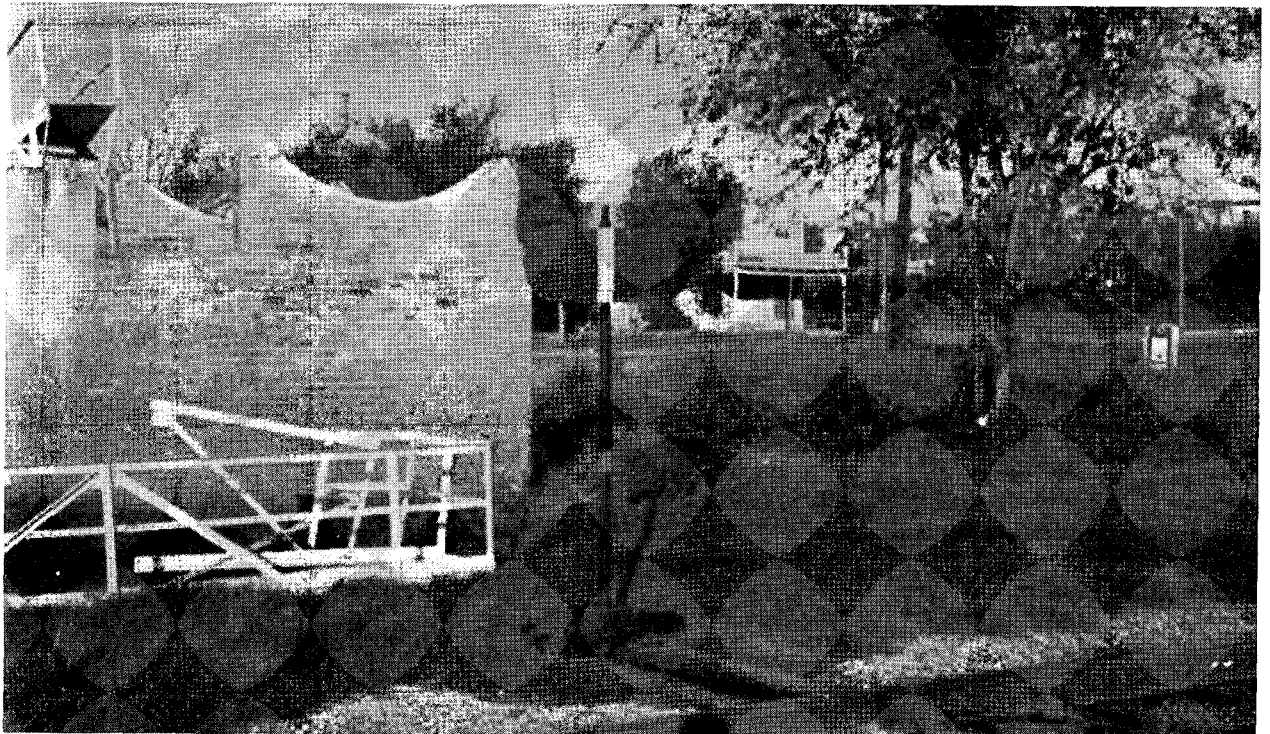
Figure 2. Switch stand at the south house track switch with the switch aligned for a movement upon the main track.

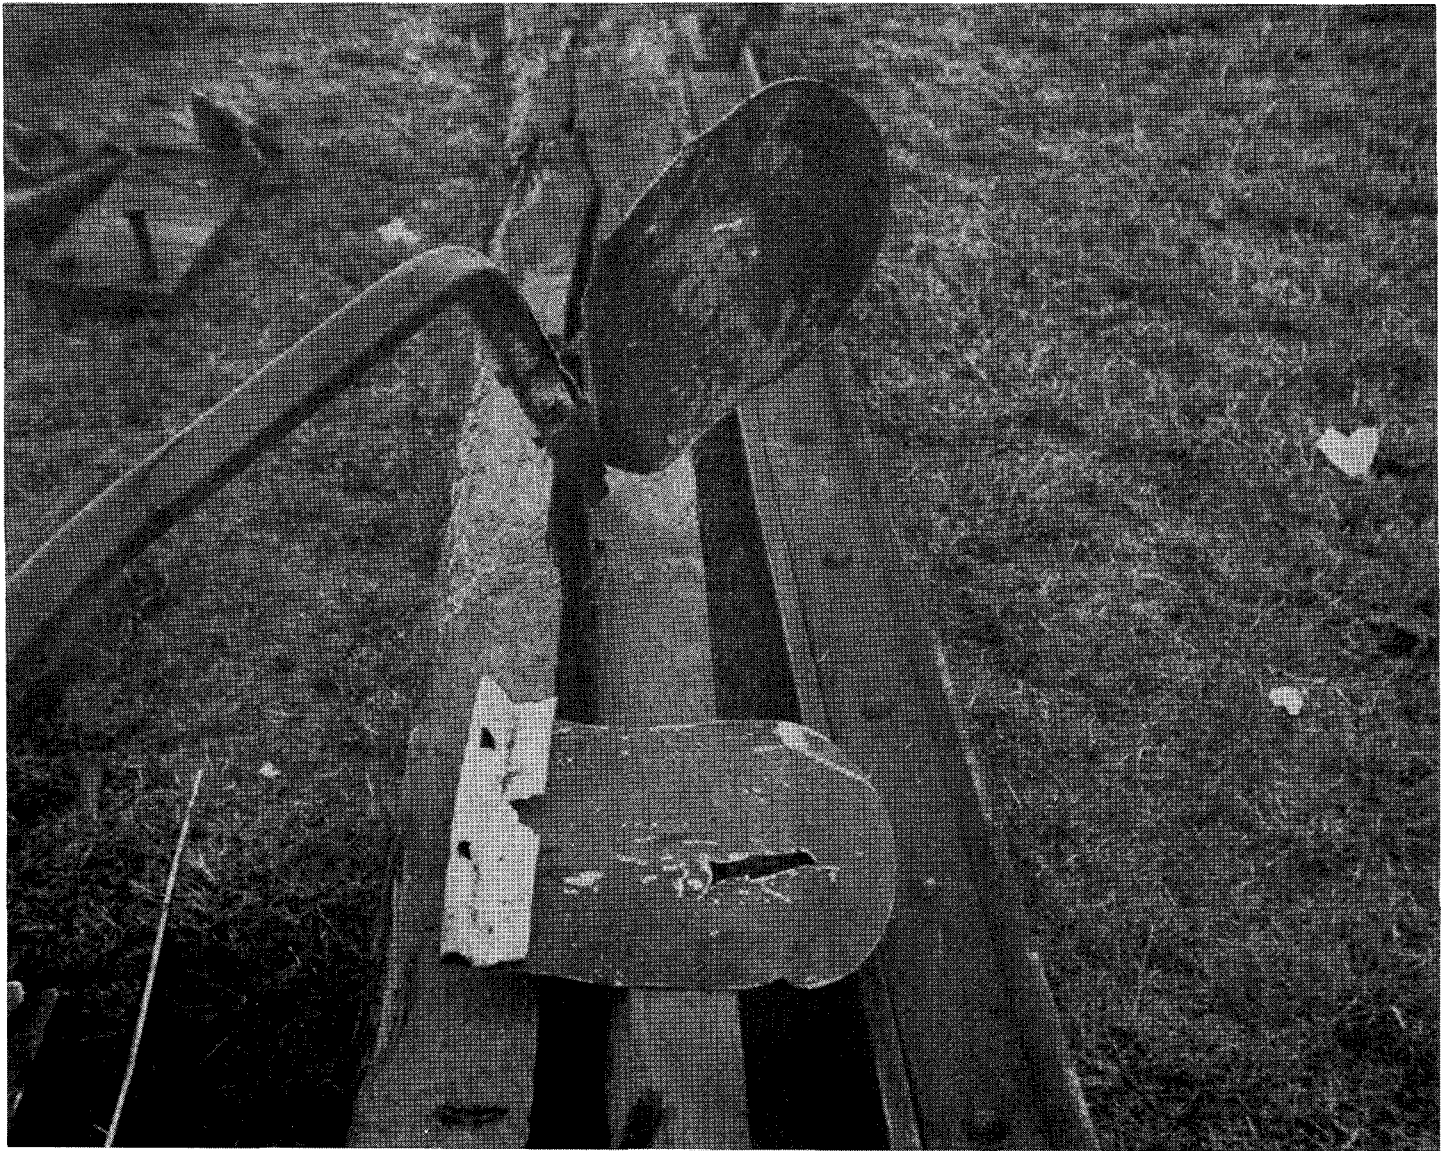
Figure 3. Switch-stand target of the north house track switch after the accident.

the position of north house-track switch was visible. The test was made at about 8:30 a.m., with visibility conditions similar to those which existed on December 1. When the switch was positioned for a movement onto the house track, the switch-stand target was plainly identifiable 1,408 feet from the switch. With the switch aligned for movement on the main track, it was possible to determine that the target was not perpendicular to the main track 1,056 feet from the switch.

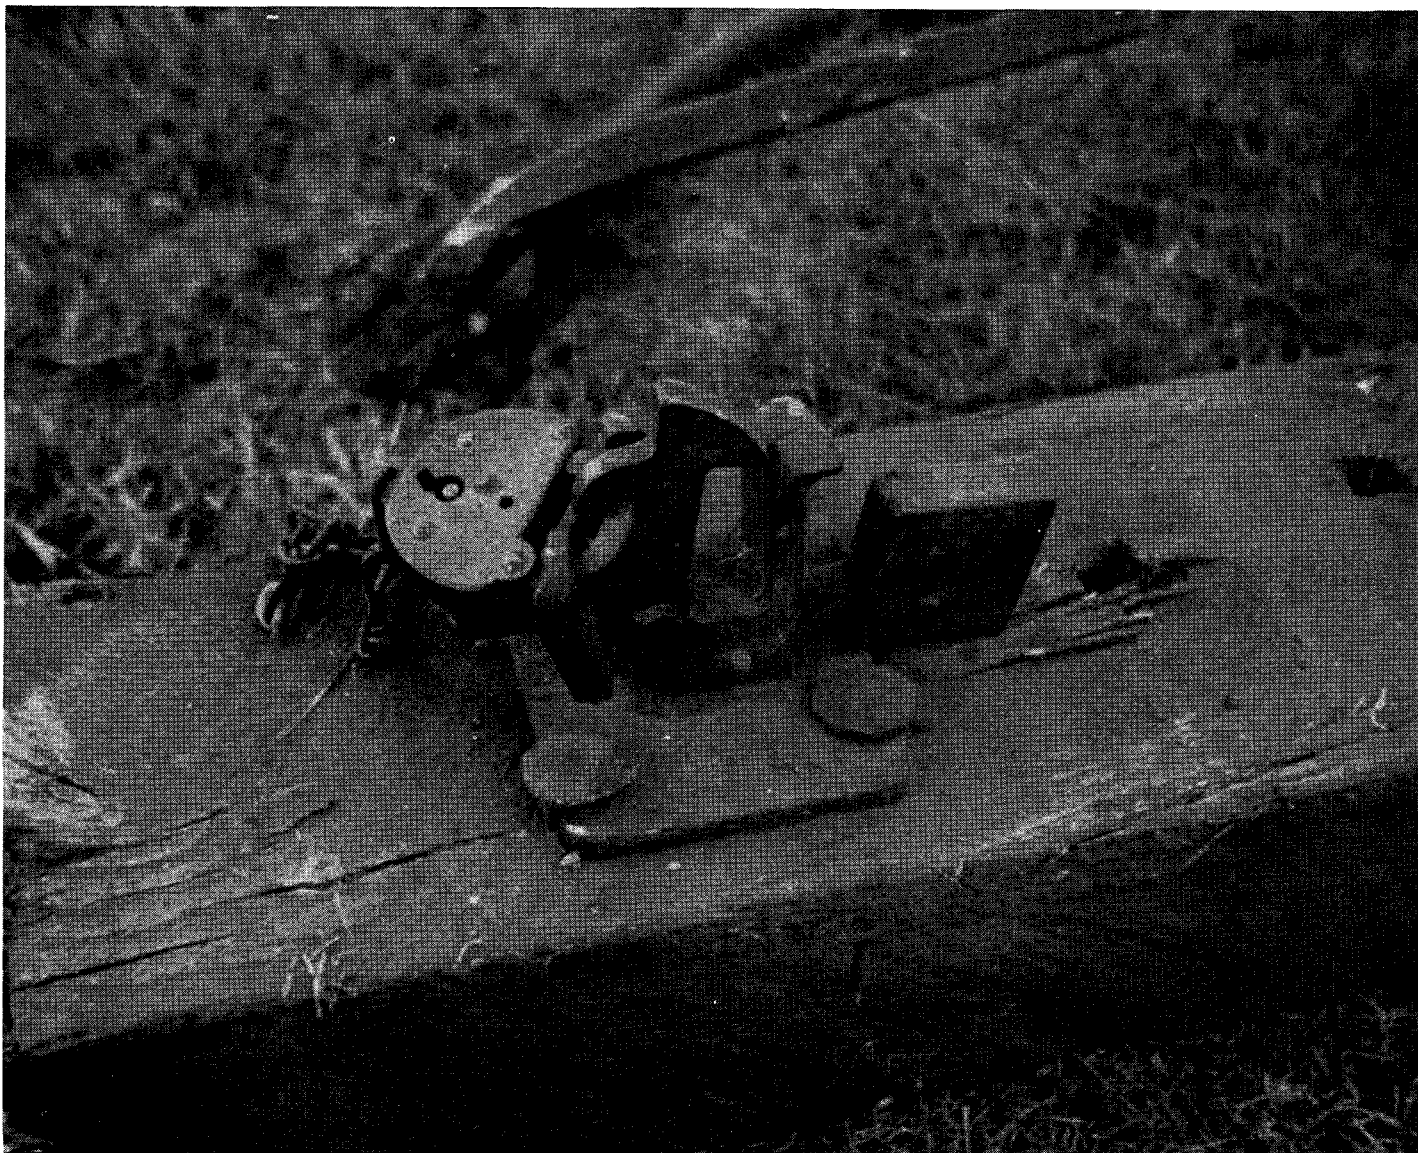
Inspection of the north house-track switch. The south foot latch of the north switch was found with the padlock chain intact and fastened to the broken head-block tie. The lock was secured, with the shackle of the lock through the hasps of the foot latch. The foot latch and padlock were undamaged, except that the vertical portion of one side of the hand-lever rest had been broken. The results of a metallurgical examination conducted by the Safety Board on the fractured lever rest are included as Appendix B.

Figure 4. South foot latch of the switch stand for the north house-track switch after the accident. Note broken hand-lever rest and padlock through the hasps.

The Safety Board's metallurgical examination of the fractured hand-lever rest showed that a small defect had existed since the switch stand was manufactured 43 to 45 years ago. The placement of the weighted hand lever into the latch by the brakeman could have caused the hand-lever rest to fracture. (If this had occurred, some other person still would have had to throw the switch to the open position.) However, if the lever rest broke as the brakeman aligned the switch, he probably would have noticed the broken lever rest when he pulled the chain to test the lock, since the fractured lever rest would have been free to dangle on the lock shackle.

9. The hand-lever rest of the south foot latch of the north switch stand broke before the cars of train DMX derailed. This fracture permitted the hand lever of the switch stand to be operated while the padlock that secured the hand lever was locked.

10. The broken hand-lever rest on the south foot latch contained a manufacturing defect which had gone unnoticed for 43 to 45 years. The exact effect of the defect on the fracture could not be determined.

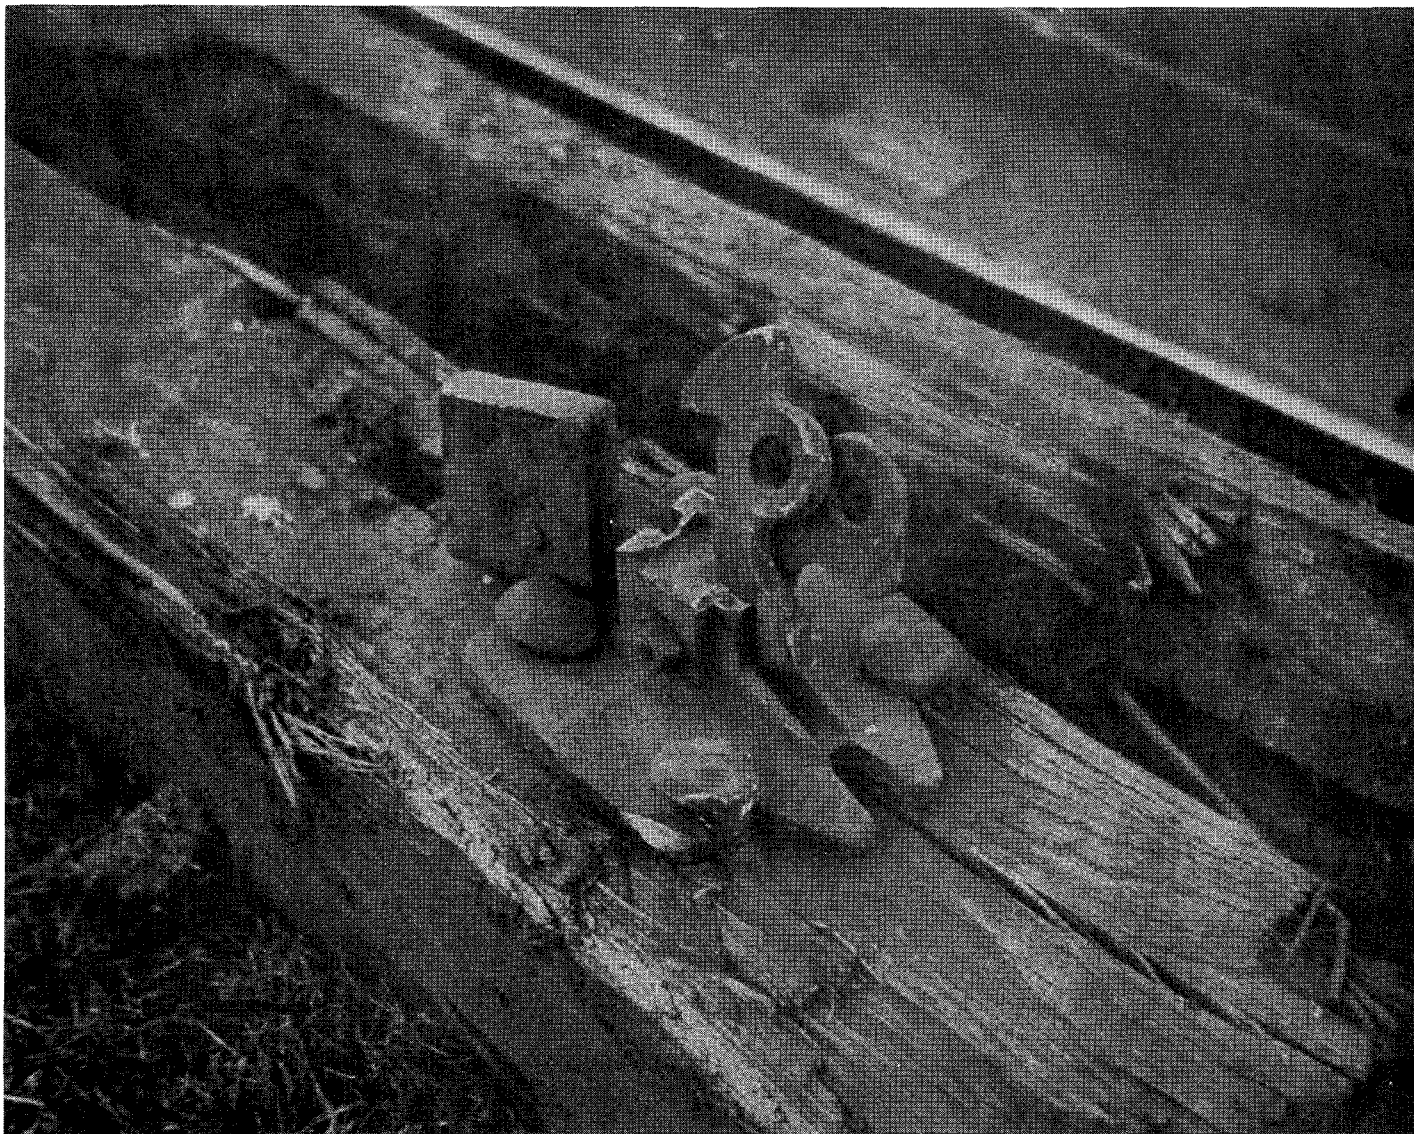
The foot latch used for securing the switch in the open position (the north latch) was bent and broken. The switch-stand housing was also broken. The crank used to link the switch-stand mechanism to the connecting rod was bent downward at about 45°. The crank was positioned in the manner that would occur if the switch were aligned for the house track.

The condition of the north foot latch provides evidence that the hand lever was secured in the open position at the time of the derailment. The hand-lever rest on the north foot latch was sheared off at the base where the lever would normally rest; the latch mechanism used to secure the lever was bent southward. The counterweight, however, was bent back to the north. (See Figure 5.) This type of damage would not normally result from railroad cars' striking the foot latch during a derailment, since in such a case all parts of the latch would have been bent southward or westward.

Figure 5. North foot latch of the switch stand for the north house-track switch after the accident.

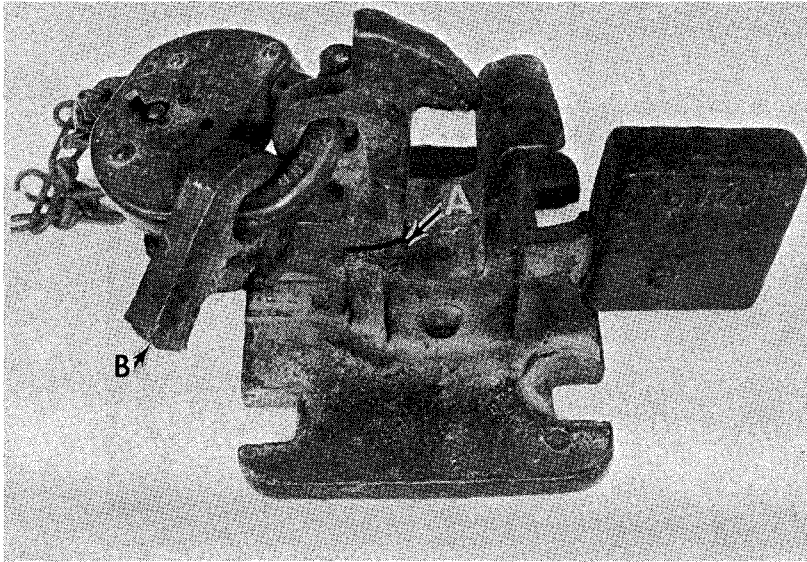
The lock arm on the switchstand foot latch fractured transversely near the base as shown by arrows "A" and "B" in Figure 6.

Figure 6. Switchstand as received. Arrows "A" and "B" denote mating fracture surfaces on lock arm. X 1/5

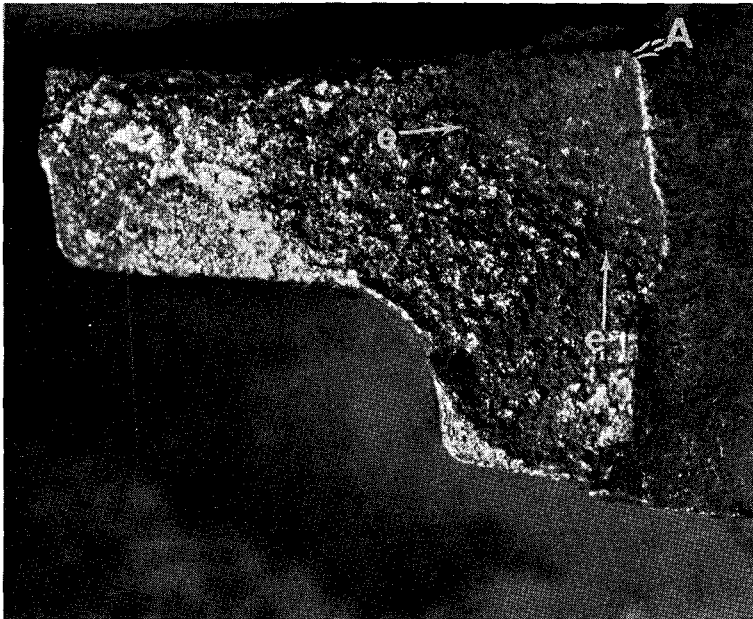
A closeup view of the lock arm fracture surface is shown in Figure 7. The fracture appearance was indicative of an overload condition except for a light brown and dark gray discolored area extending from one of the corners. This discolored area on the fracture is shown between arrow "A" and the curved boundary denoted by arrows "e" in Figure 7.

Figure 7. Fracture on lockarm. Note the discolored fracture area between the corner, shown by arrow "A" to the curved line indicated by arrows "e". X4

The underlying microstructure along part of the fracture indicated a crack was present in the lock arm during heat treatment of the casting. This crack probably grew during service of the foot latch to the extent indicated in the factual report. A crack of this magnitude would severely weaken the arm to impact loads.

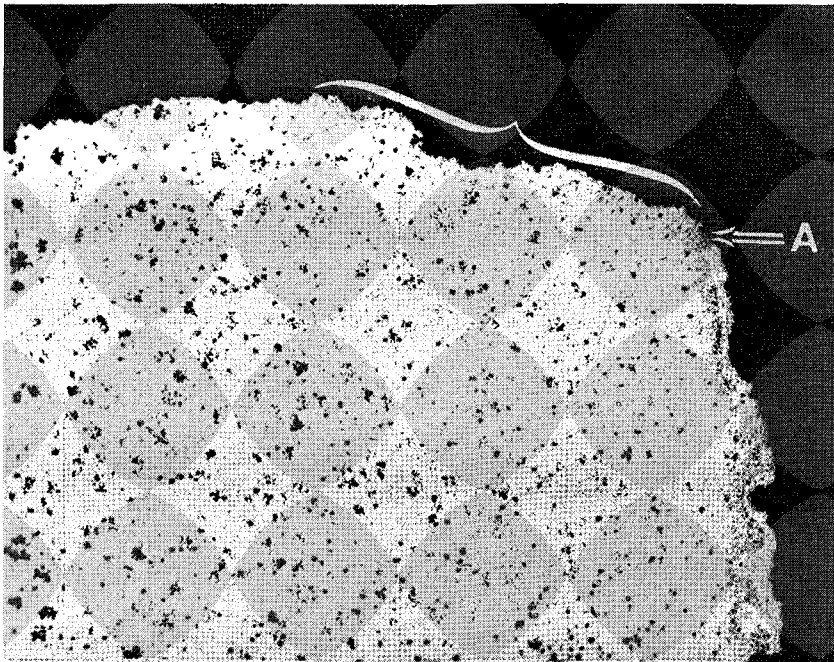
Decarburization also occurred along the fracture surface in the area shown by the bracket in Figure 8. The typical microstructure within this area is depicted in Figure 11.

Figure 8. Metallographic cross section through the discolored fracture area indicated in Figure 7. Arrow "A" denotes corner area shown by arrow "A" in Figure 7. Profile of the fracture surface is along the top of the photograph and the lockarm side surface is along the right side of the photograph. X25 unetched

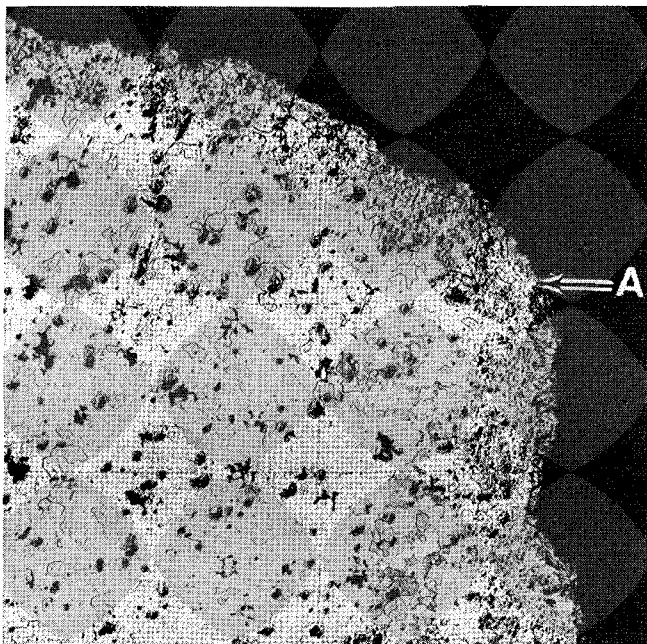
Figure 9. Photomicrograph after etching microsection the area shown by arrow "A" in Figure 8. X50 nital etched

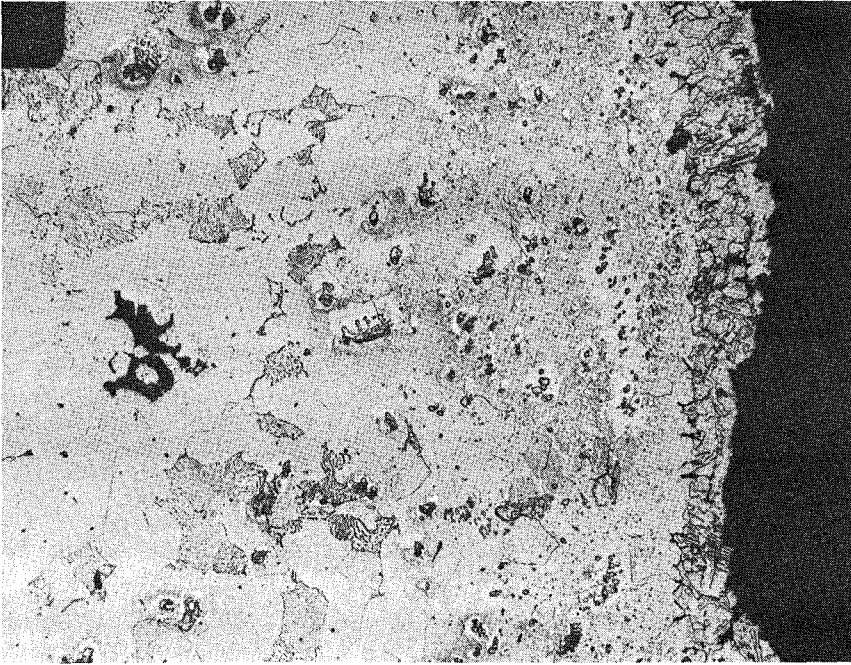
The microstructure of the material below the surface appeared normal for ferritic malleable iron. The microstructure on the case surface of the lockarm (see Figure 10) indicated that the structure was excessively decarburized.

Figure 10. Typical surface along the side of the lockarm showing excessive decarburization that formed a ferritic skin on the casting surface and underlying rum of pearlite. X200 nital etched

The excessive decarburization on the as cast surface would occur on heat treatment of the casting and is undesirable since it further weakens the material in this area. No control of the heat treatment was noted, however, on the engineering drawing.

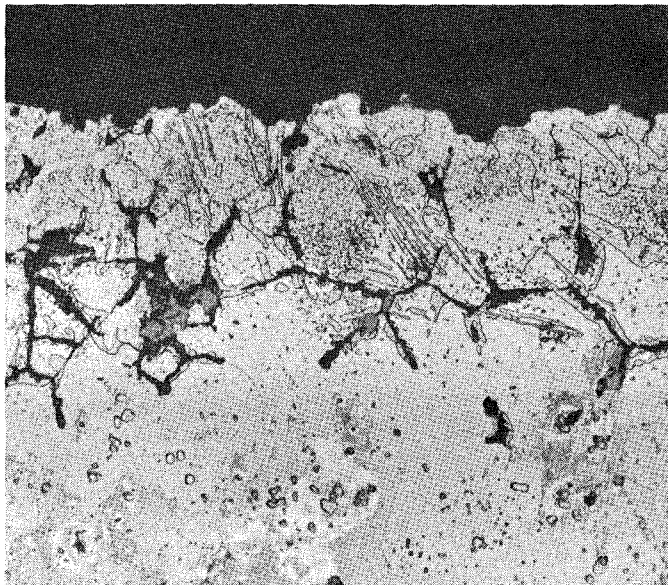
Figure 11. High magnification photomicrograph showing typical underlying surface of the fracture within the bracket area depicted in Figure 8. X500 nital etched
