BUREAU OF SAFETY

REPORT NO. 1971

Railroad:	Missouri Pacific
Date:	February 25, 1935
Location:	Cunningham Spur, Ark.
Kind of accident:	Derailment
Train involved:	Freight
Train number:	96
Engine number:	1244
Consist:	17 cars and caboose
Speed:	35-45 m.p.h.
Track:	Tangent and level
Weather:	Sleet
Casualties:	1 killed and 1 injured
Cause:	Broken arch bar on eleventh car.

REPORT OF THE DIRECTOR OF THE BUREAU OF SAFETY CONCERNING
AN ACCIDENT ON THE MISSOURI PACIFIC RAILROAD AT
CUNNINGHAM SPUR, ARK., ON FEBRUARY 25, 1935.

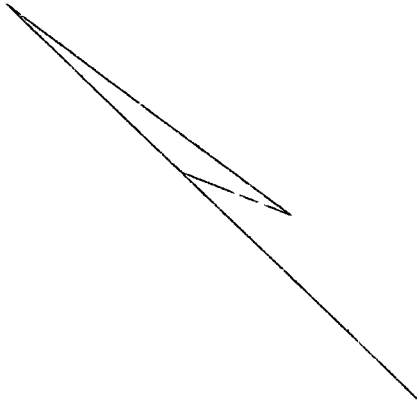
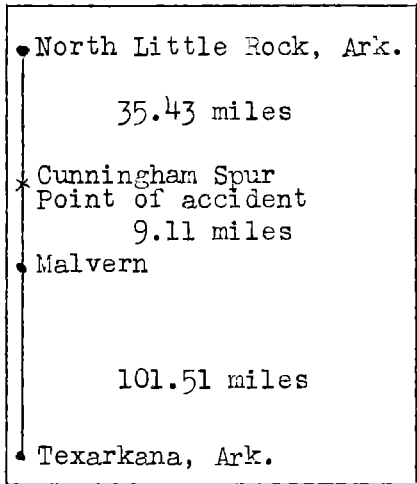
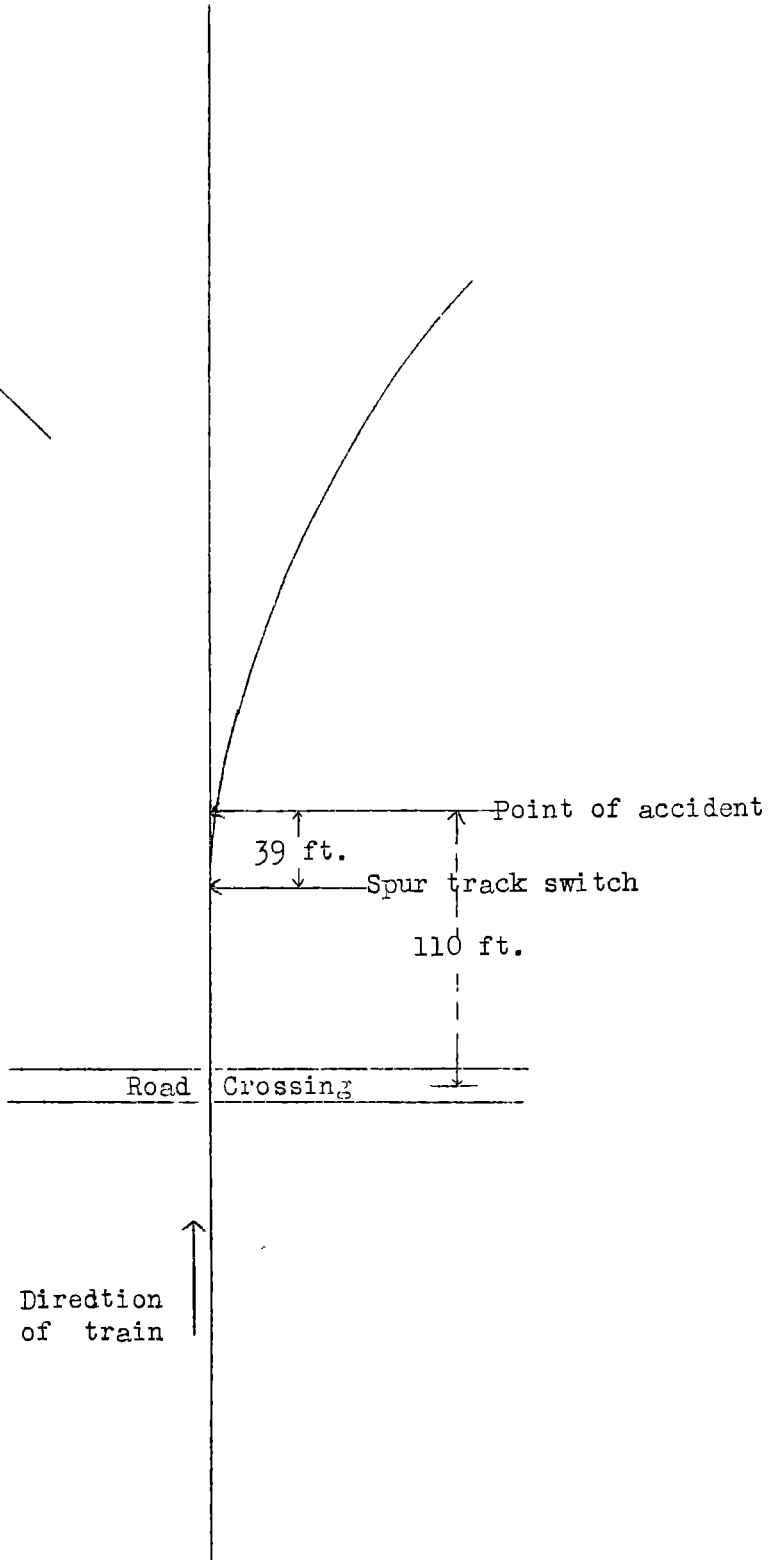
Inv. No. 1971
Missouri Pacific Railroad
Cunningham Spur, Ark.
February 25, 1935.

Inspection of the rear truck of MP 68733 disclosed that the top bar was broken at the front column-bolt hole and the bottom bar was broken at the bend, about 3 inches from the center of the rear hole of the front journal box; both breaks were fresh. The end of the front column bolt had been sheared and broken off flush with the bottom of the tie bar, the end of the bolt together with the nut and grip nut being found in the vicinity of the point of accident. The nut and grip nut were missing from the front journal-box bolt, but the other

bolts were intact and tight, and from the appearance of the broken column bolt and nut it had been tight prior to the accident. The ends of the top arch bar fitted snugly to the lips of the bottom bar, and there was but little wear in the column and journal-box bolts. This car is a gondola, built in February, 1917; it has a capacity of 100,000 pounds, with a light weight of 41,500 pounds and a load limit of 127,500 pounds, and at the time of the accident contained gravel which had not been weighed. While the load had been dumped at the scene of the accident and the weight could not be ascertained, this car together with three other cars of like capacity had been loaded with approximately the same amount of gravel, which in the case of the other cars was weighed subsequently and found to have an average net weight of 105,000 pounds.

This investigation disclosed that the top and bottom arch bars on the right side of the rear truck of the eleventh car were broken. The top bar was broken at the front column-bolt hole and the bottom bar was broken at the bend about 3 inches

from the center of the rear hole of the front journal box. Each break was new, but the break in the bottom bar indicated that it had snapped, while the break in the top bar indicated that it had been torn apart as a result of the derailment. From the marks at the road crossing a short distance south of the spur-track switch, the bottom bar apparently failed at that point, and when the truck reached the switch the lower end of the front column bolt engaged the outside of the ball of the stock rail and struck the angle bar, but before the bolt broke off the pull was sufficient to jerk the lead wheels of that truck off the track. No apparent reason for the failure of the bottom arch bar at this particular point could be discovered.

This accident was caused by the failure of an arch-bar truck.

In view of the record of performance of arch-bar trucks shown in this report it is suggested that further consideration be given to the use of such trucks and that measures be taken by carriers and private car lines to eliminate arch-bar trucks from service at the earliest practicable date.

It is further suggested that consideration be given to the desirability of materially reducing the load limits of cars equipped with arch-bar trucks until such equipment can be eliminated from service.
