# Railroad Accident Investigation Report

Report No. 79-8  
**MISSOURI PACIFIC RAILROAD COMPANY**  
**HECLA, KANSAS**  
**OCTOBER 5, 1978**

RAILROAD ACCIDENT INVESTIGATION  
ACCIDENT REPORT NO. 79-8

MISSOURI PACIFIC RAILROAD COMPANY  
HECLA, KANSAS  
OCTOBER 5, 1978

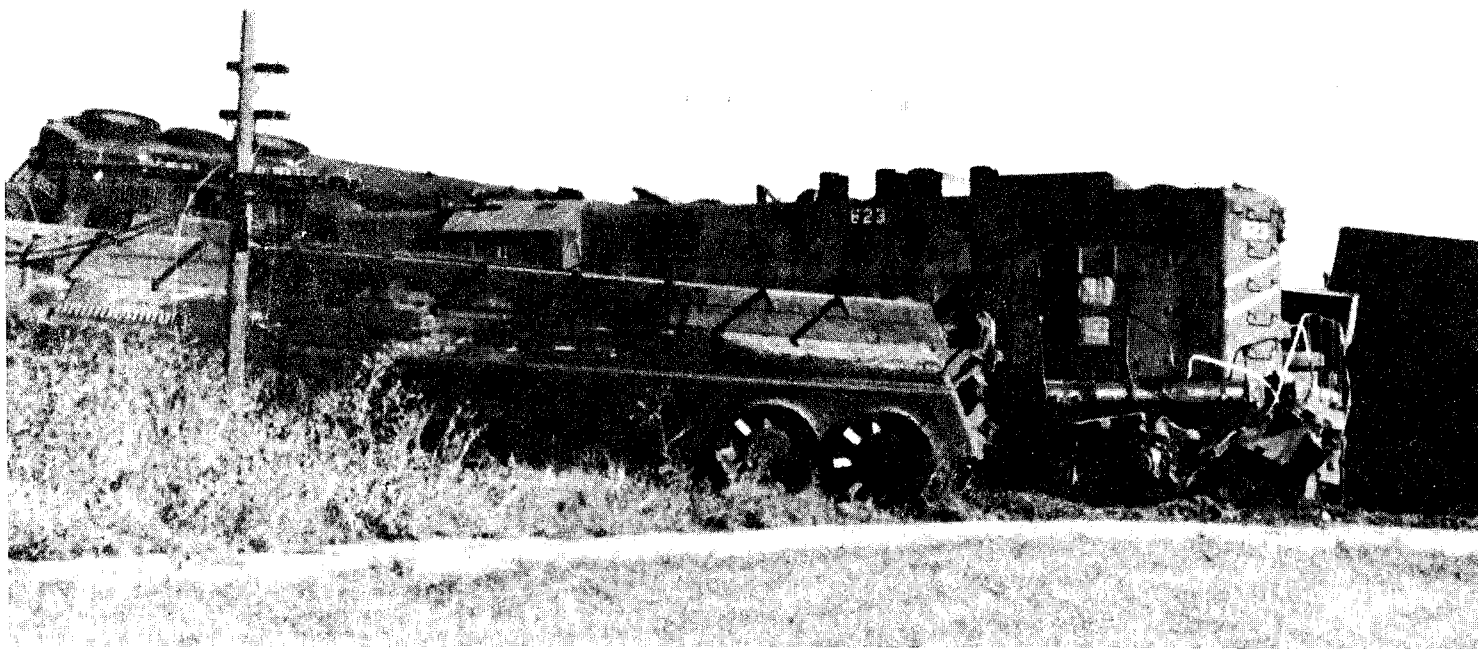
### View of Collision

Locomotive Unit 623 (Upright) is the second locomotive unit in the consist of Extra 2080 South.

In the collision, the lead locomotive unit of Extra 2080 South, No. 2080, was derailed and turned at a 75° angle to the east of the main track, coming to rest on its left side with the front, or south end on the main track structure, 190 feet south of the collision point. The second unit (No. 623) derailed remained upright turned at a 90° angle to the main track, and was propelled eastward coming to rest on the right-of-way, 15 feet from the main track structure and 160 feet south of the collision point. The third unit (No. 2553) derailed remained upright slightly canted to the east, and turned at a 75° angle to the east of the main track, coming to rest with the rear, or south end on the track structure, 160 feet south of the collision point. All three units were substantially damaged.
