RAILROAD ACCIDENT REPORT

DERAILMENT OF MISSOURI PACIFIC
RAILROAD COMPANY'S TRAIN 94 AT

Houston, Texas
October 19, 1971

NATIONAL TRANSPORTATION SAFETY BOARD
Washington, D. C. 20591
REPORT NUMBER: NTSB-RAR-72-6

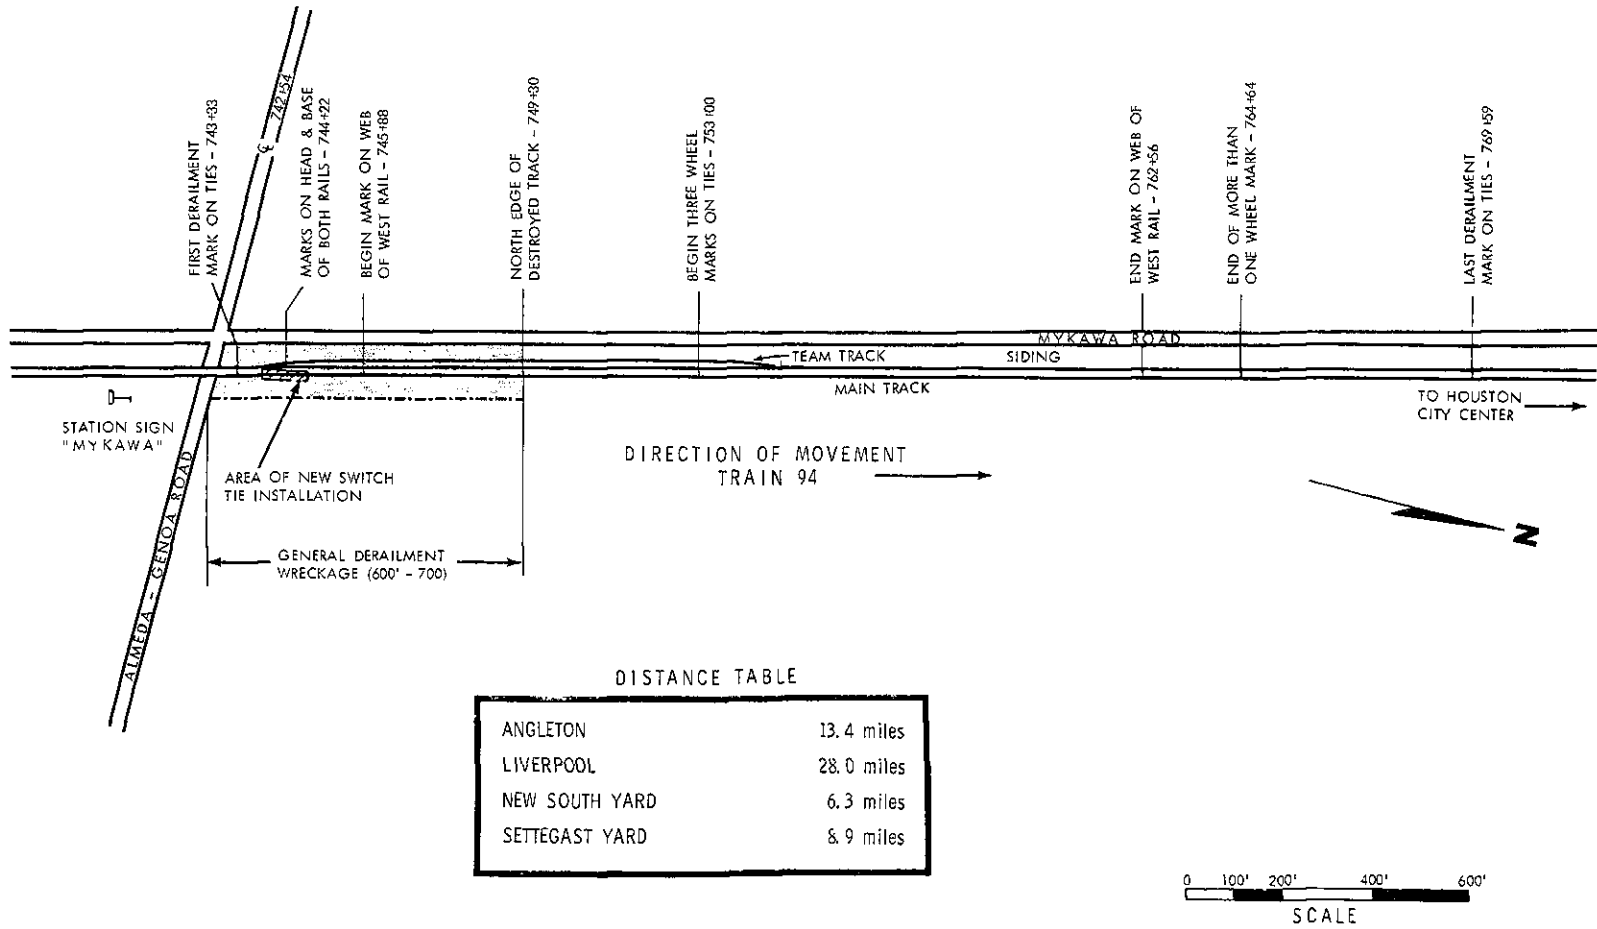
Figure 2 - Sketch showing derailment area

The derailment and fire demolished the track for a distance of 607 feet between Santa Fe's Engineering Stations 743 + 23 and 749 + 30. Station 743 + 23 is located 69 feet north of the centerline of the Alameda-Genoa Road crossing (742 + 54). From Station 749 + 30 north to Station 751 + 00 both the east and west rails were spread out and the west rail was overturned. From Station 751 + 00 to Station 762 + 56 only the west rail was overturned. The 52 d car was found at Station 762 + 56. The web of the west rail was marked continually from Station 749 + 30 to Station 762 + 56. The outside edge of the head of the east rail was scored from Station 744 + 22 to 762 + 56. The correlation of the engineering stations with various derailment marks is shown in Figure 2 on page 3.

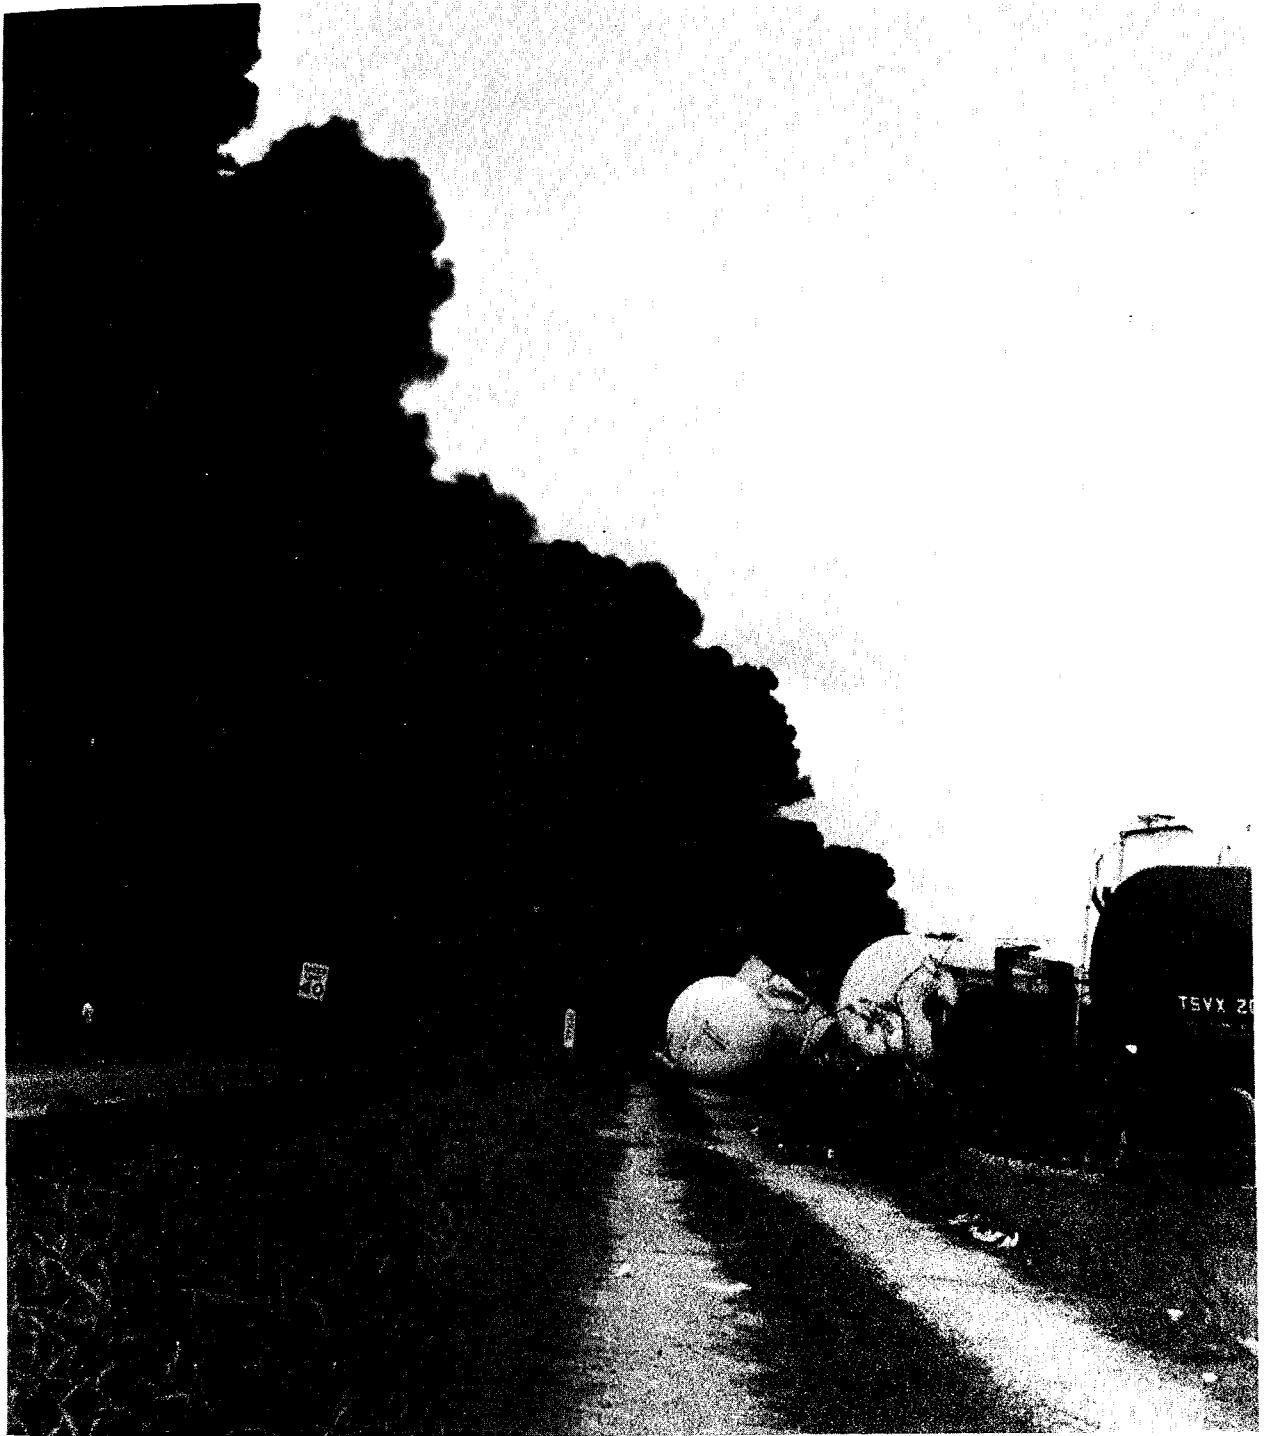
The two punctured cars came to rest in the area in which vinyl chloride vapors were burning. Great quantities of heat, flame, and dense, black smoke accompanied the fire. The fire enveloped large areas of the tank cars and the heat increased the internal pressure of ESMX 4804's damaged tank. (See Figures 3 and 4.)

Figure 3 - View from the west side of track, south of the general wreckage prior to 2:30 p.m. on October 19, 1971. Tank car to extreme left is ESMX 4803. Car lettering and position of body bolster indicates car is inverted. Frost line indicates liquid level of contents.

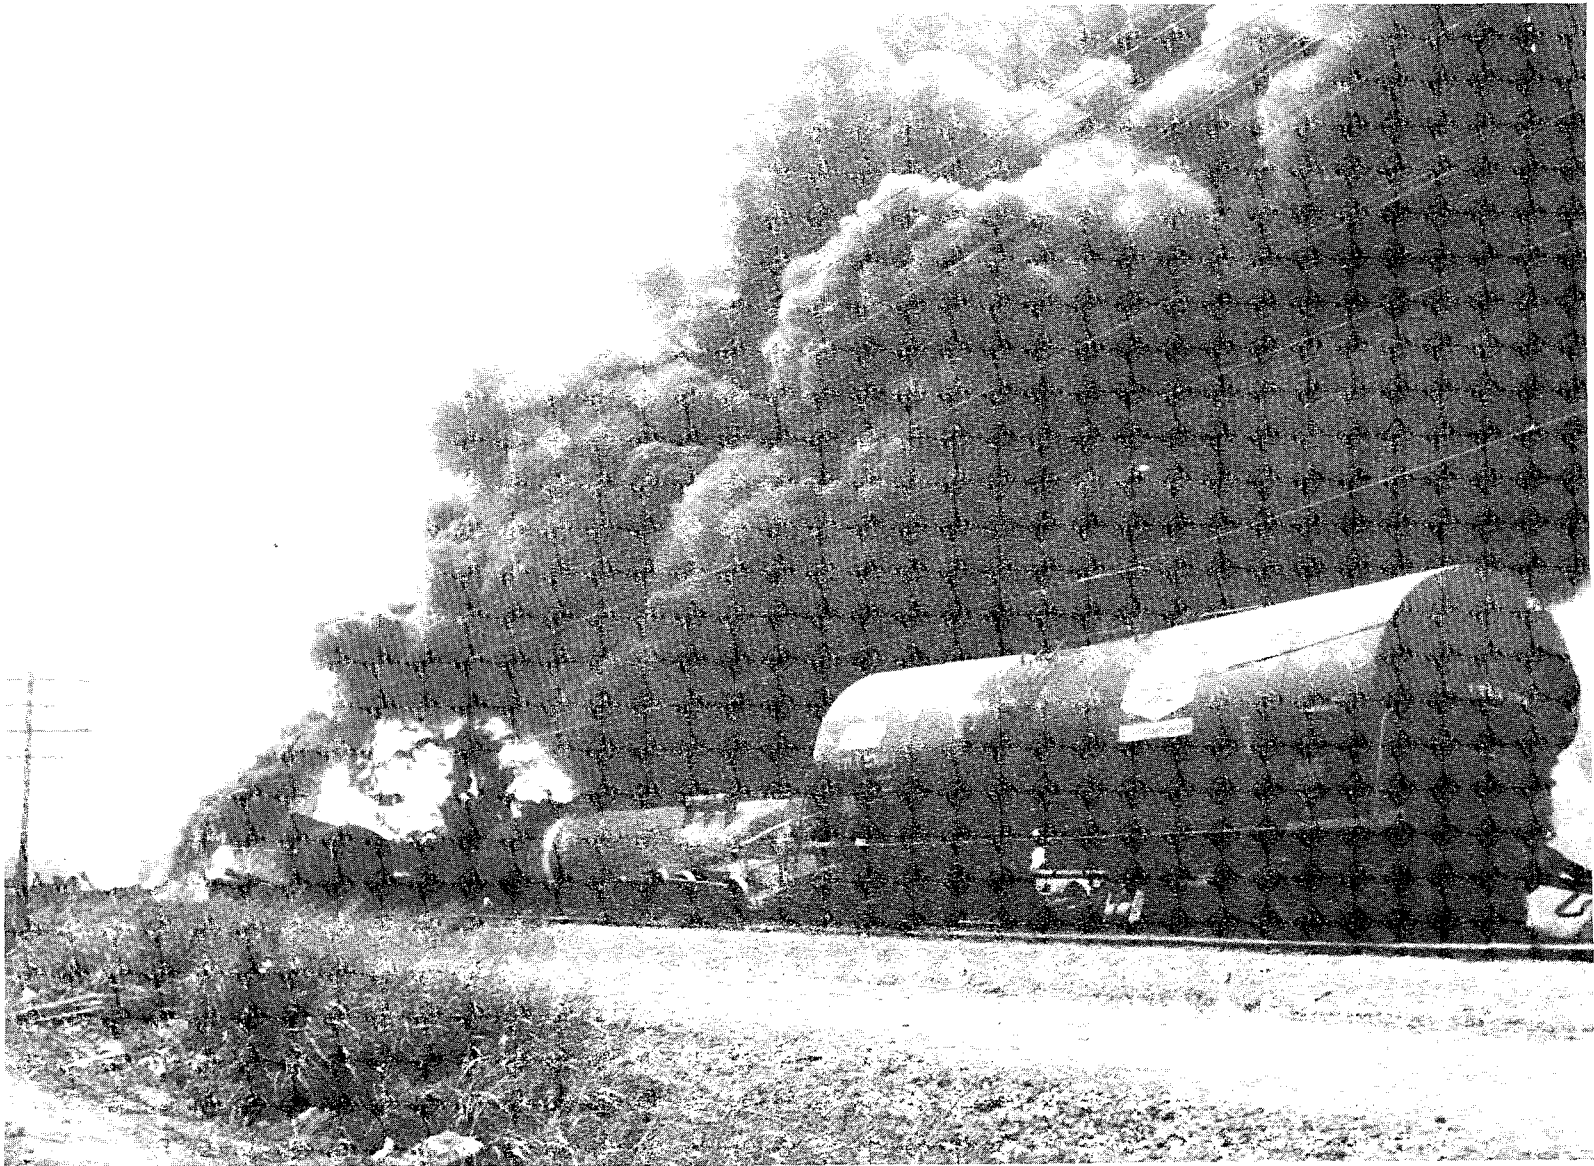
Figure 4 - View from north prior to 2:30 p.m. Tank car to right is the 54th car. Inverted position of tank cars to the left can be detected by the positions of body bolsters. Fireball is emitting from the vicinity of ESMX 4804.

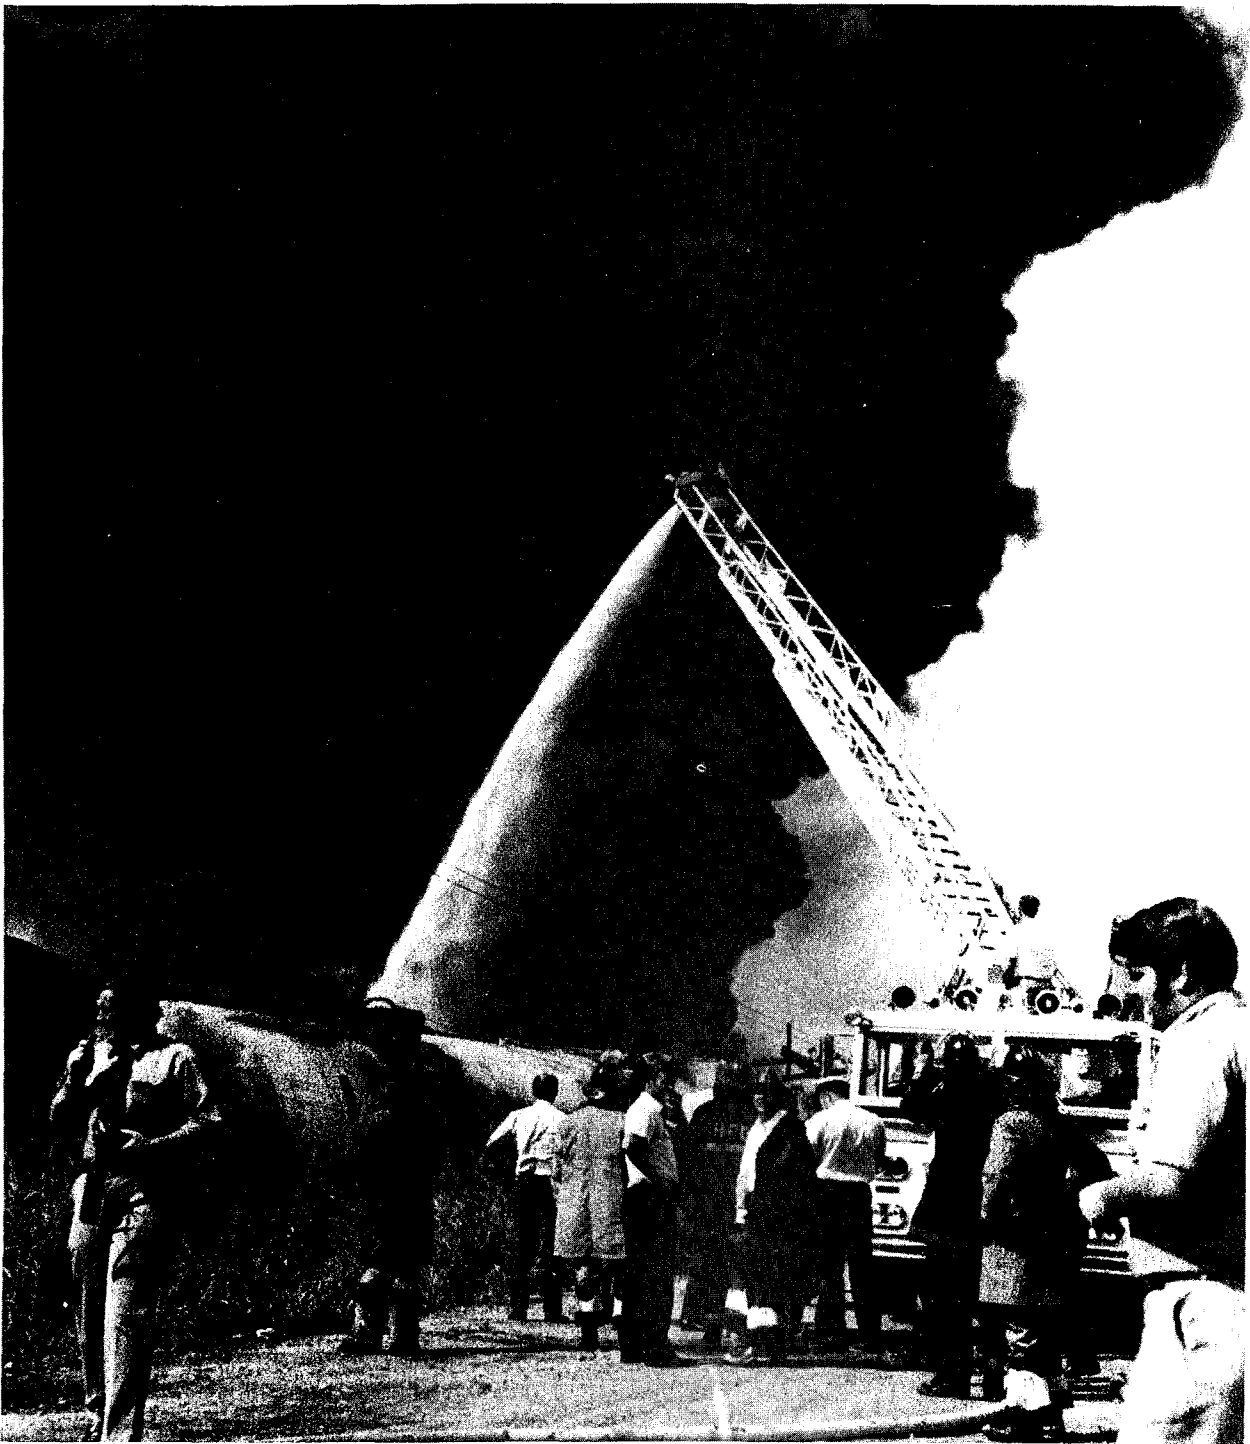
Figure 5 - View looking northwest prior to 2:30 p.m. showing fireman on ladder directing spray of water on burning tank cars.

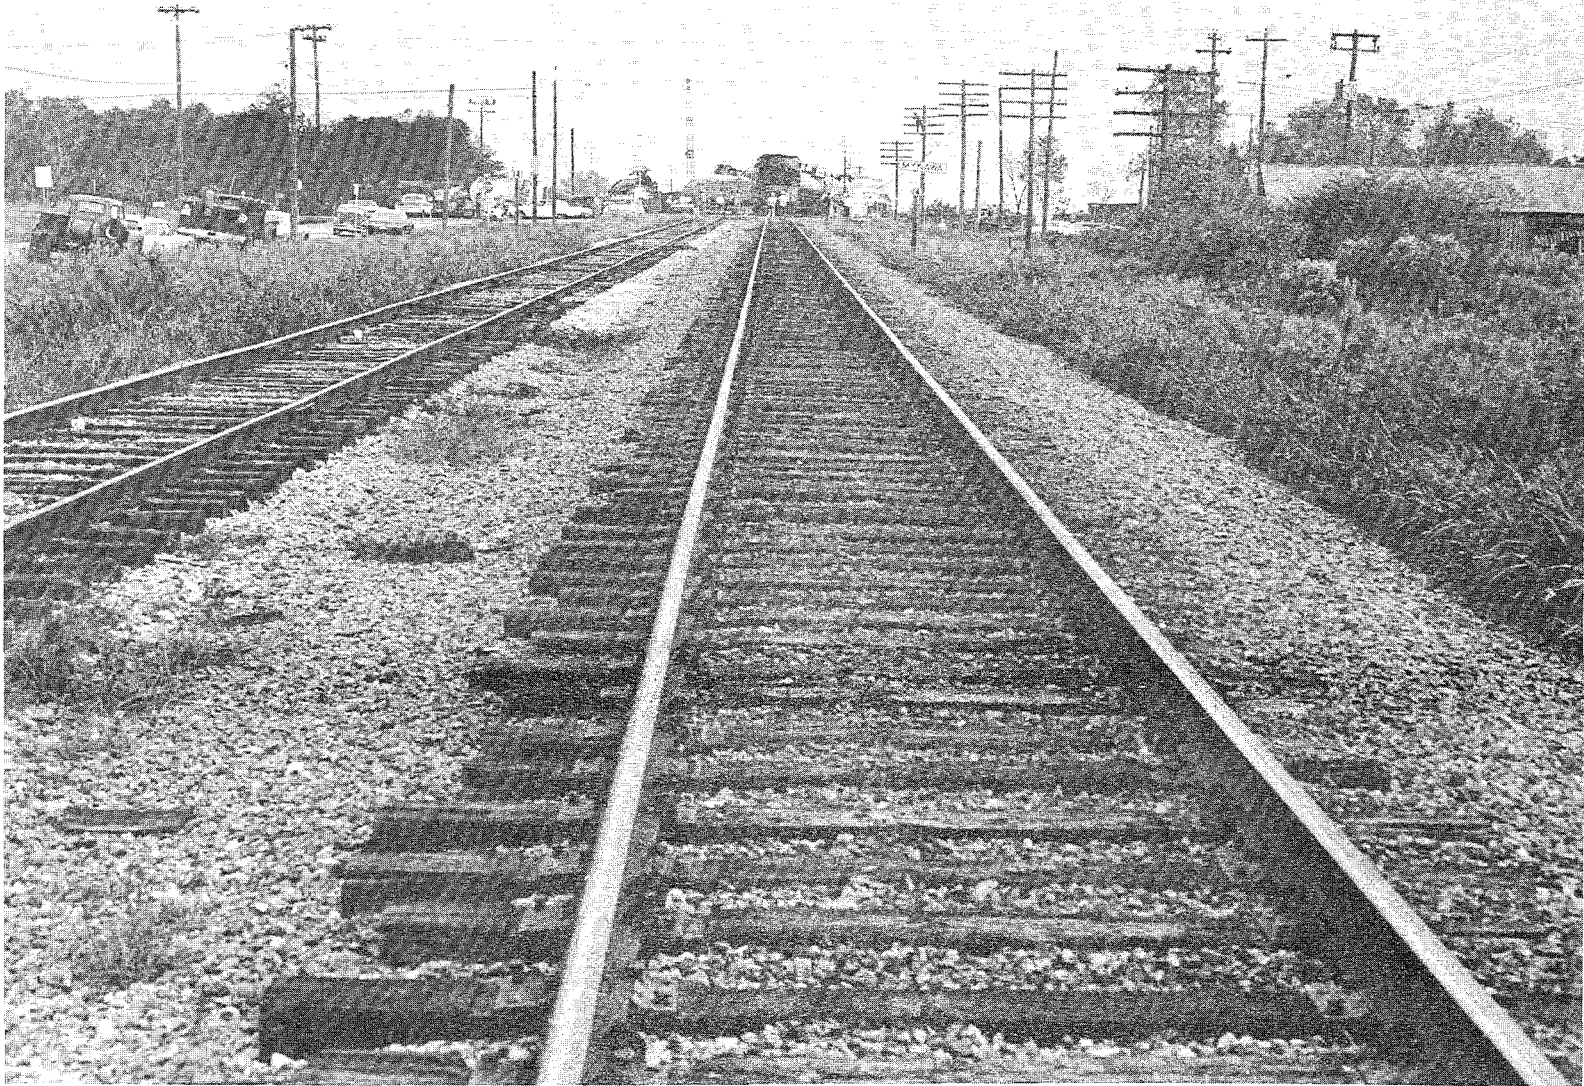
Figure 6 - View of tracks south of accident scene. The main track is on the right.

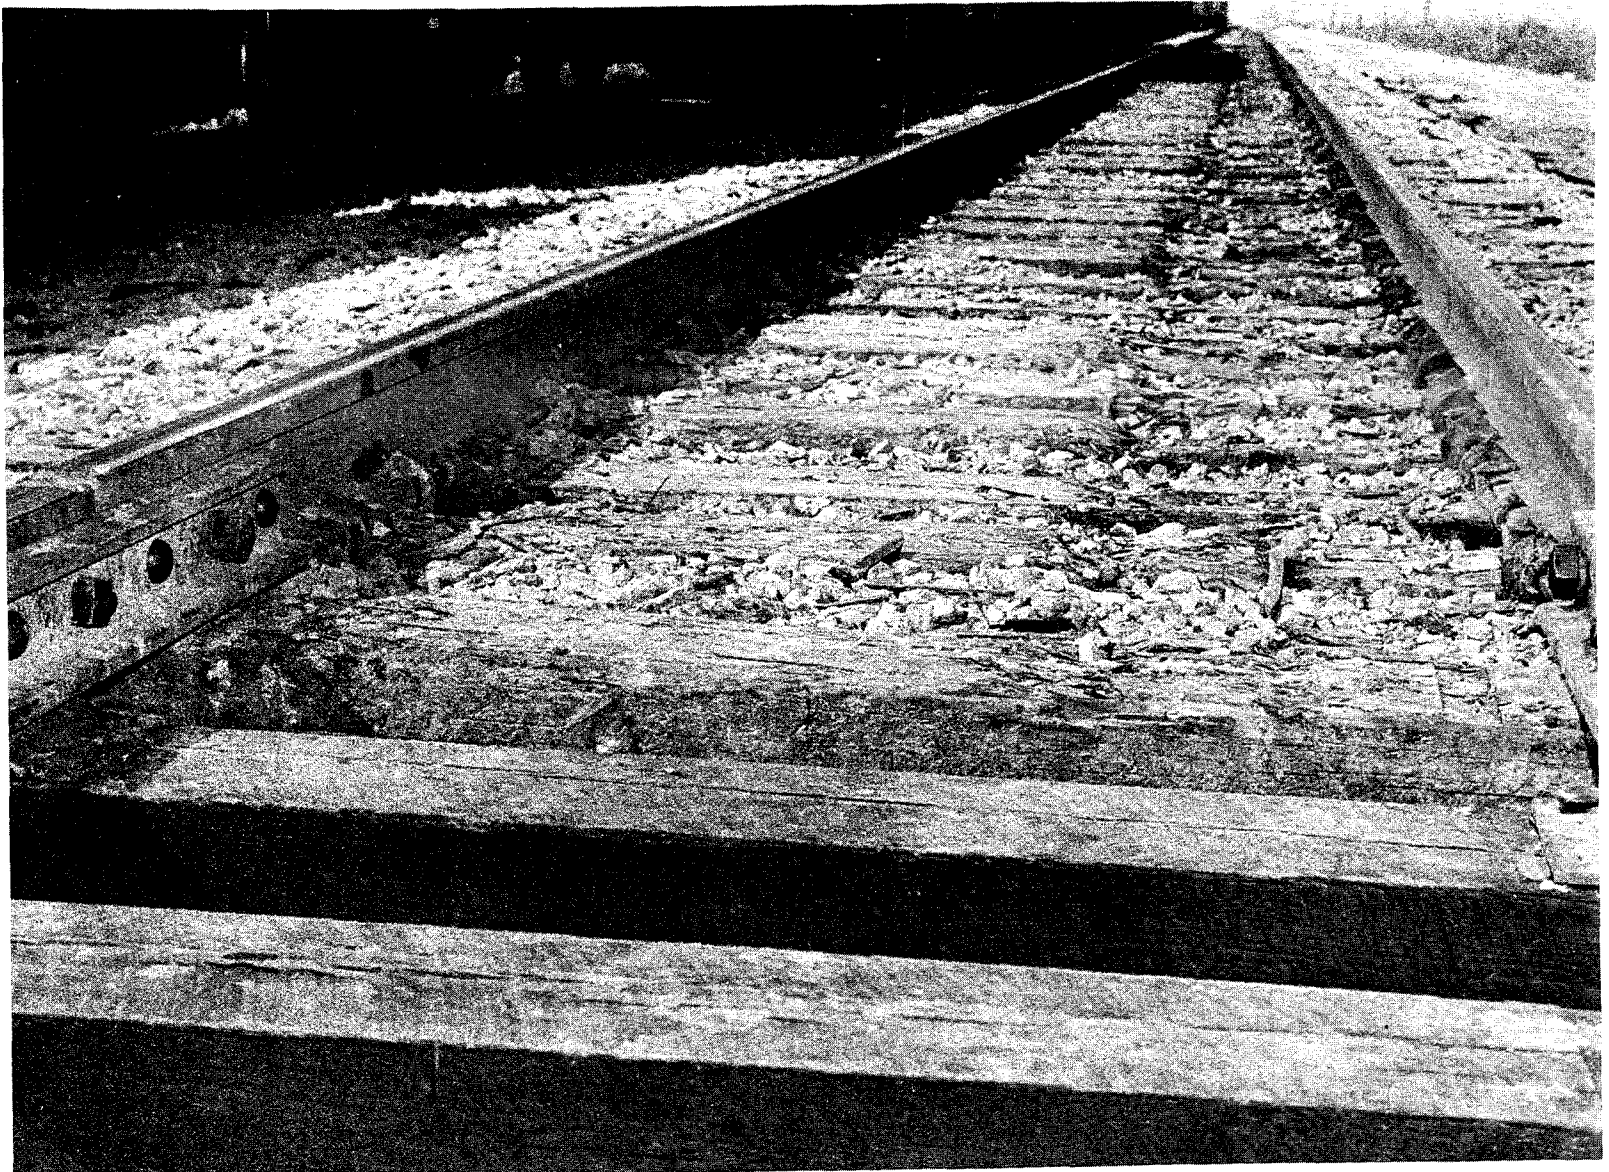
In addition to the spread rails, the crossties were damaged north of the area where the track was demolished. At Station 749 + 30, the first location where the track was not completely destroyed, three fresh marks were found on the crossties between rails (See Figure 7). Two of these marks were generally continuous northward to the location where the 48th and 49th cars came to rest after the derailment. Between Station 749 + 30 and the area of Station 752 + 70, the third mark was intermittent and appeared only on ties that were in poor condition from decay. It was located approximately 3 inches from one of the more distinct, continuous marks on the ties. From Station 753 + 00 north to Station 764 + 64, there was clear evidence of three distinct marks (Figure 8). From Station 764 + 64 to Station 769 + 59, where the 38th car came to rest, there was one mark between rails on the crossties (Figure 9).

The scrape mark discernible on the web of the west rail also was apparent on the reassembled rail in the area of the wreckage. This mark could be traced back to Station 745 + 88, or 30 feet south of the broken rail discussed above. At that location, the mark on the rail web ended. Just above the end of the mark, the gage side of the west rail head was scored diagonally downward, as viewed from south to north. Five feet 6 inches south of this mark, there was another mark on the gage side of the west rail head and still another at Station 744 + 42. This latter mark was scored diagonally upward, as viewed from south to north. The web and base of the west rail also were marked between Stations 744 + 42 and 744 + 22.

Figure 7 - View of main track at engineering station 749 + 30 showing the marks on cross-ties north of the area of reconstructed track. The mark on the web of left rail extends between stations 745 + 88 and 762 + 56.

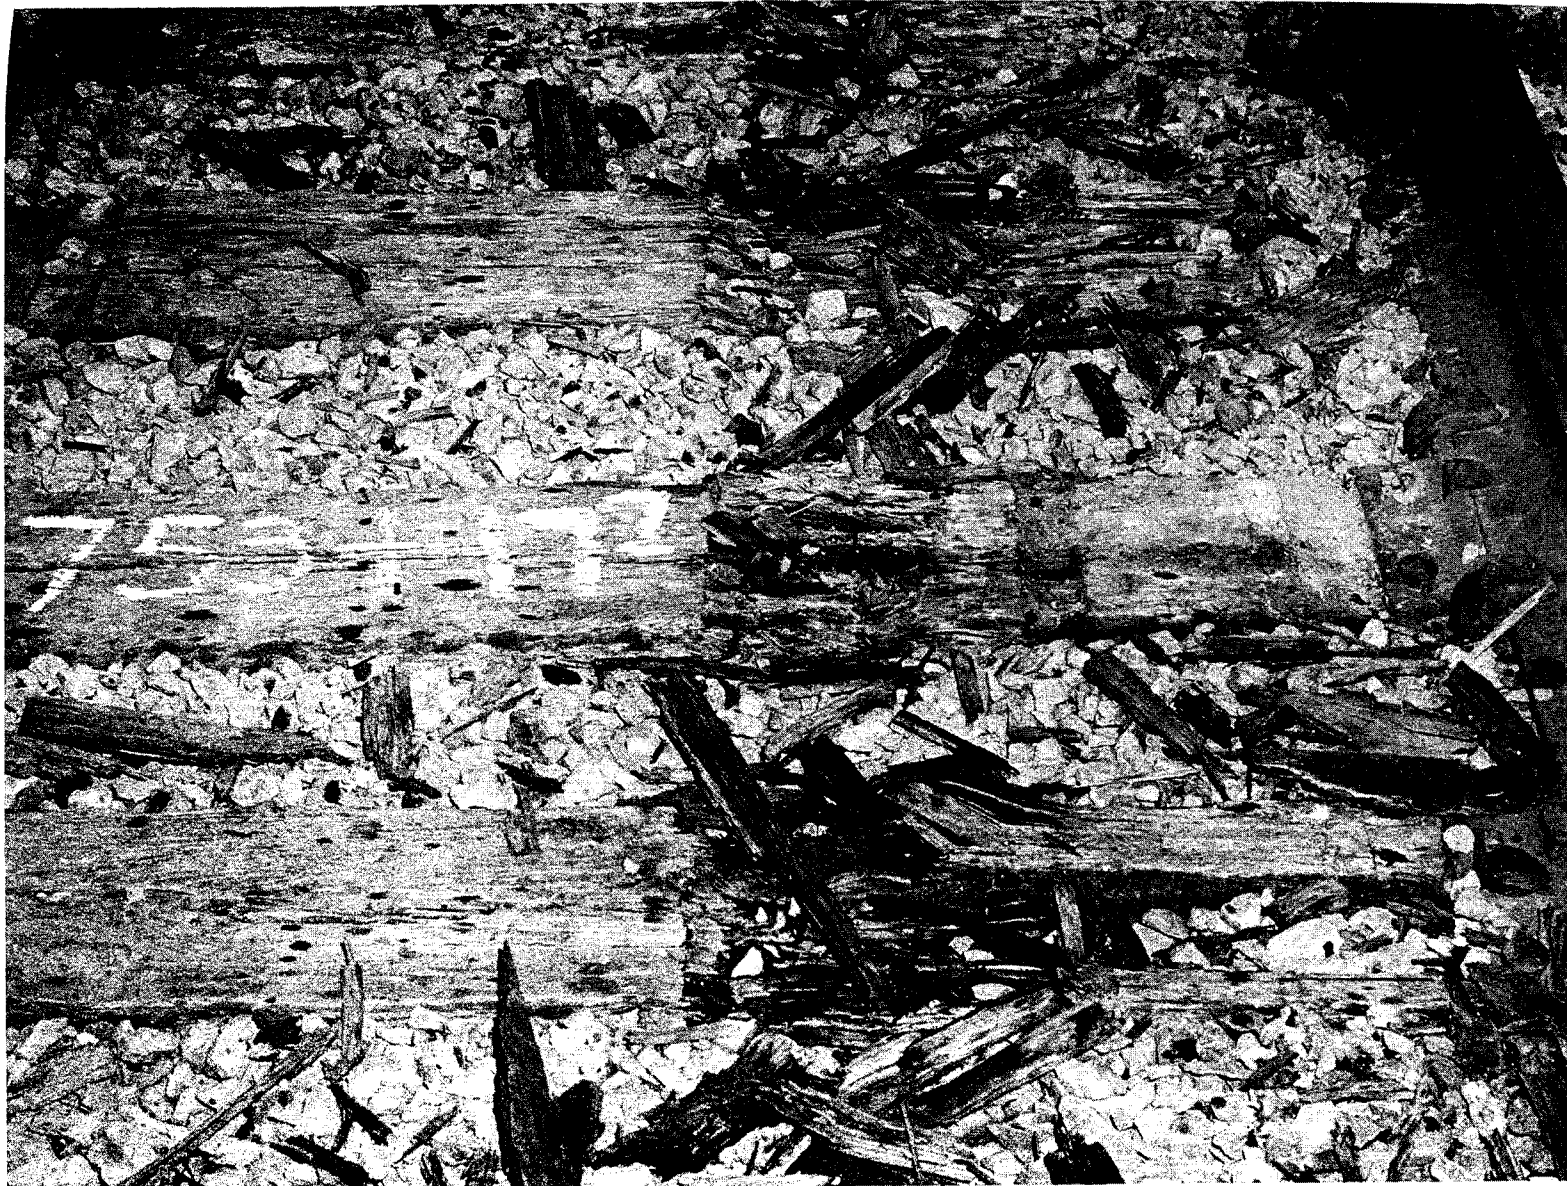
Figure 8 - View of marks on track at engineering station 753 + 17.7 looking north.

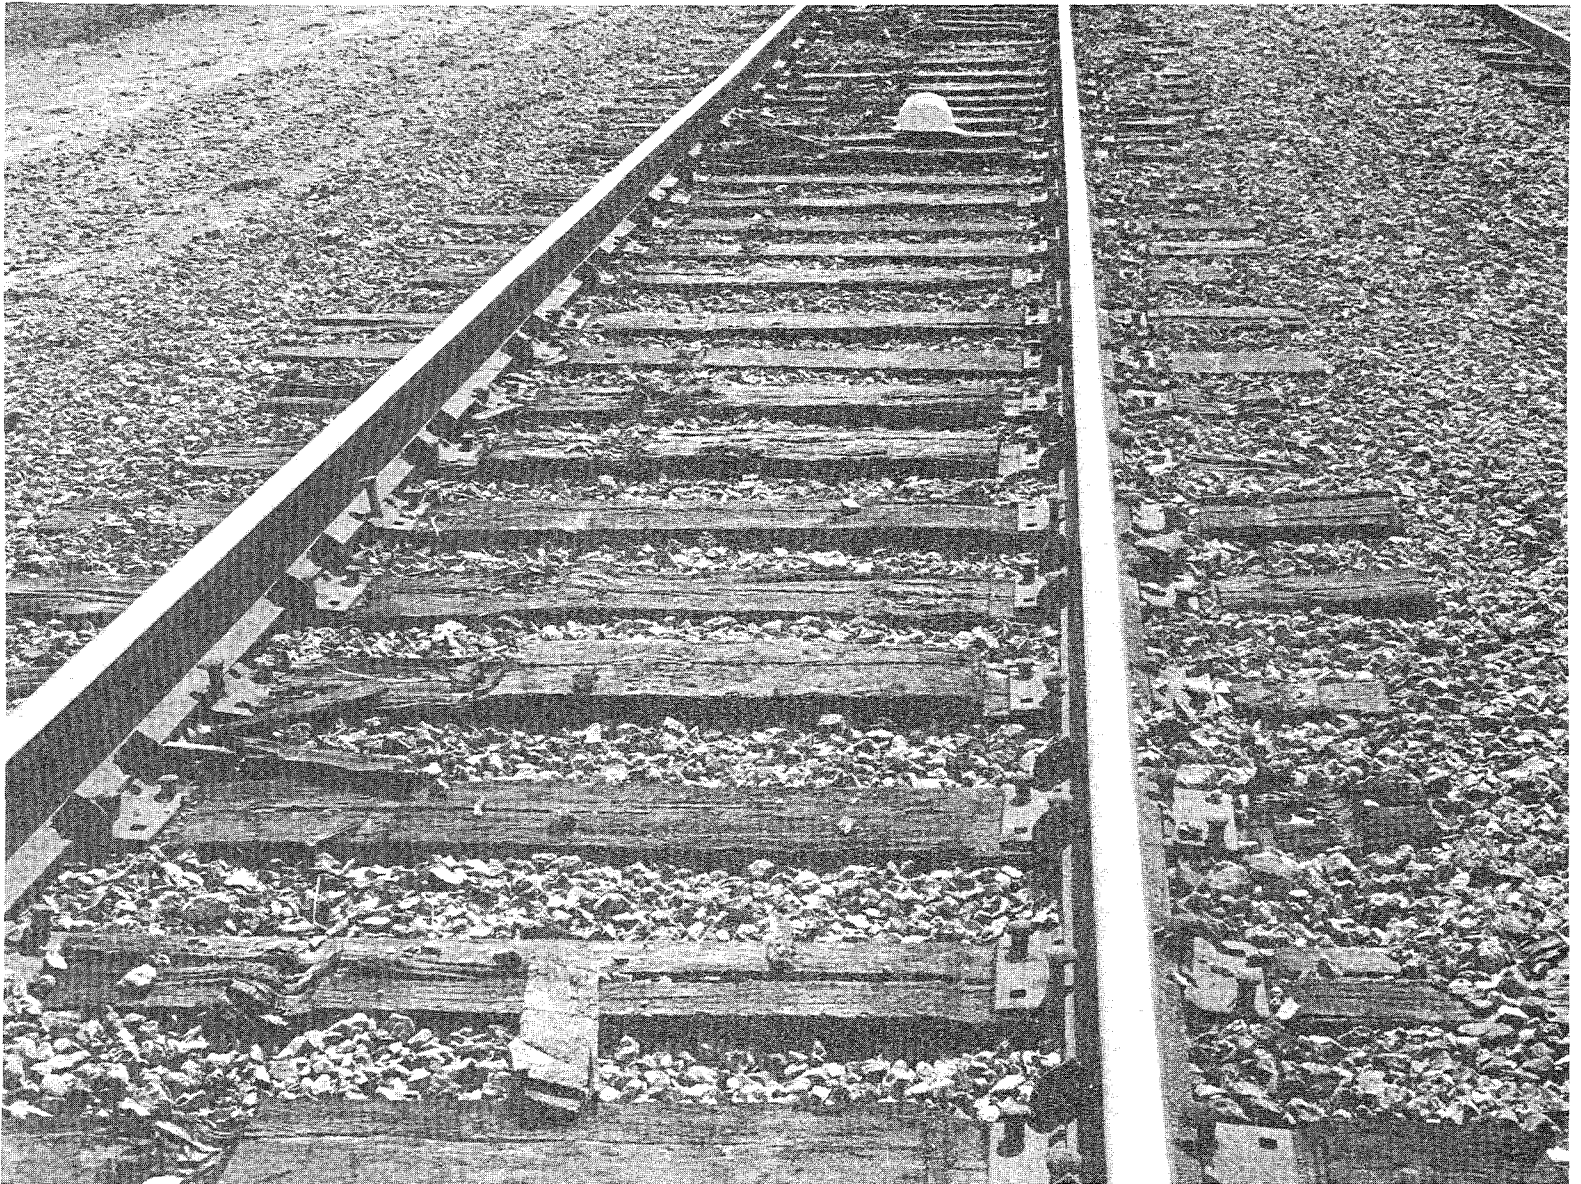
Figure 9 - View of marks on track looking south. Hard hat is located in the vicinity of engineering station 764 + 64.

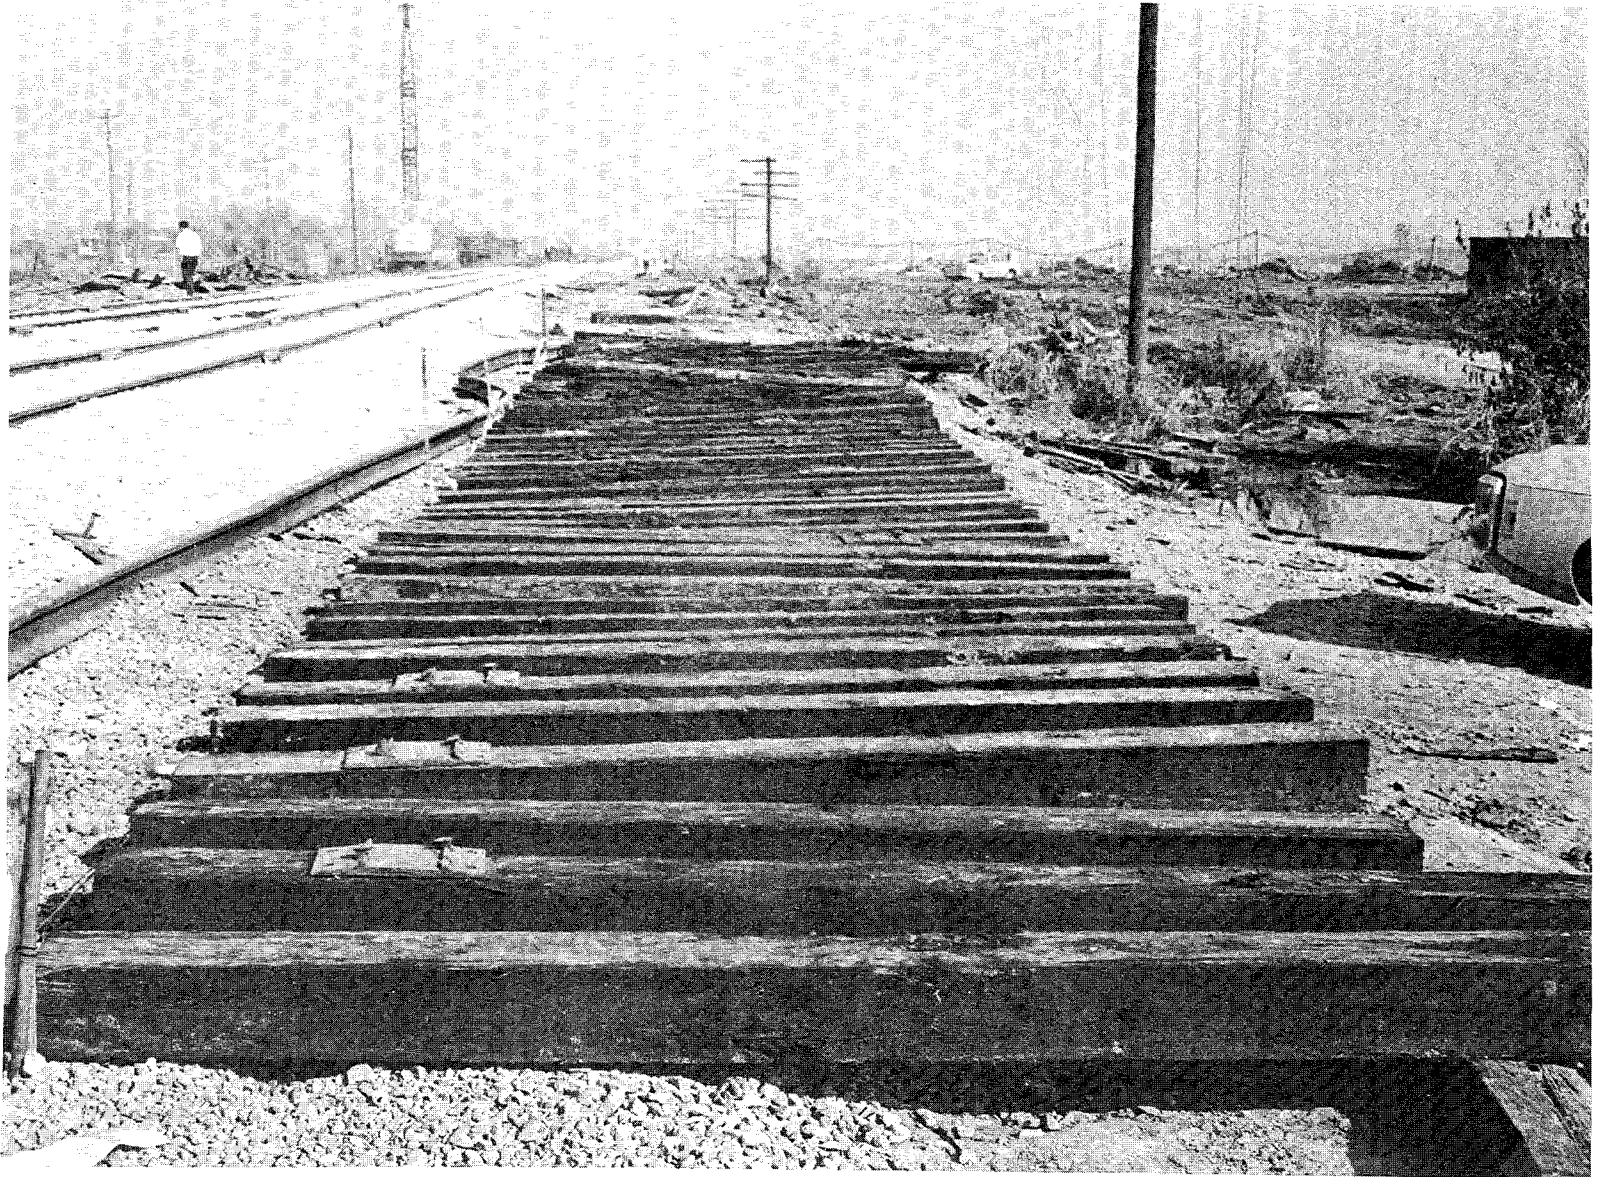
other condition was substantiated. The condition of the reconstructed switch ties and rail are shown in Figures 10 and 11.

Figure 10 - View looking north showing switch ties reassembled after the accident. Tie at the bottom of photograph is the first headblock tie. Rail to the left of switch ties is the east rail repositioned following the accident.

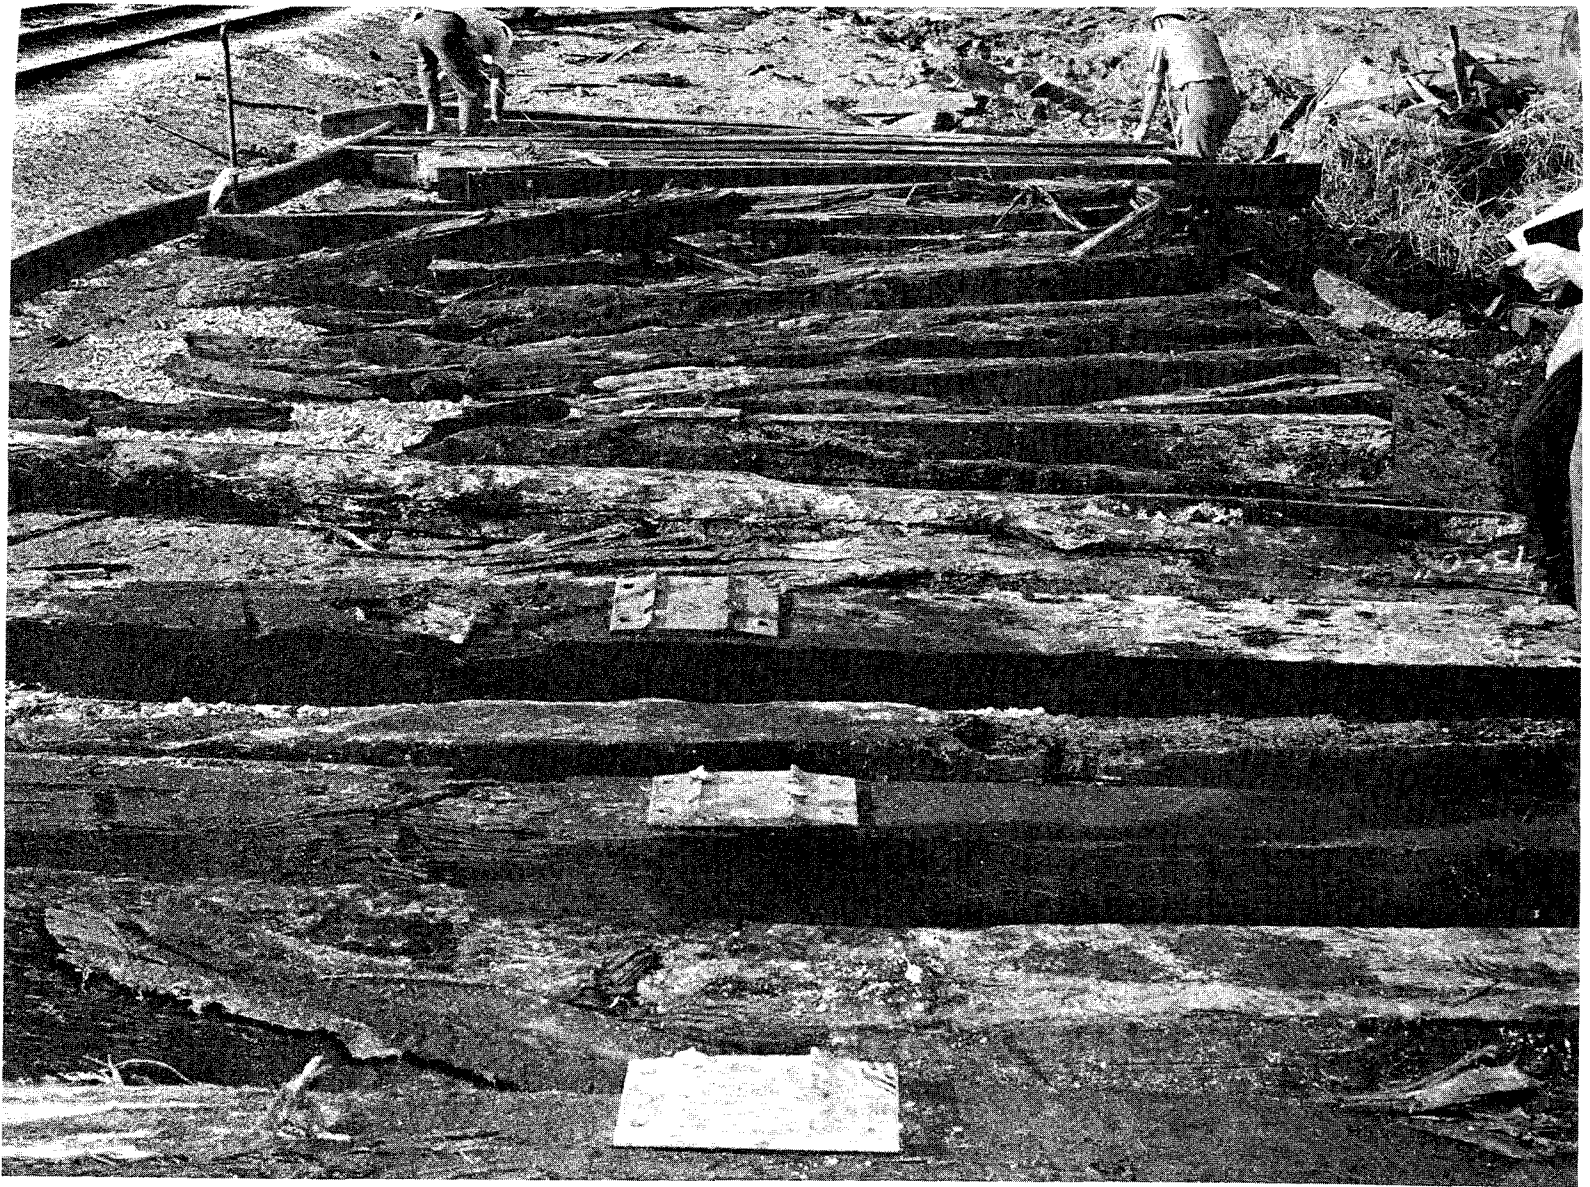
Figure 11 - View looking north showing switch ties reassembled after the accident. First tie at bottom of photograph was positioned as tie No. 42. The switch ties at the top of photo had not been installed at the time of derailment.

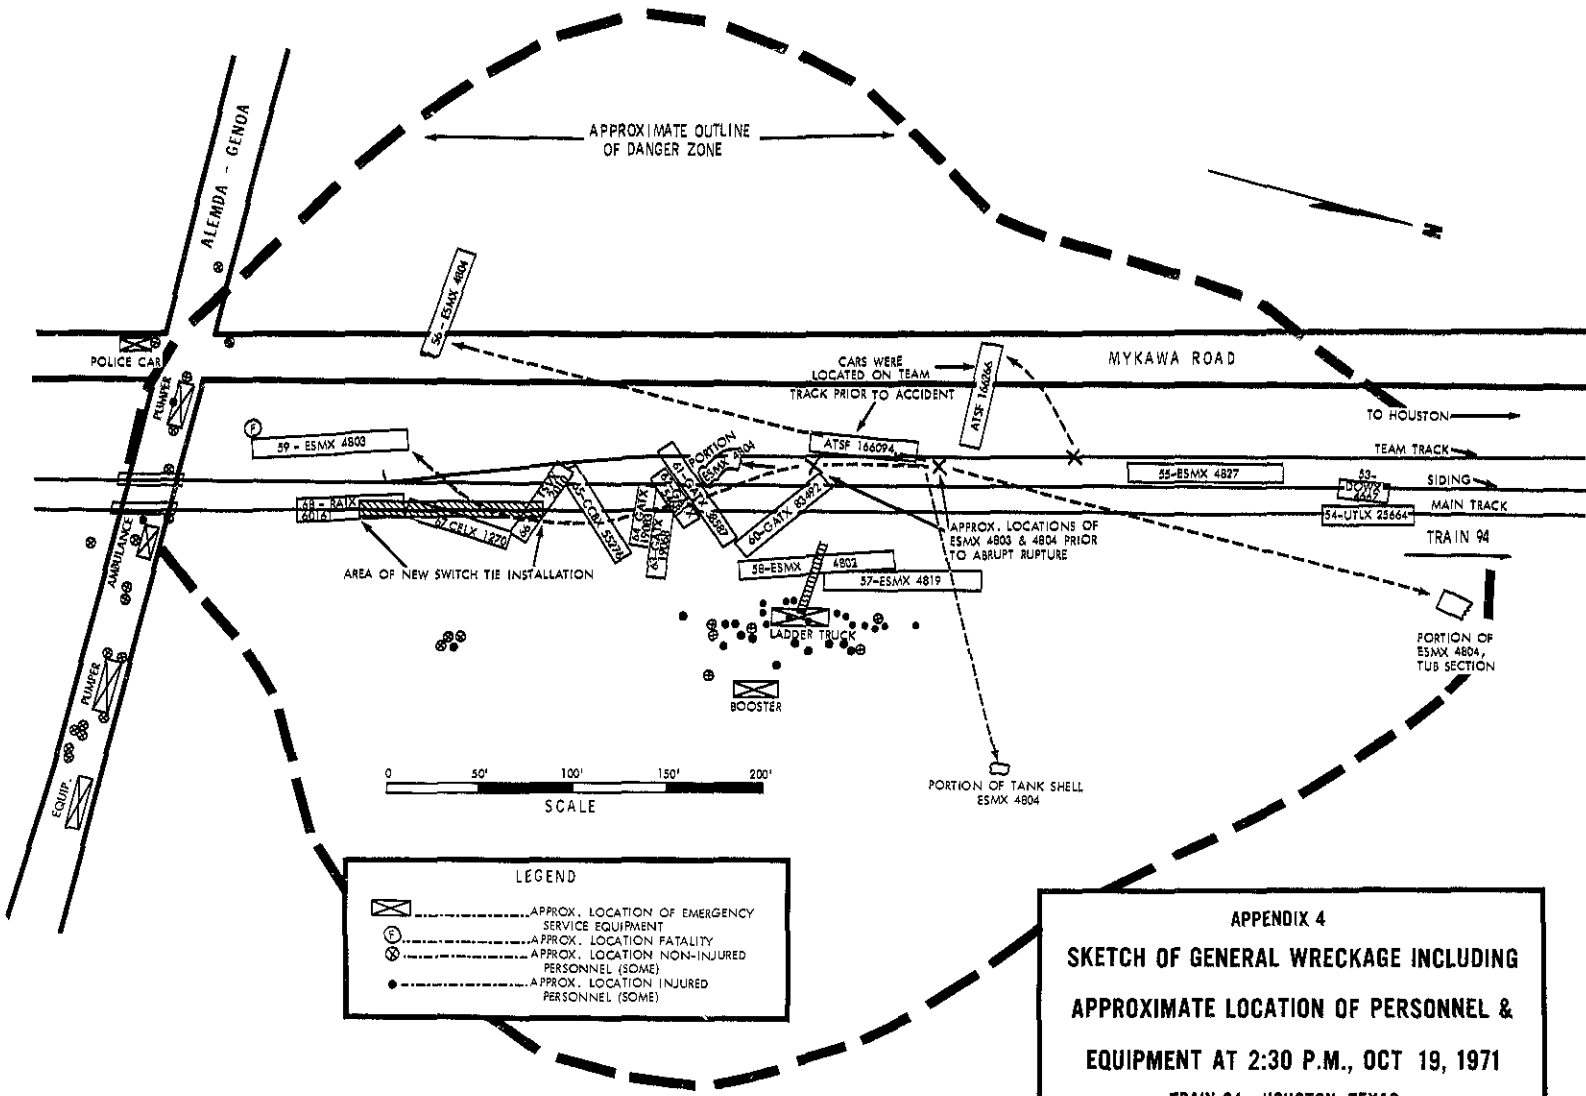
At approximately 2:30 p.m., a violent rupture and massive energy release occurred when the tank of ESMX 4804 suddenly failed. Numerous firemen and bystanders were injured. Locations of the firefighters and their equipment when the tank car ruptured are shown in Appendix 4.

Appendix 4 shows the location of fire department personnel whose positions at the scene of the fire could be established with a reasonable degree of accuracy. Scorch damage and debris were observed within the broken line on this sketch.
