INTERSTATE COMMERCE COMMISSION

REPORT OF THE DIRECTOR

MISSOURI PACIFIC RAILROAD

INVESTIGATION NO. 2184

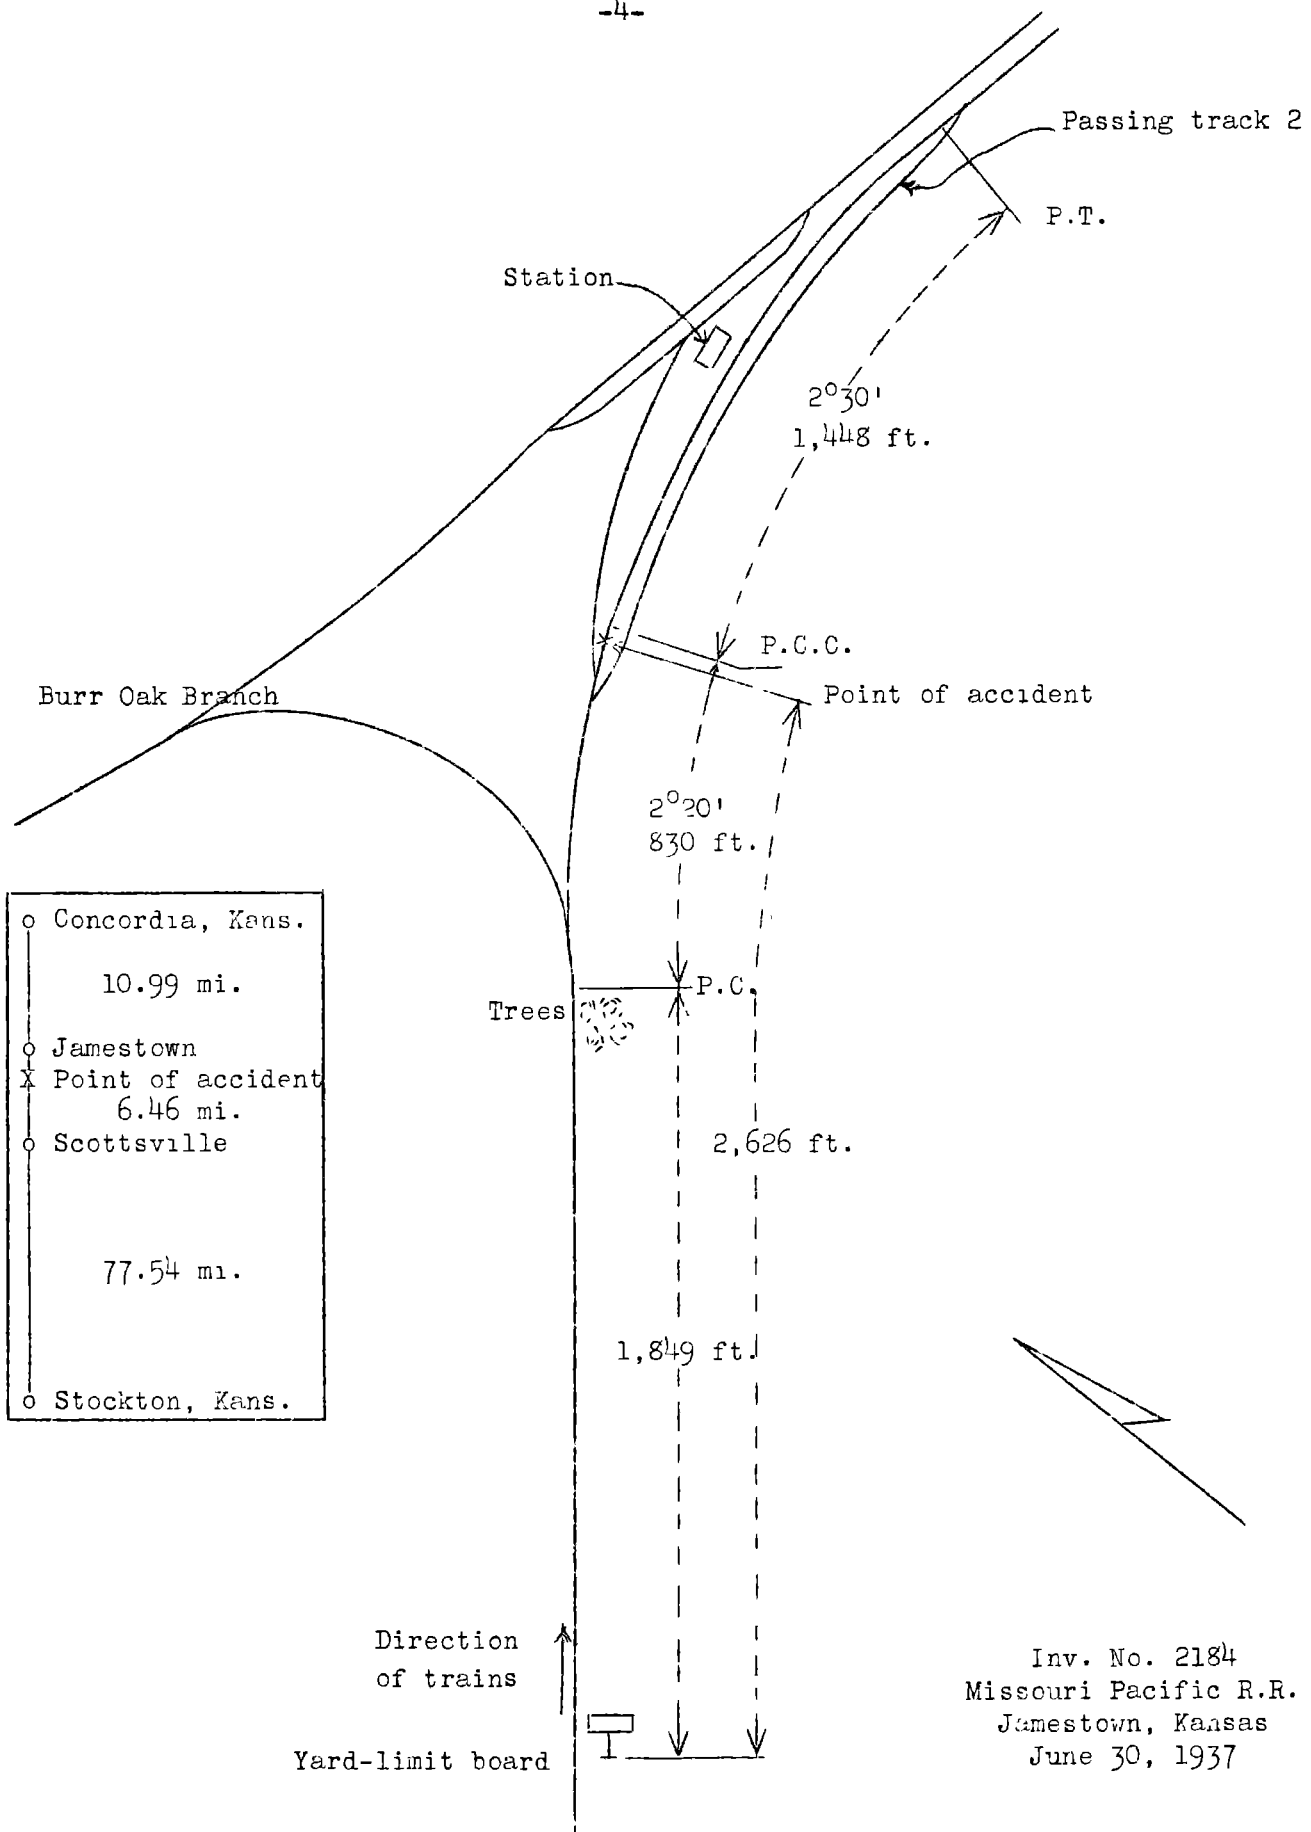
Inv. No. 2184  
 Missouri Pacific R.R.  
 Jamestown, Kansas  
 June 30, 1937

Due to trees and a side hill cut on the inside of the curve the view of the point of accident to be had by the engineman of an east-bound train, is limited to about 800 feet.

Conductor Wolfe and Engineman Holmes. This train left Scottsville, 6.46 miles from Jamestown, at 1.30 a.m., according to the train sheet, stopped at Jamestown with the caboose standing on the main track at a point 2,626 feet east of the west yard-limit board, and while switching was being performed at the head end of the train, the rear end was struck by Extra 101.
