INVESTIGATION NO. 3027  
MISSOURI PACIFIC RAILROAD COMPANY  
REPORT IN RE ACCIDENT  
AT KANSAS CITY, MO., ON  
SEPTEMBER 28, 1946

Accident at East Yard, Kansas City, Mo., on September 28,  
1946, caused by a crossover switch being improperly  
lined for the intended movement of an engine.

Inv. No. 3027  
Missouri Pacific Railroad  
Kansas City, Mo.  
September 28, 1946

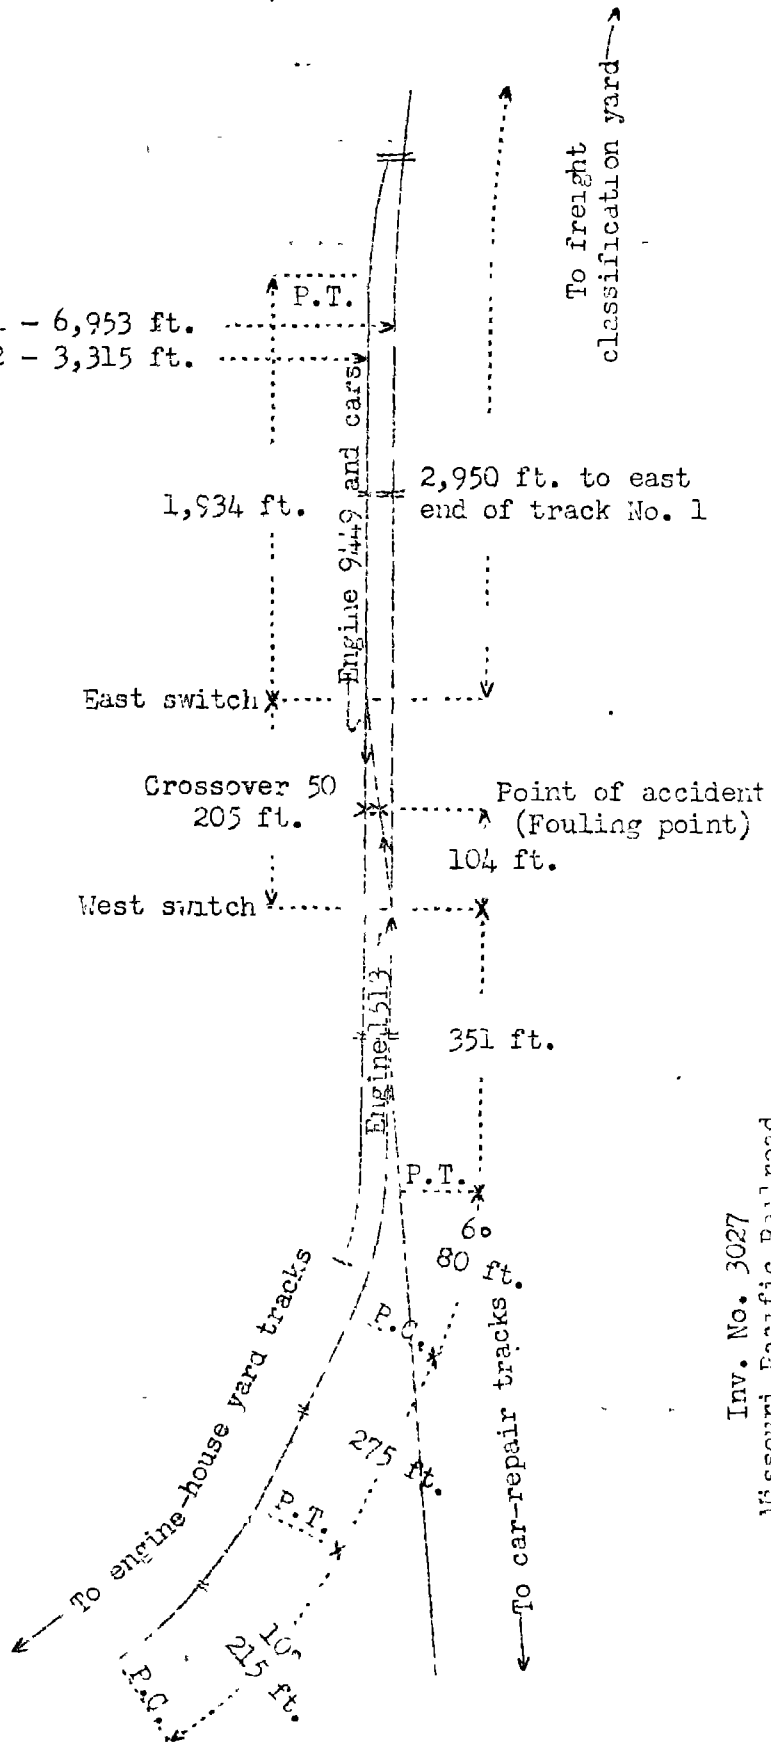
Lead track No. 1 - 6,953 ft.  
Lead track No. 2 - 3,315 ft.

This accident occurred on that part of the Kansas City Terminal Division designated as East Yard. In the vicinity of the point of accident two lead tracks, which parallel one another, connect a classification yard on the east and a car-repair yard and engine-house yard-tracks on the west. The lead tracks are designated from south to north as tracks Nos. 1 and 2, which are, respectively, 6,953 feet and 3,315 feet long. The east switch of a crossover, 205 feet long and designated as crossover 50, which connects tracks Nos. 1 and 2, is about 2,950 feet west of the east end of track No. 1. Crossover 50 is facing-point for east-bound movements from track No. 1 to track No. 2. Movement of engines on tracks Nos. 1 and 2 are governed by operating rules. The accident occurred at the fouling point of track No. 2 and crossover 50. From the east track No. 2 is tangent throughout a distance of 1,934 feet to the east switch of crossover 50 and some distance westward. From the west on track No. 1 there are, in succession, a 10° curve to the left 215 feet in length, a tangent 275 feet, a 6° curve to the left 80 feet and a tangent 351 feet to the west switch of crossover 50. The grade is practically level.

The switchstand of the west switch of crossover No. 50 is of the hand-throw low-stand type. Neither a target nor a switch lamp or other illuminating device is provided on the switchstand.

Engine 9449, headed eastward and pushing 9 cars westward, was moving on track No. 2 at an estimated speed of 2 miles per hour when the engine was struck by engine 1513 at the fouling point of crossover 50.

Engine 1513, headed eastward, was moving eastward on track No. 1 at an estimated speed of 2 miles per hour when it entered crossover 50 at the west switch and struck engine 9449.

If the switchstand of the west crossover-switch had been provided with a lamp or other illuminating device, it would have indicated to the employees involved that the switch was not properly lined for the intended movement of engine 1513, and this accident could have been averted.
