REPORT NO. 1991

REPORT OF THE DIRECTOR OF THE BUREAU OF SAFETY CONCERNING AN
ACCIDENT ON THE MISSOURI PACIFIC RAILROAD NEAR LITTLE
ROCK, ARK., ON JUNE 23, 1935.

Inv. No. 1991
Missouri Pacific R.R.
Little Rock, Arkansas
June 23, 1935

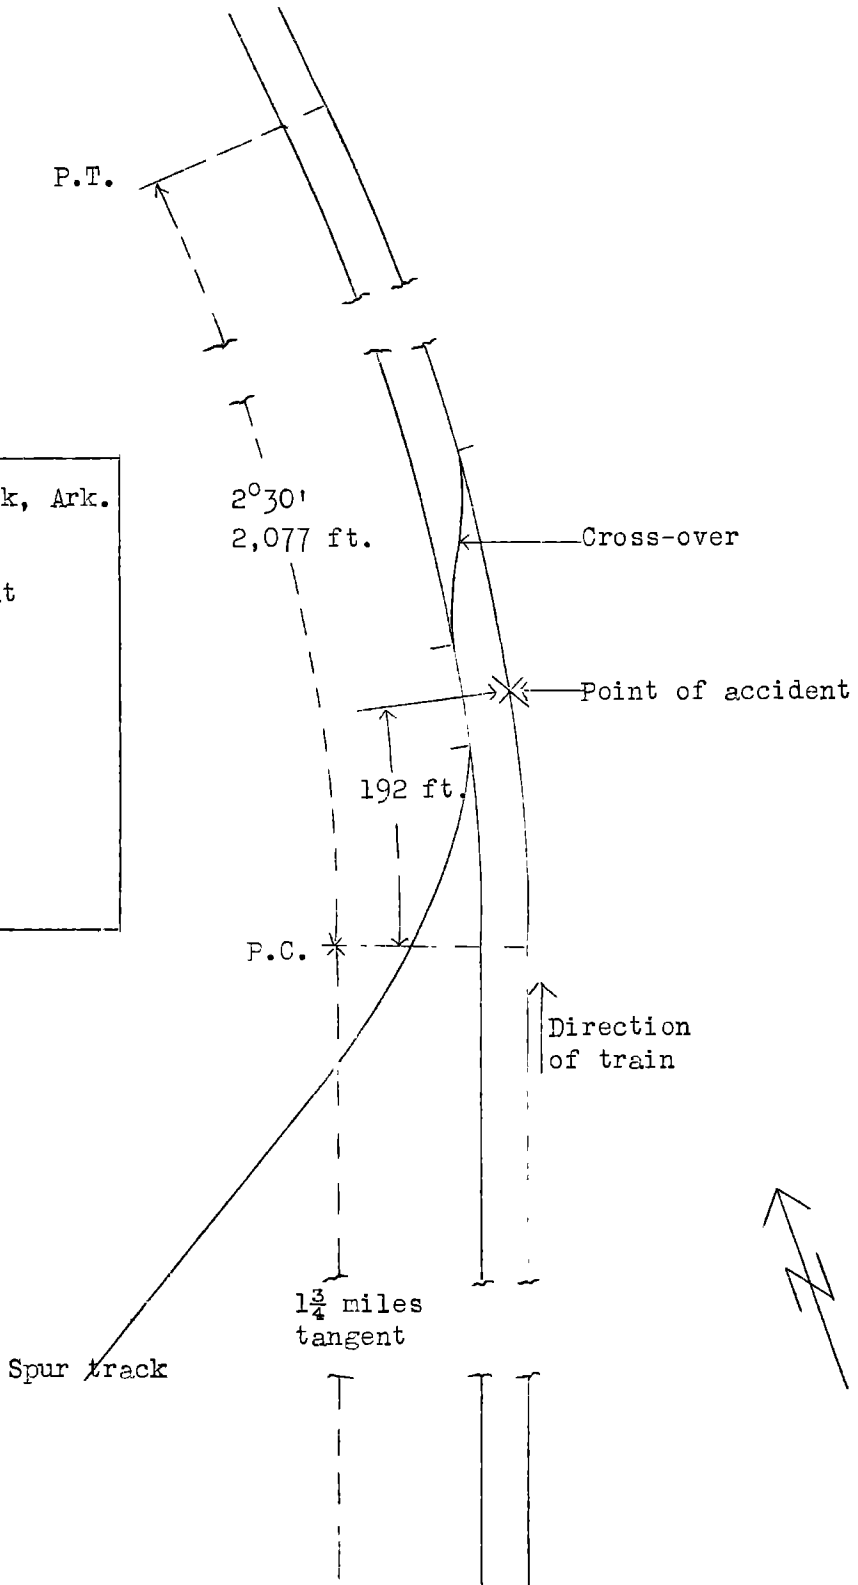
Engine 1535, its tender, the first 27 cars, and the forward truck of the twenty-eighth car were derailed. The engine stopped on its right side at a point 410 feet north of the point of derailment; the first 26 cars were piled up within a distance of about 150 feet, obstructing both main tracks, and 24 of them were destroyed by fire that broke out immediately after the accident. The employee injured was the fireman.
