ACCIDENT ON THE
MISSOURI PACIFIC RAILROAD

LITTLE ROCK, ARK.

APRIL 17, 1938.

INVESTIGATION NO. 2267

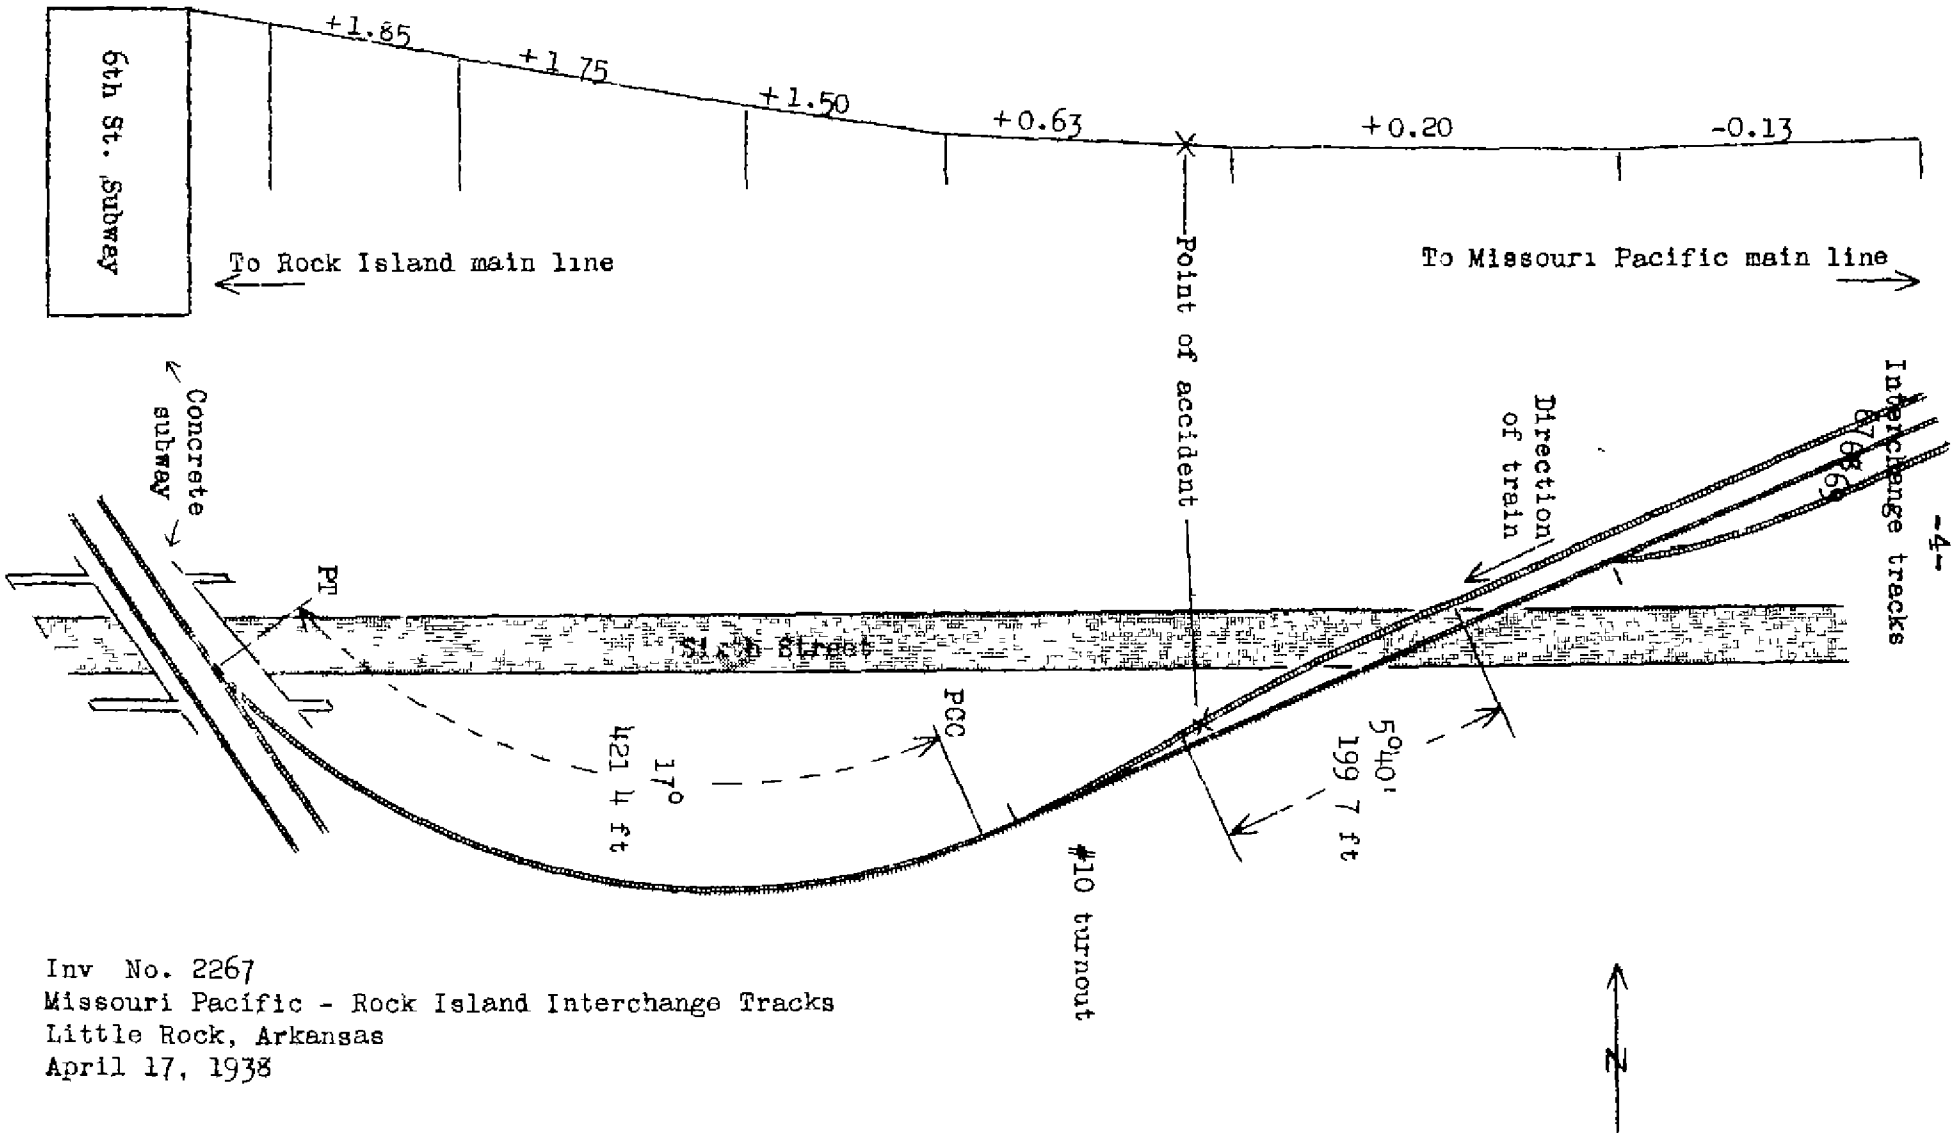
Inv No. 2267
 Missouri Pacific - Rock Island Interchange Tracks
 Little Rock, Arkansas
 April 17, 1938

The trailing-point switch involved consists of a #10 turnout; the initial derailment occurred 102.9 feet east of the switch points, at a compromise rail joint in the north rail of track No. 67, where the rail-section changes from 85 pound to 75 pound.

mounted, or 15.8 feet, the rails were found to be level under load, and without load the north rail was 1/8 inch higher than the south rail. At a point 40 feet eastward the north rail was 1 inch higher than the south rail under load, and without load it was 1-1/8 inches higher. The total cross level variation between the twenty-fourth tie eastward and the tie at the compromise rail joint was 3 1/2 inches. Westward from the point where the wheels mounted the rail a distance of 7 ties, the cross levels of the track under load showed the north rail to be 1/4 inch higher than the south rail. The effects in these differences in cross levels would have a tendency to lift the front trucks of the most easterly car when the rear trucks are opposite the twenty-fourth tie east; also, the effect of the rear truck in the preceding car when about opposite the seventh tie west would have a tendency, due to the difference in cross levels, to raise the following car to the point where the wheels would mount the tops of the rails. At the turnout curve east of the switch the measured superelevation averaged almost 1 inch, the maximum of 1 1/2 inches being at the thirty-third tie east. The required superelevation for a 5°40' curve at 10 miles per hour is 1/2 inch, for equilibrium speed. The excess elevation in the turnout curve had a direct effect at the point of derailment, tending to throw the center of gravity of the car to the south of the center line of the track. At the compromise joint at which the wheel mounted the rail on the gauge side rail wear of 1/8 inch was indicated. The gauge side of the two rail ends in the joint were flush. From the marks and position of the equipment after the accident, he was of the opinion that the front wheels of S.P. 69135 were the first wheels to become derailed, followed by the rear wheels of the leading truck and after being derailed and reaching a point opposite the straight lead rail, the entire truck and leading end of this car continued in a direction to the right of the path taken by the car ahead of it, causing the sixth car to become derailed which movement was transmitted in turn to the fifth and fourth cars. He stated that he did not make a mechanical inspection of the equipment, but it was his opinion that track conditions as previously described were the primary cause of the derailment.

Inspection of track No. 67 east of the point of derailment did not disclose any indication that defective or broken equipment would have contributed to the cause of the accident. The track was in good condition as to rails, spikes, ties and gauge; however, the cross levels from the point of accident to a point about 250 feet therefrom were very irregular and found to be substantially the same as described by the division engineer.
