## INTERSTATE COMMERCE COMMISSION

ACCIDENT ON THE

MISSCURI PACIFIC RAILROAD

INVESTIGATION NO. 2093

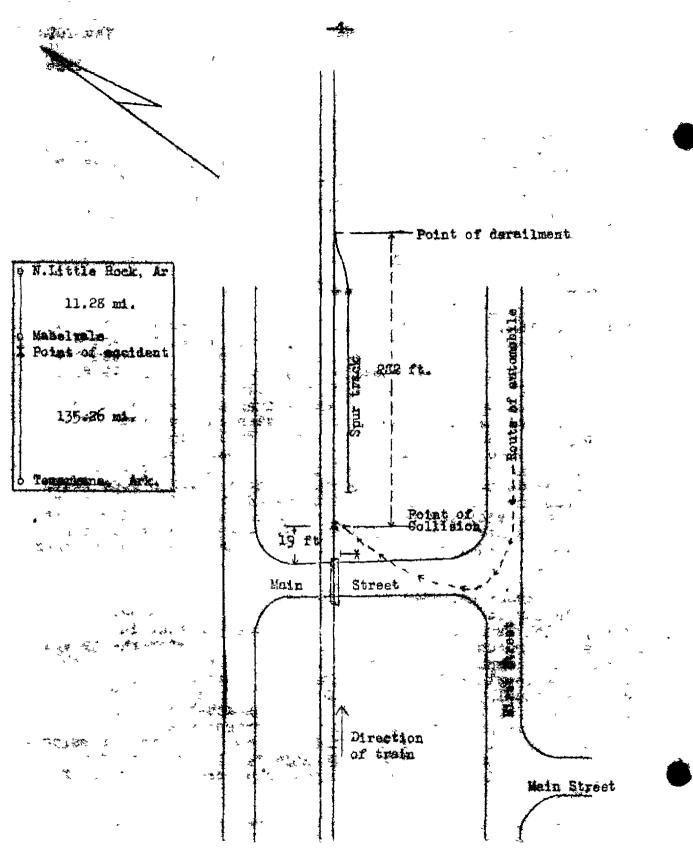
Inv. No. 2093 Missouri Pacific R.R. Mabelvale, Ark. September 8, 1936.

This accident occurred on the Little Rock District of the Arkansas Division which extends between North Little Rock and Texarkana, Ark., a distance of 146.5 miles, in the vicinity of the point of accident this is a double-track line over which trains are operated by timetable, train order and an automatic block-signal system. The accident occurred at a point 19 feet north of the Main Street crossing at Mabelvale. Approaching this point from the south the truck is tengent for a distance of approximately 1 mile, this tangent extending for some distince beyond. The grade for north-bound trains is level for a distance of 1,000 feet, 0.112 percent ascending for a distance of 500 feet and then level for a distance of 300 feet to the point of accident. A whistle board is located 1,318 feet south of the crossing and the maximum authorized speed for passenger trains in this vicinity is 70 miles per hour. A trailing-point switch located 317 feet north of the crossing leads to a spur track, 278 feet in length, which parallels the north-bound track on the cast.

First Street parallels the tracks on the east and intersects Main Street at a point 125 feet from the crossing. Lain Street, which is a gravel road approximately 25 feet in width, crosses the tracks at right angles. At the crossing the gravel is laid on an asphalt base, with the exception that the northbound track is planked. The crossing is in good condition and is practically level, although there is a descent of about 4 inches between the north-bound and the south-bounds tracks. The crossing is protected by a standard crossing sign of the cross-bar type, located at the northeast corner of the crossing and bearing the words "RATIROAD CROSSING". The driver of a vehicle approaching from the east has an unobstructed view of this sign.
